# » Grid Incident in Czech Republic on 4 July 2025

ICS Investigation Expert Panel  
Factual Report

19 December 2025

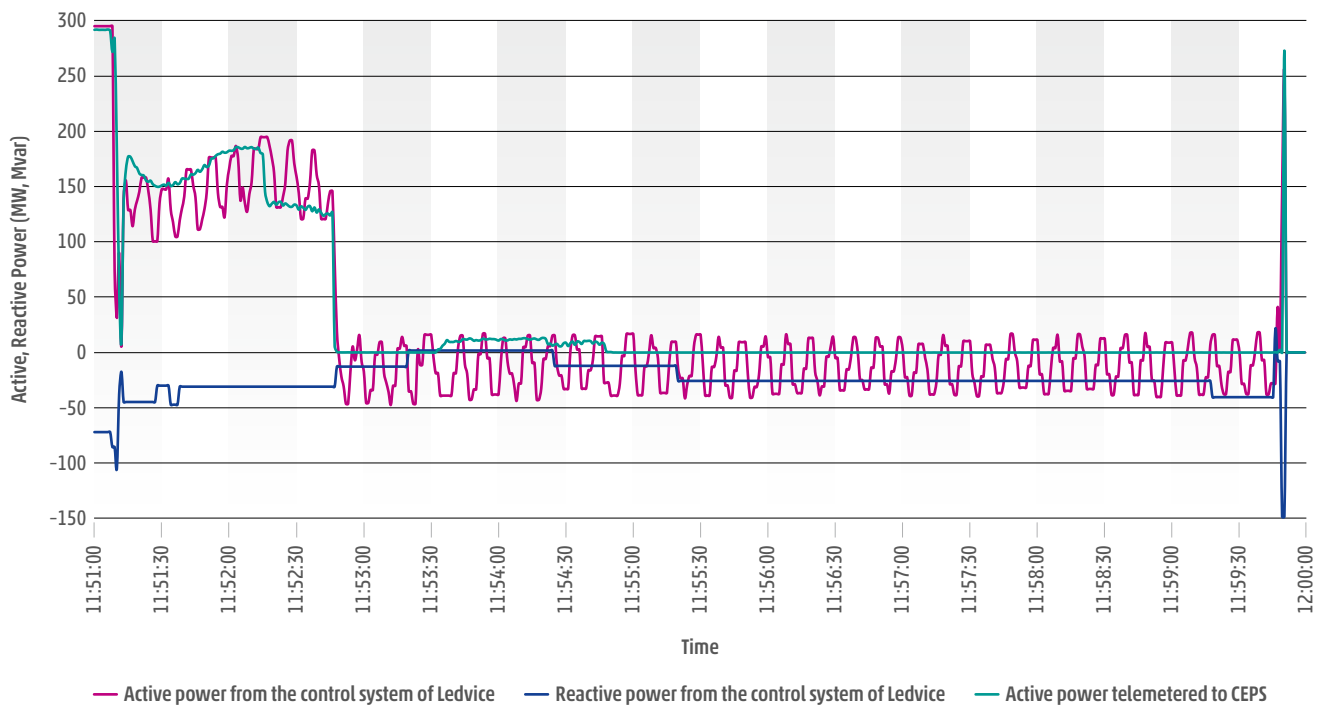
Figure 3.10: Trend of power output at generator terminals of ELED unit 6 from 11:51 to 12:00

Unit 6 of the Ledvice power plant lost all active power output due to a boiler outage caused by high steam temperature behind the high-pressure bypass stations.

The high temperature was due to a stuck high-pressure turbine bypass valve, caused by a defective relay on the actuator motor for that valve.

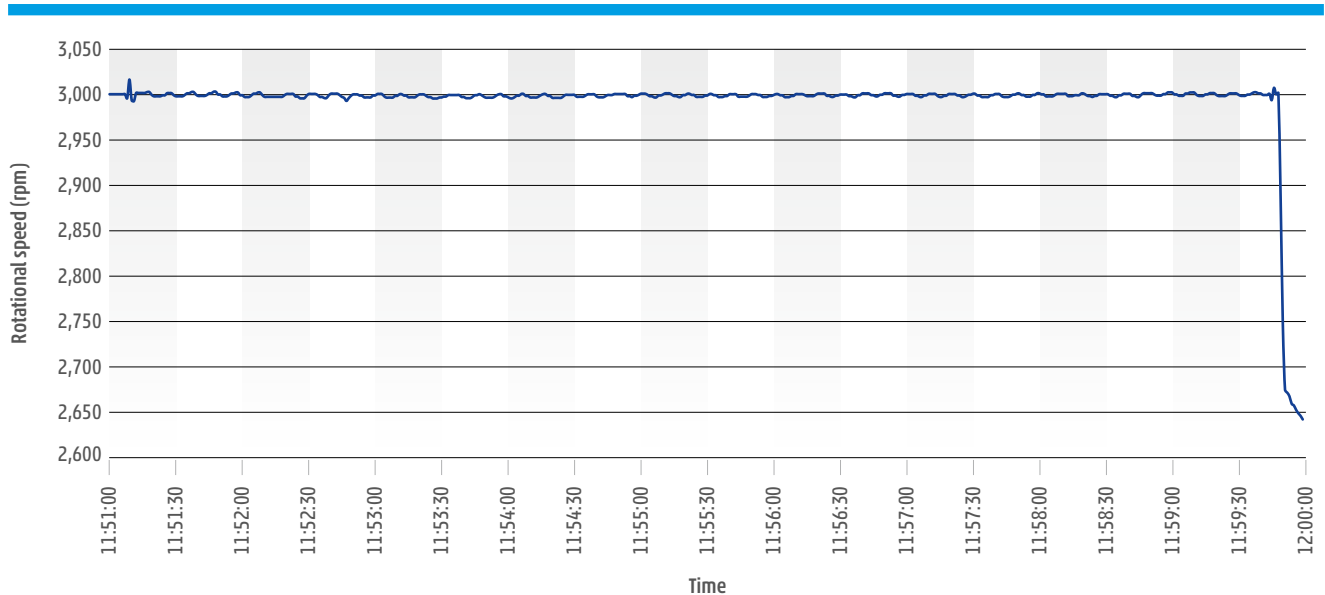
Figure 3.12: Trend of measured turbogenerator speed of ELED unit 6 from 11:51 to 12:00

Since a frequency deviation of 200 mHz as a threshold for transition to droop speed control mode corresponds to 12 rpm, unit 6 recorded a deviation greater than the set limit.

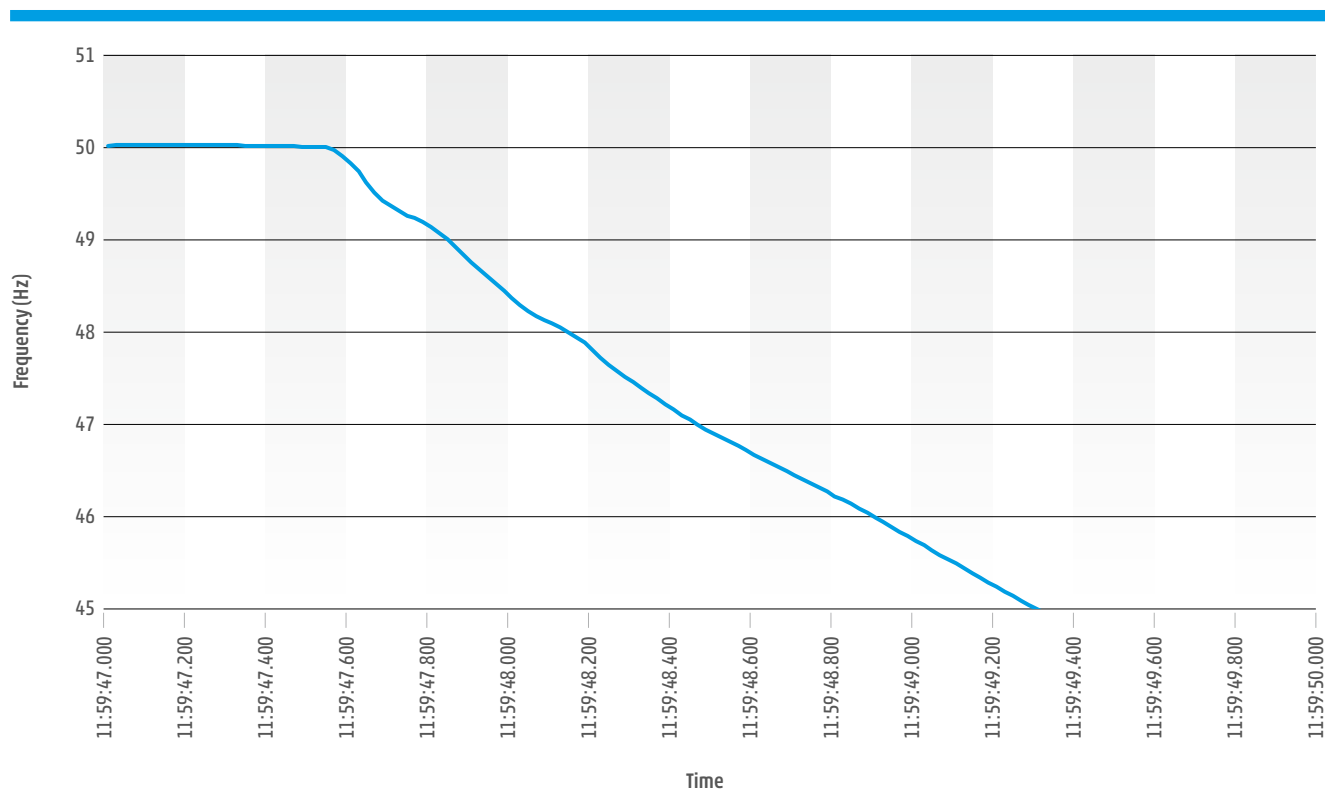
Figure 3.22: Recorded frequency collapse in the WAMS frequency measurement at the CST substation

As mentioned above, the WAMS measurement in the area affected by the voltage outage is installed at the Čechy Střed substation. The following course of the frequency collapse of the already-formed deficit island after the Krasíkov busbar coupler was switched off at 11:59:47 is also taken from this measurement.

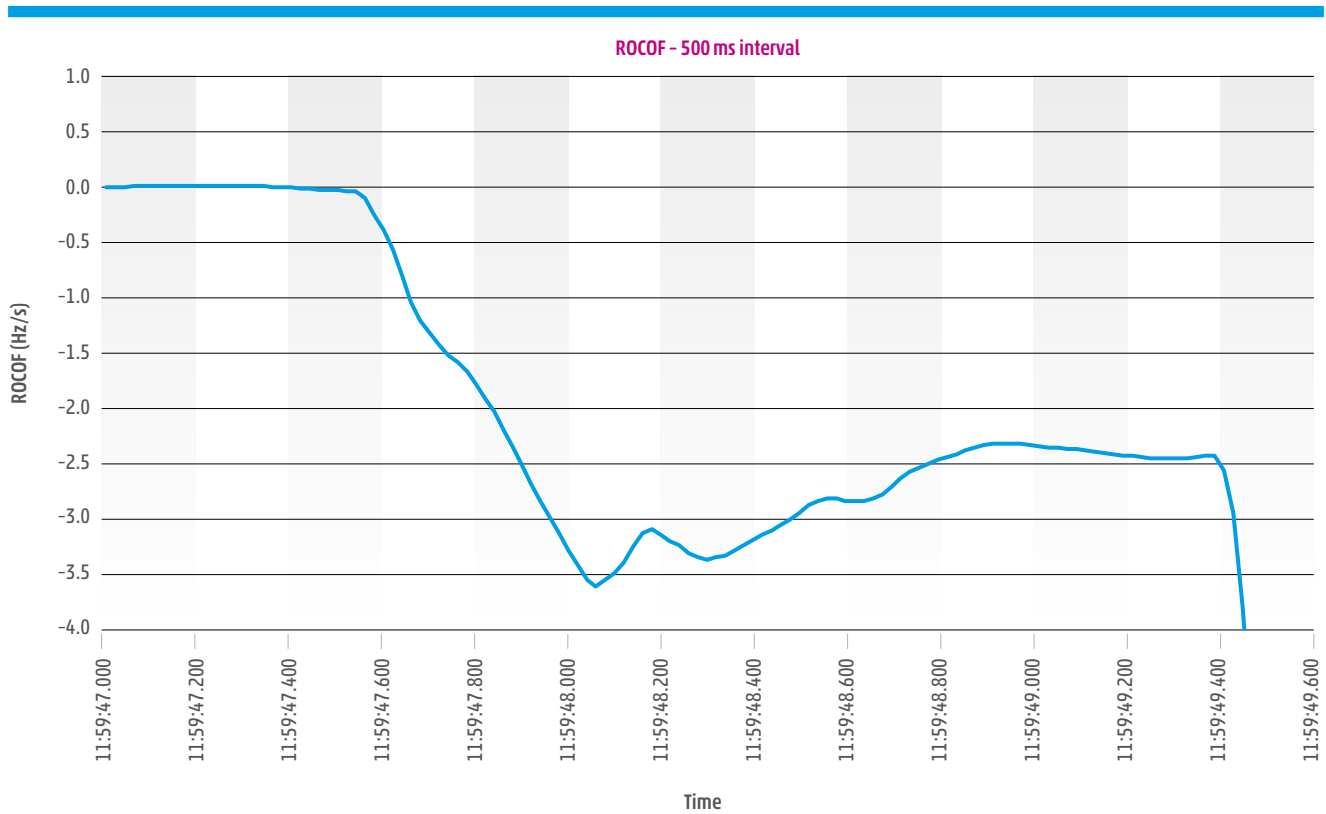
Figure 3.23: RoCoF profile during the frequency collapse

value during the frequency collapse is shown in Figure 3.23. The highest recorded RoCoF value was around  $-3.5 \text{ Hz/s}$ .

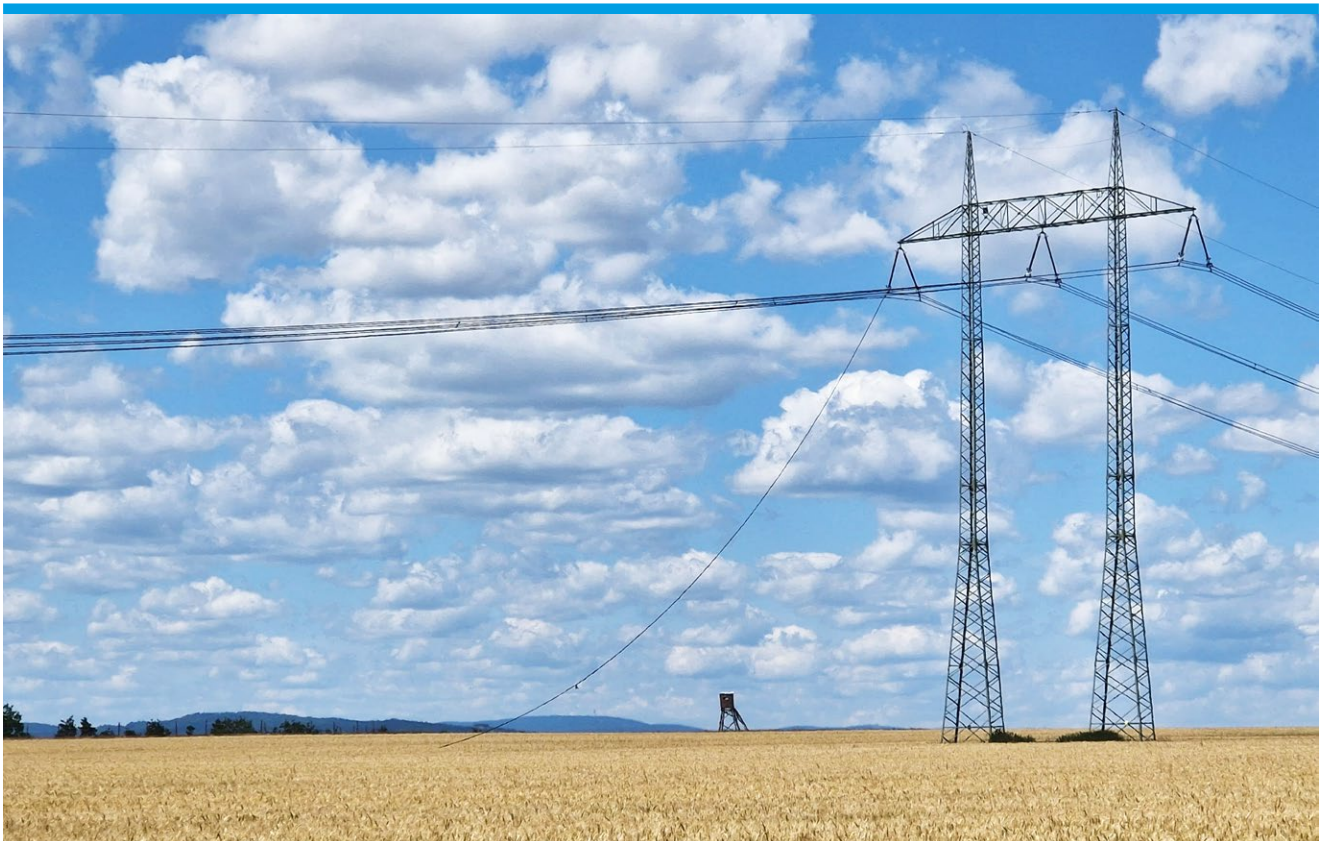
Figure 3.25: Photo of the fallen conductor

The unsuccessful autoreclosure of V411 in phase L2 was caused by a cable break. After further examination and analysis, it was found that the tensile coupling had an insufficiently tight connection at the aluminium part of the conductor. Ultimately, the rope at the coupling broke, and the conductor fell.

Distance protection relays detected a fault 15 km from the HRA4 substation and 35 km from the VYS4 substation. The fault was ultimately located 14 km from the HRA4 substation. The fault was switched off in 81 ms.

At 23:13, the V411 line was switched on following repairs.
