» Grid Incident in Czech Republic on 4 July 2025

ICS Investigation Expert Panel
Final Report

26 June 2026

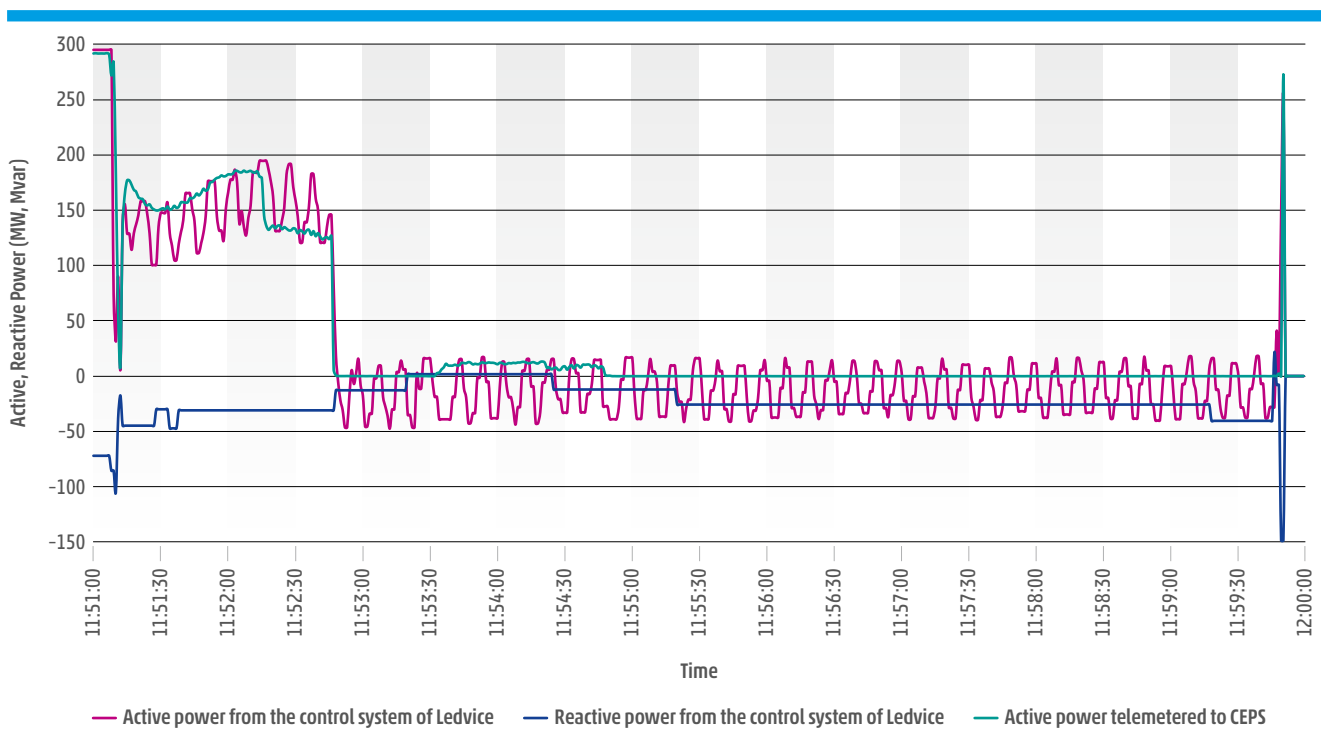
Figure 3.10: Trend of power output at generator terminals of ELED unit 6 from 11:51 to 12:00

The following series of graphs illustrates the dynamic behaviour of TPP Ledvice unit 6. The graph of active power output shows periodic oscillations for unit 6 at TPP Ledvice. Such oscillations are not present in the telemetered active power data transmitted to the ČEPS dispatching control system.

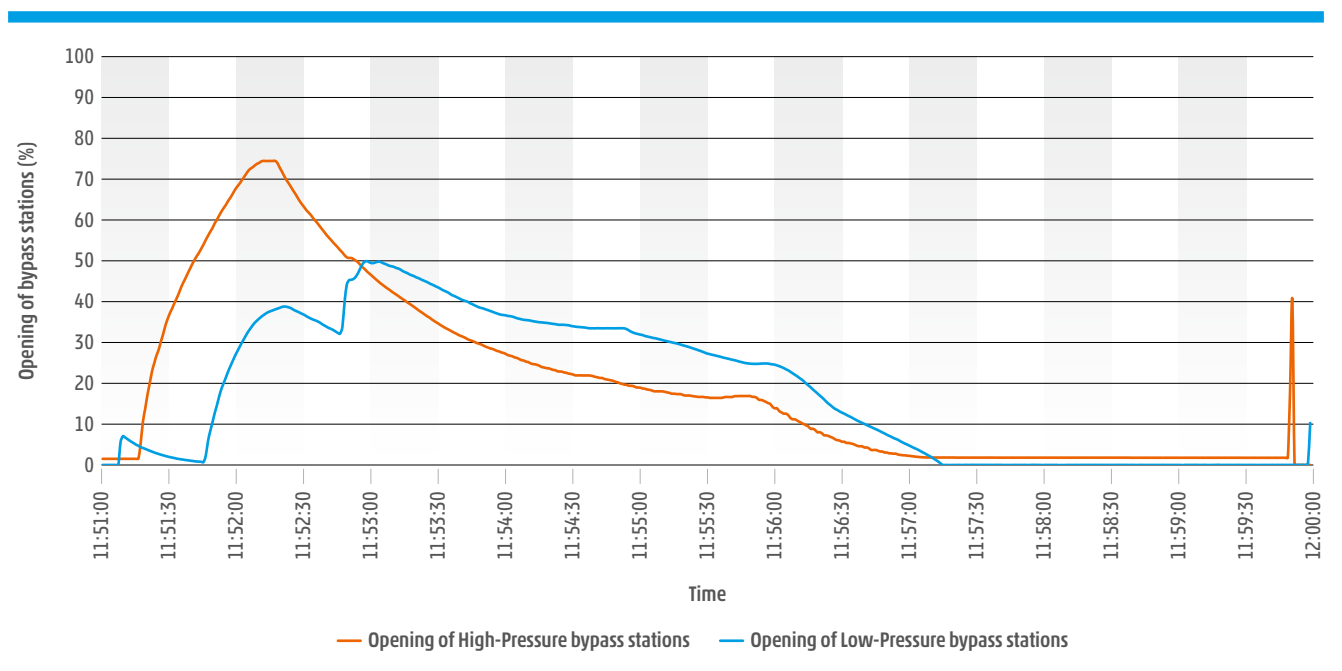
Figure 3.15: Trend of bypass stations opening for ELED unit 6 from 11:51 to 12:00

Unit 6 of the Ledvice power plant lost all active power output due to a boiler outage caused by high steam temperature behind the high-pressure bypass stations. The high temperature was due to a stuck high-pressure turbine bypass valve, caused by a defective relay on the actuator motor for that valve. According to the power plant, the fault was in no way related to the droop speed control mode operation.

The following graphs show profiles of the opening of bypass stations and control valves of TPP Ledvice unit 6. The graphs show that changes in the variables occurred already after the V411 outage.

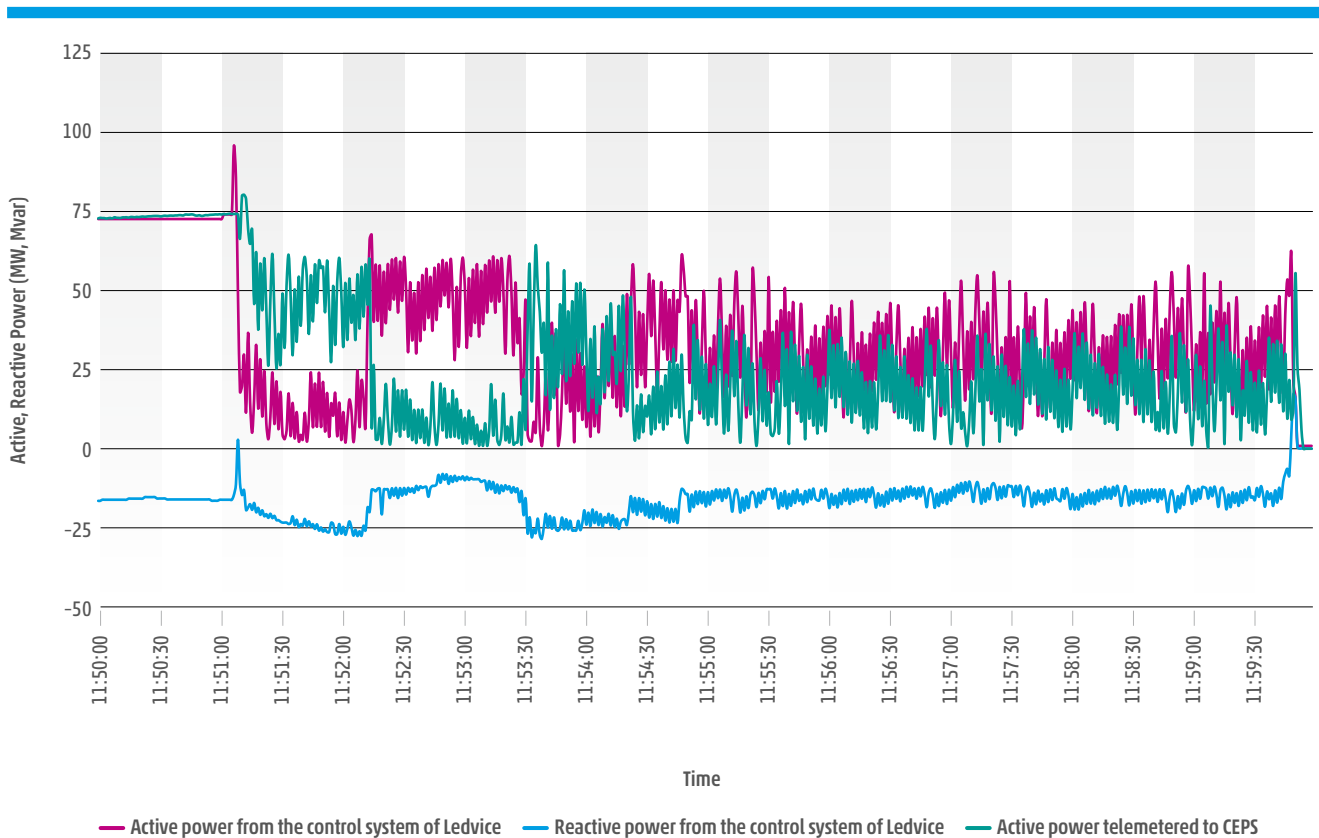
Figure 3.16: Trend of power output at generator terminals of ELED unit 4 from 11:50 to 12:00

Figure 3.16 shows the output of the TPP Ledvice unit 4 generator, again compared with the values from the Ledvice power plant control system and the telemetered values to the ČEPS dispatch control system. From the trends, it is evident that unit 4 experienced oscillations, and the output active power telemetered to the ČEPS dispatch control system differs from the output power recorded in the power plant control system. Therefore, it is also more difficult to calculate the total loss of active power generation after the V411 outage.

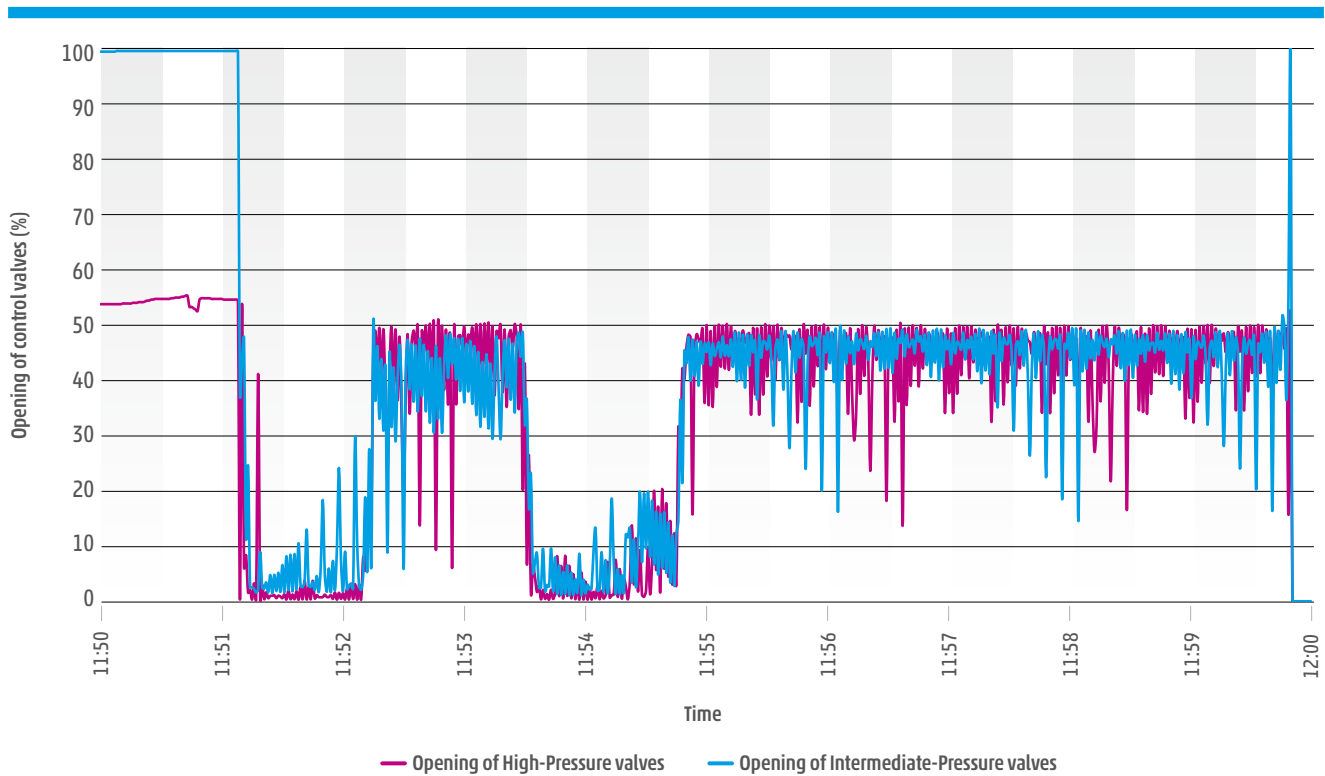
Figure 3.17: Trend of control valves opening for ELED unit 4 from 11:50 to 12:00

Oscillations are also evident in the opening of the turbine control valves on TPP Ledvice unit 4 following the V411 trip and the switch to droop speed control mode.

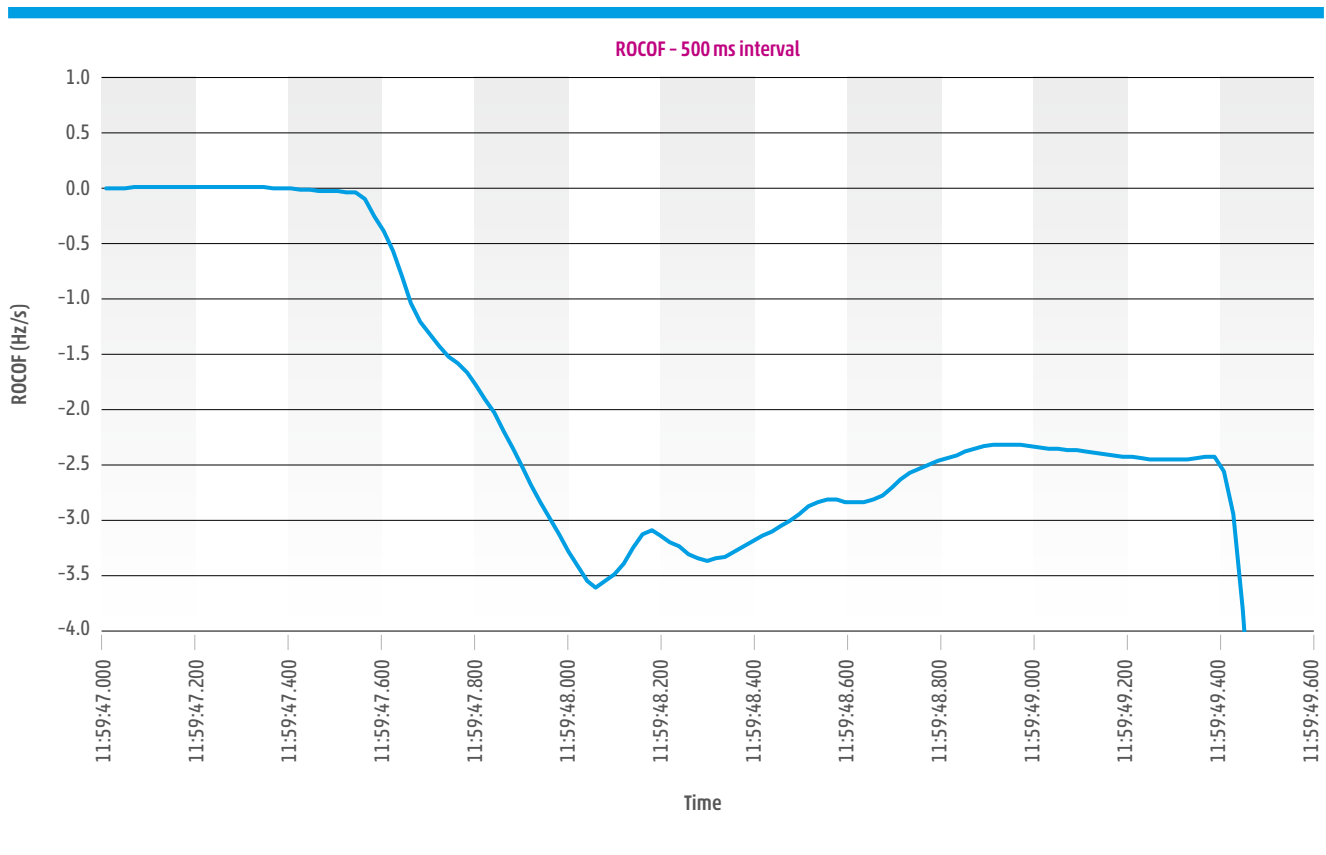
Figure 3.23: RoCoF profile during the frequency collapse

The RoCoF value during the frequency collapse is shown in Figure 3.23. The highest recorded RoCoF value was around -3.5 Hz/s.

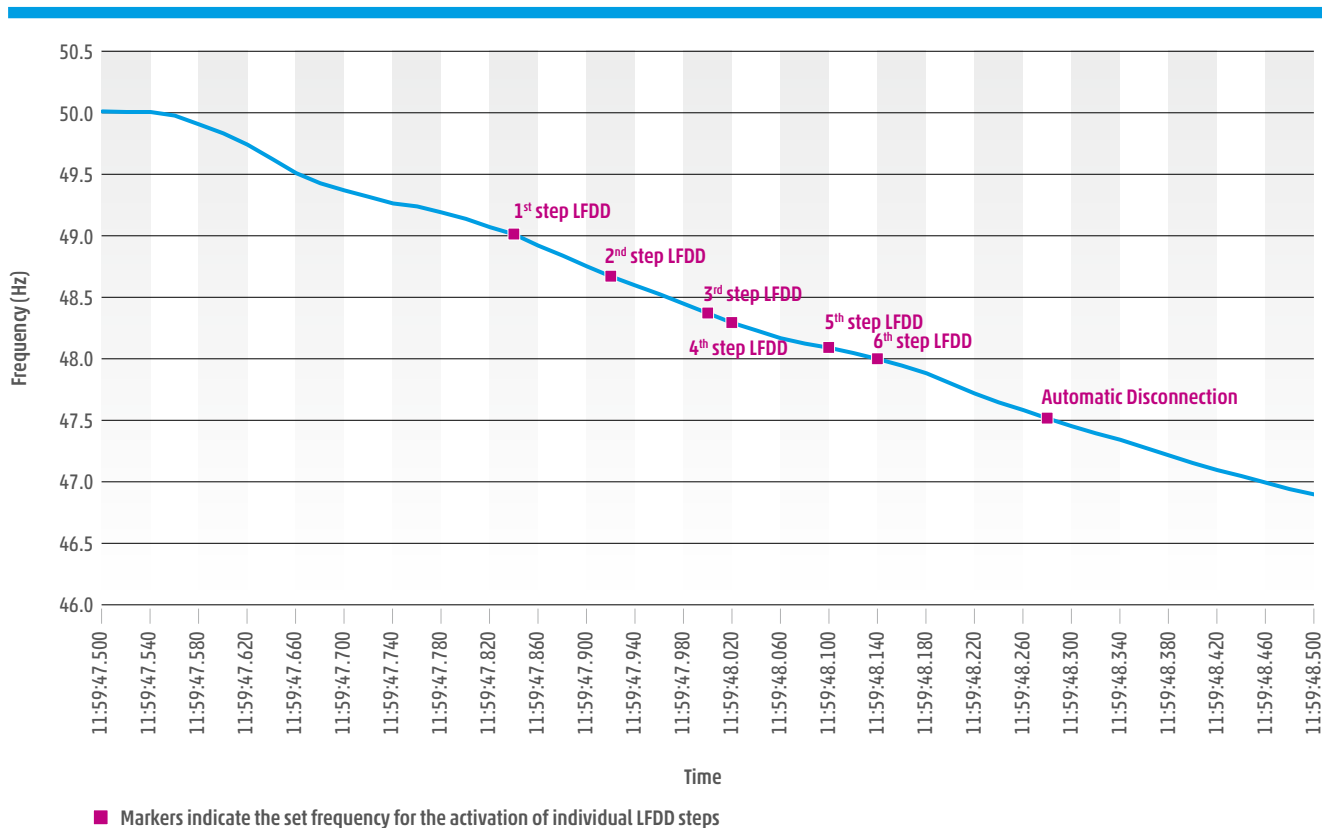
Figure 3.24: Frequency profile during the frequency collapse with indication of the set limits for LFDD steps

even the activation of LFDD was insufficient to prevent the final collapse. Figure 3.24 illustrates the expected activation sequence of individual LFDD steps.

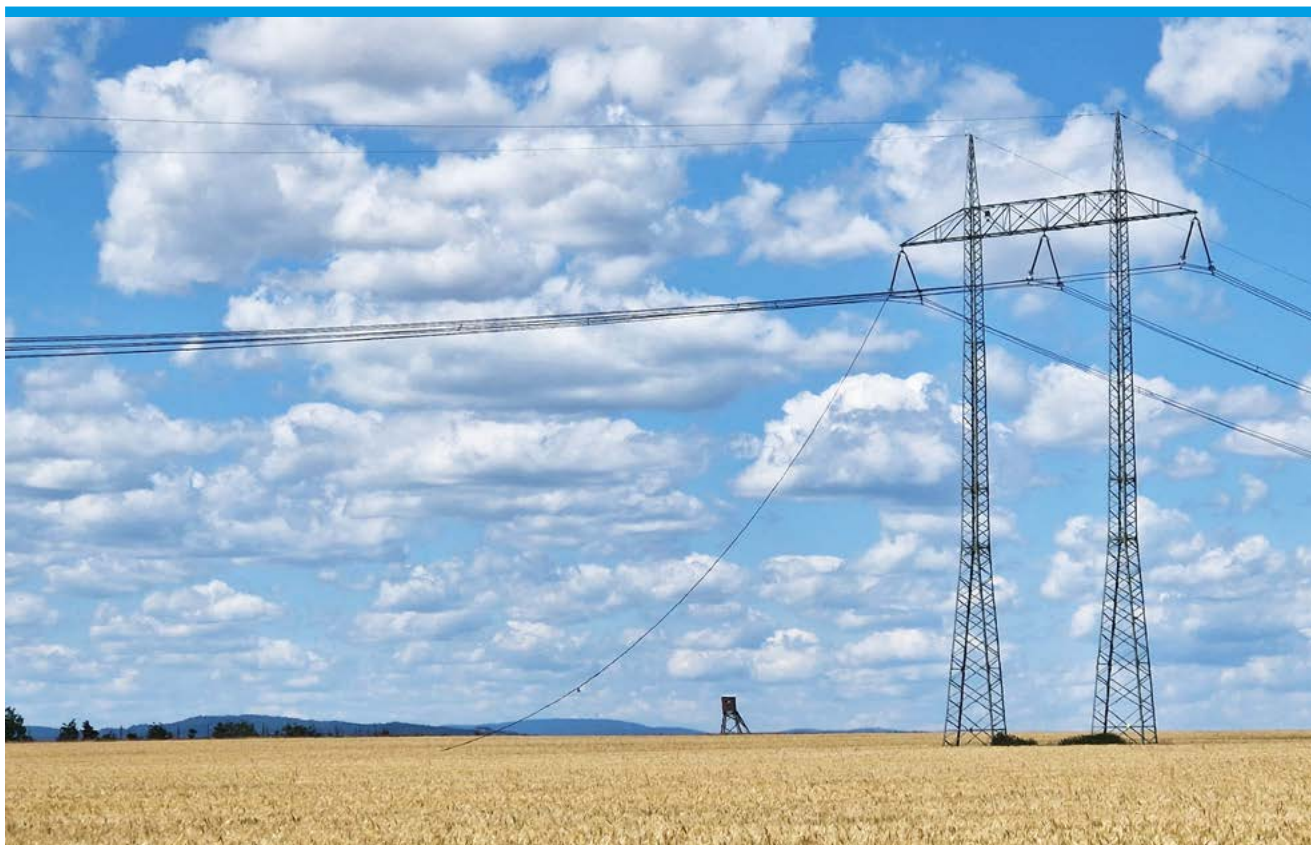
Figure 3.25: Photo of the fallen conductor

The unsuccessful auto-reclosure of V411 in phase L2 was caused by a wire break. After further examination and analysis by an expert institute, it was found that the tensile coupling had an insufficiently tight connection at the aluminium part of the conductor. Ultimately, the rope at the coupling broke, and the conductor fell. The Expert Panel was unable to determine the exact reason due to which the repair procedure resulted in an insufficiently tight tensile coupling. The Expert Panel issues a related recommendation R1 on quality assurance for works on the transmission network.

The fault was ultimately located 14 km from the HRA4 substation. The fault was switched off in 81 ms.

- » 1 // R1 – Strengthen verification and quality assurance for works on the transmission network, with particular focus on emergency repairs and works affecting the mechanical integrity of primary equipment.
