» Grid Incident in South-East Europe on 21 June 2024

ICS Investigation Expert Panel » Interim (factual) Report » 4 November 2024

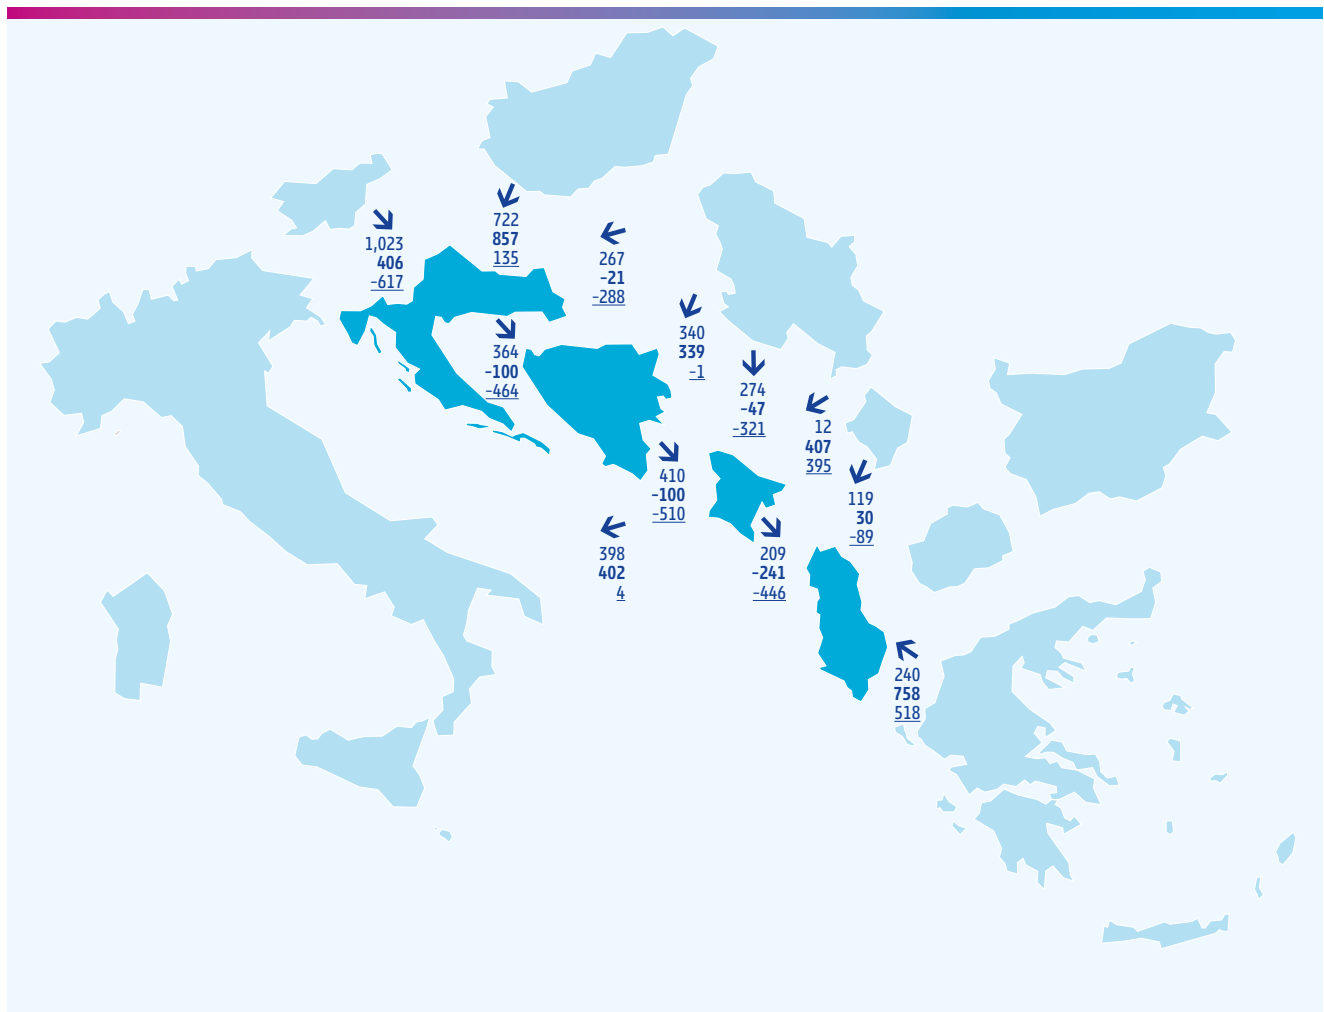
In essence, the difference between the scheduled and physical flows (mainly loop-flows, as no significant system disbalances were recorded during the day) alongside the Adriatic coast was present on all the borders in the amount of approximately 500 MW.

Figure 16: Cross-Border physical flows for 12th hour, 21 June 2024 (bold) and corresponding unscheduled loop-flows (underlined) in MW

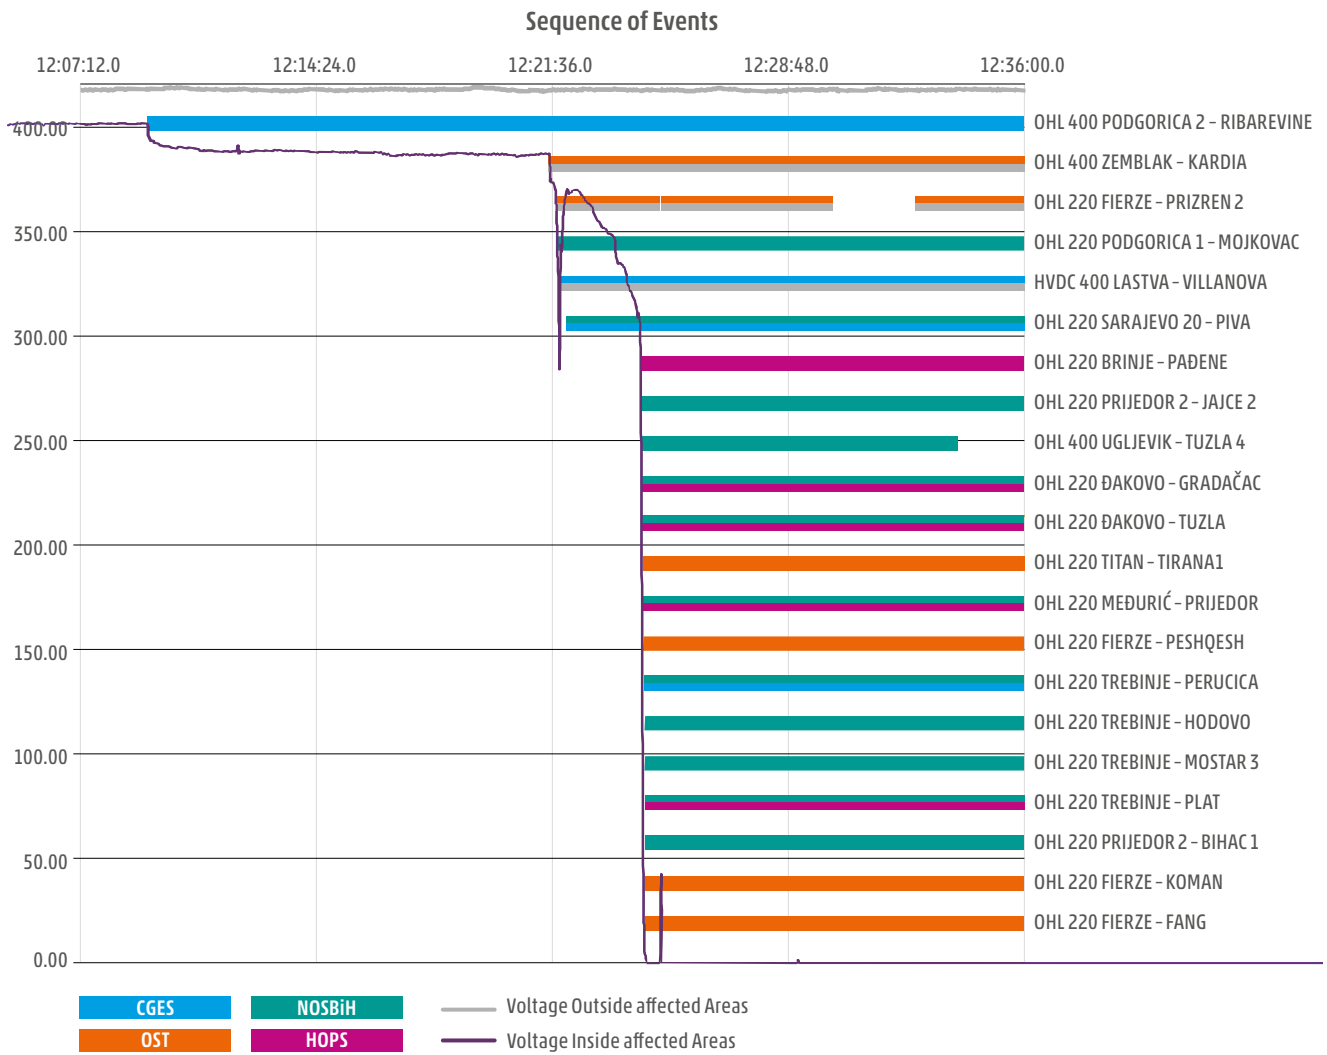
Figure 20 shows the sequence of events together with the voltage trajectory in substation Trebinje (NOSBiH) and in substation Tumbri (HOPS).

Figure 20: Sequence of Events plotted over voltage in substation Trebinje (NOSBiH) PMU data (purple) and voltage in substation Tumbri (HOPS); the length of the horizontal bars indicates the duration of the outage; two-colour bars indicate tie-lines (OHL 220 kV Fierze-Prizren, the separation of the bar indicates switching during restoration).

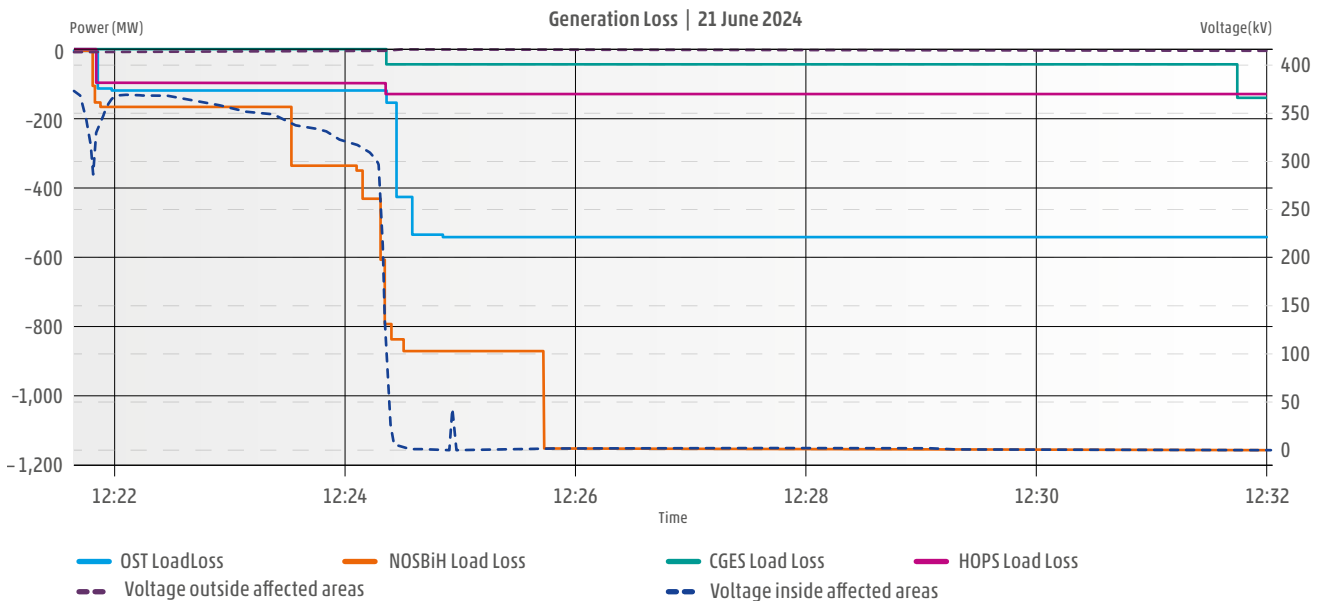
Figure 22 shows the loss of generation for the affected TSOs.

Figure 22: Loss of generation of different affected TSOs; including exemplary voltage within and outside of the affected area.

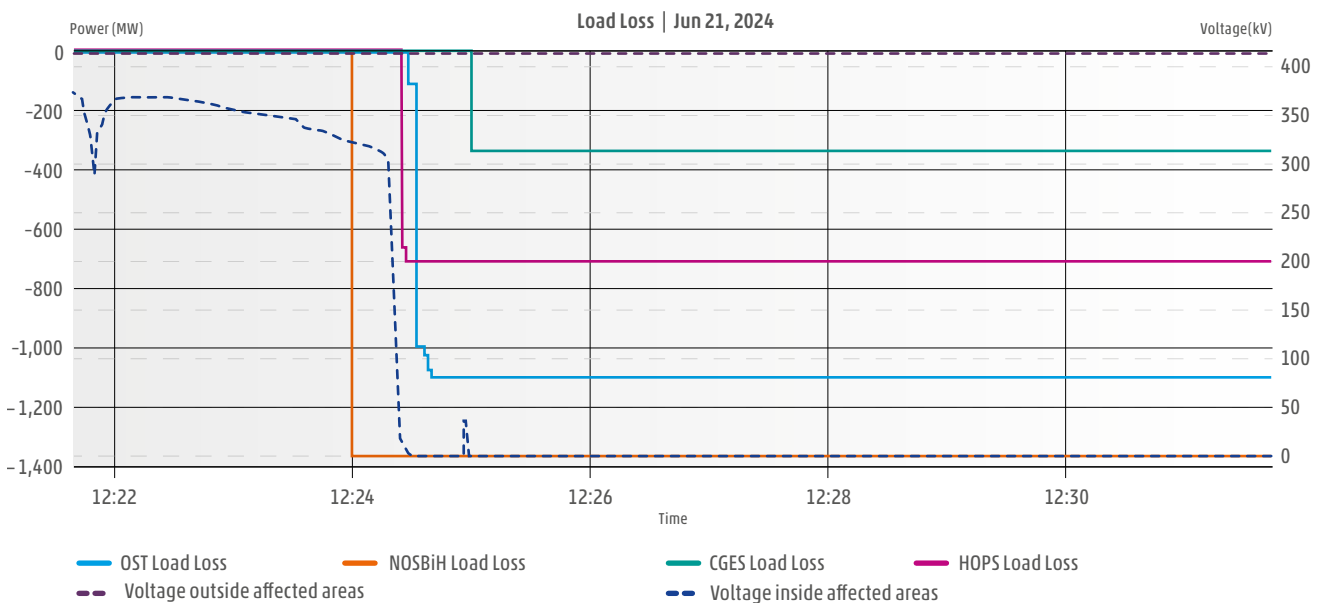
The voltage drops at 12:24 resulted in a substantial loss of load in the affected area. Subsequently, at 12:24:21, a severe voltage drop that reduced voltage to zero resulted in a generation loss of 2,214 MW in the affected area.

Figure 23: Loss of load of different affected TSOs; including exemplary voltage within and outside of the affected area.

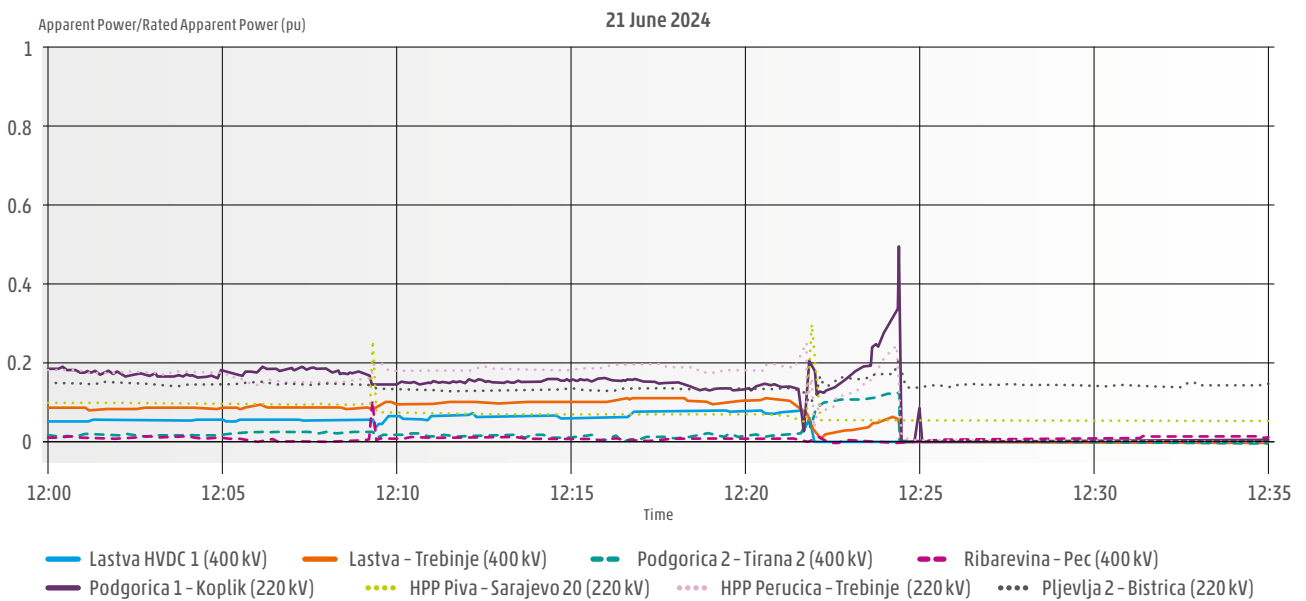
Figure 26: Evolution of line loadings (reactive power) in the CGES network.

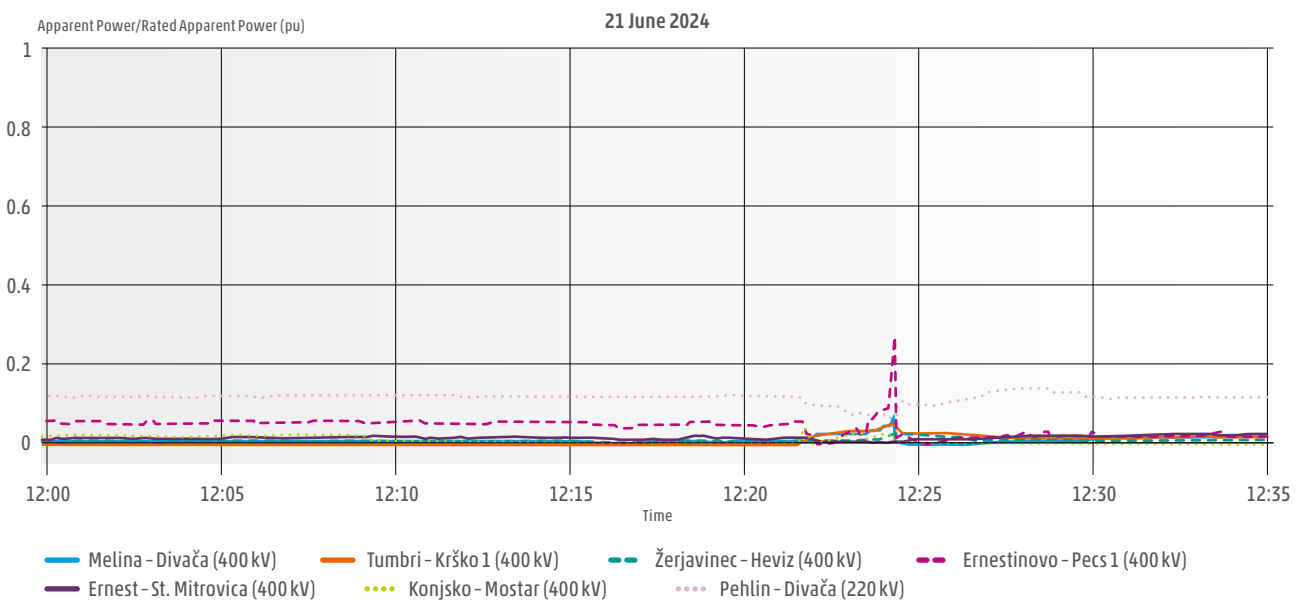
Figure 28: Evolution of line loadings (reactive power) in HOPS network.

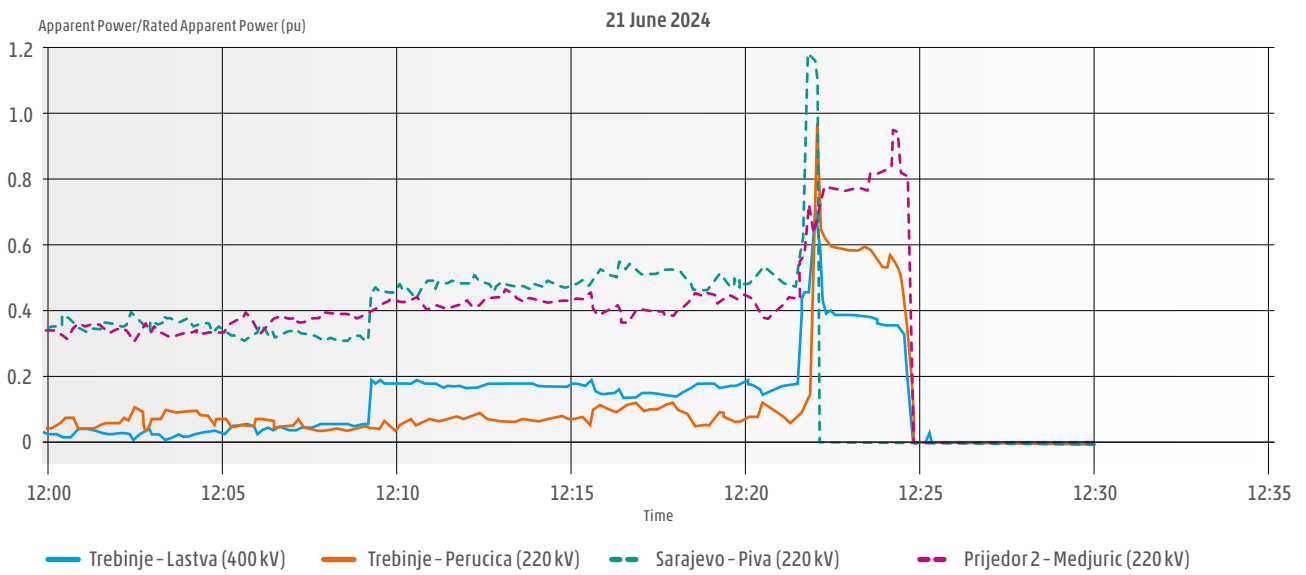
Figure 30 and Figure 31 show the line loadings within the NOSBiH control area relative to their thermal capacity limits.

Figure 30: Evolution of line loadings (active power) in NOSBiH network; "Sarajevo" refers to "Sarajevo 20".

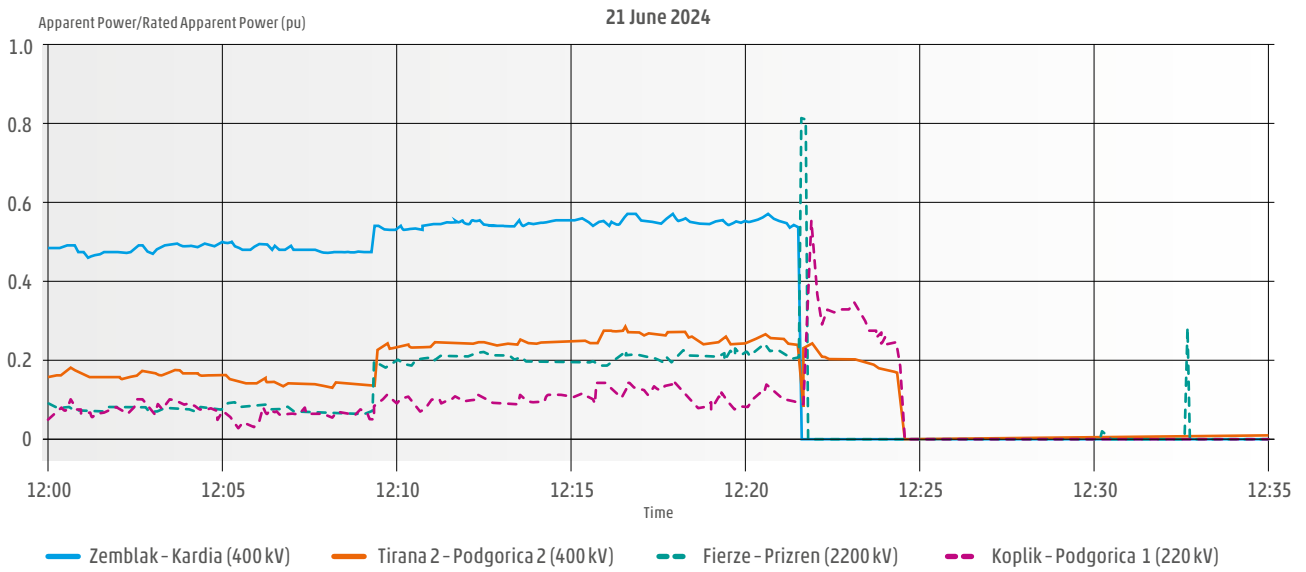
Figure 32: Evolution of line loadings (active power) in the OST network. The value for line Fierze - Prizren (220 kV) is estimated, due to pick up time of OC protection, which is shorter than SCADA interval of 4 second)

The outage of OHL TIE 400 kV Zemblak-Kardia due to distance protection caused an overload of OHL TIE 220 kV Fierze - Prizren 2, which resulted in the disconnection of this line due to overcurrent protection. These outages caused a voltage drop that resulted in the disconnection

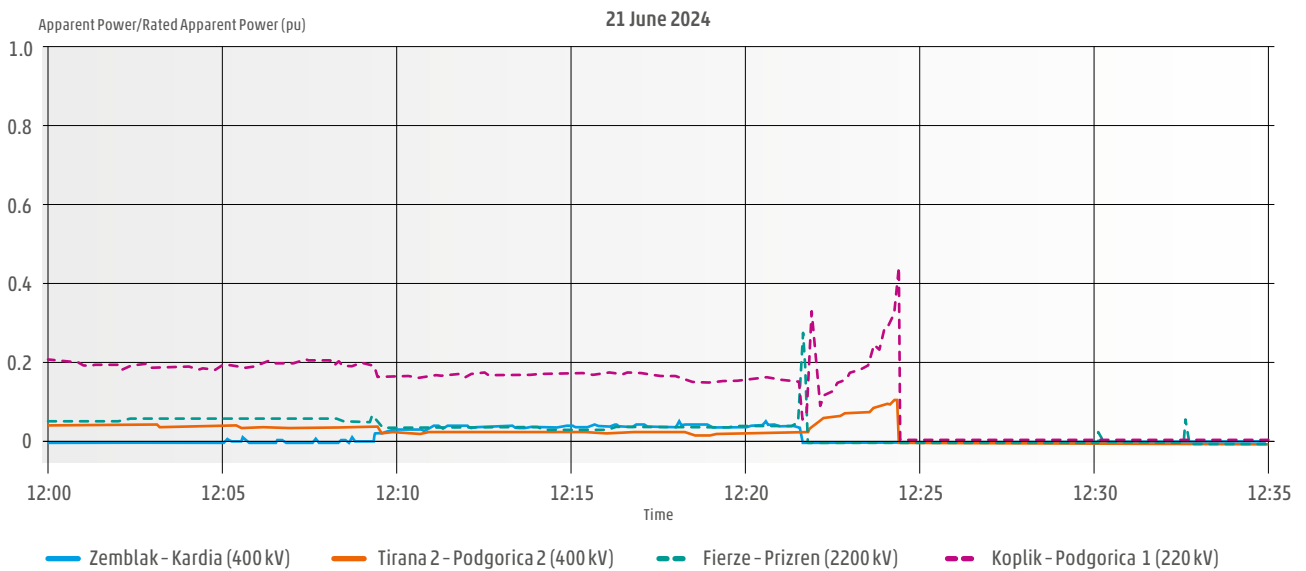
Figure 33: Evolution of line loadings (reactive power) in the OST network.

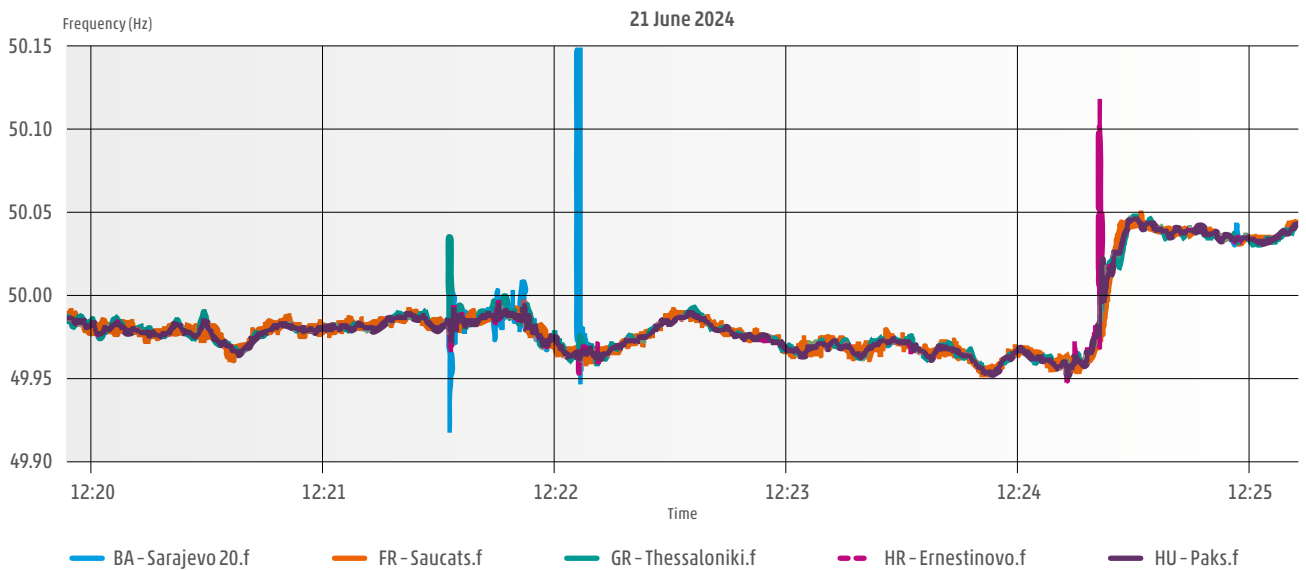
Figure 45: Frequency (zoomed)

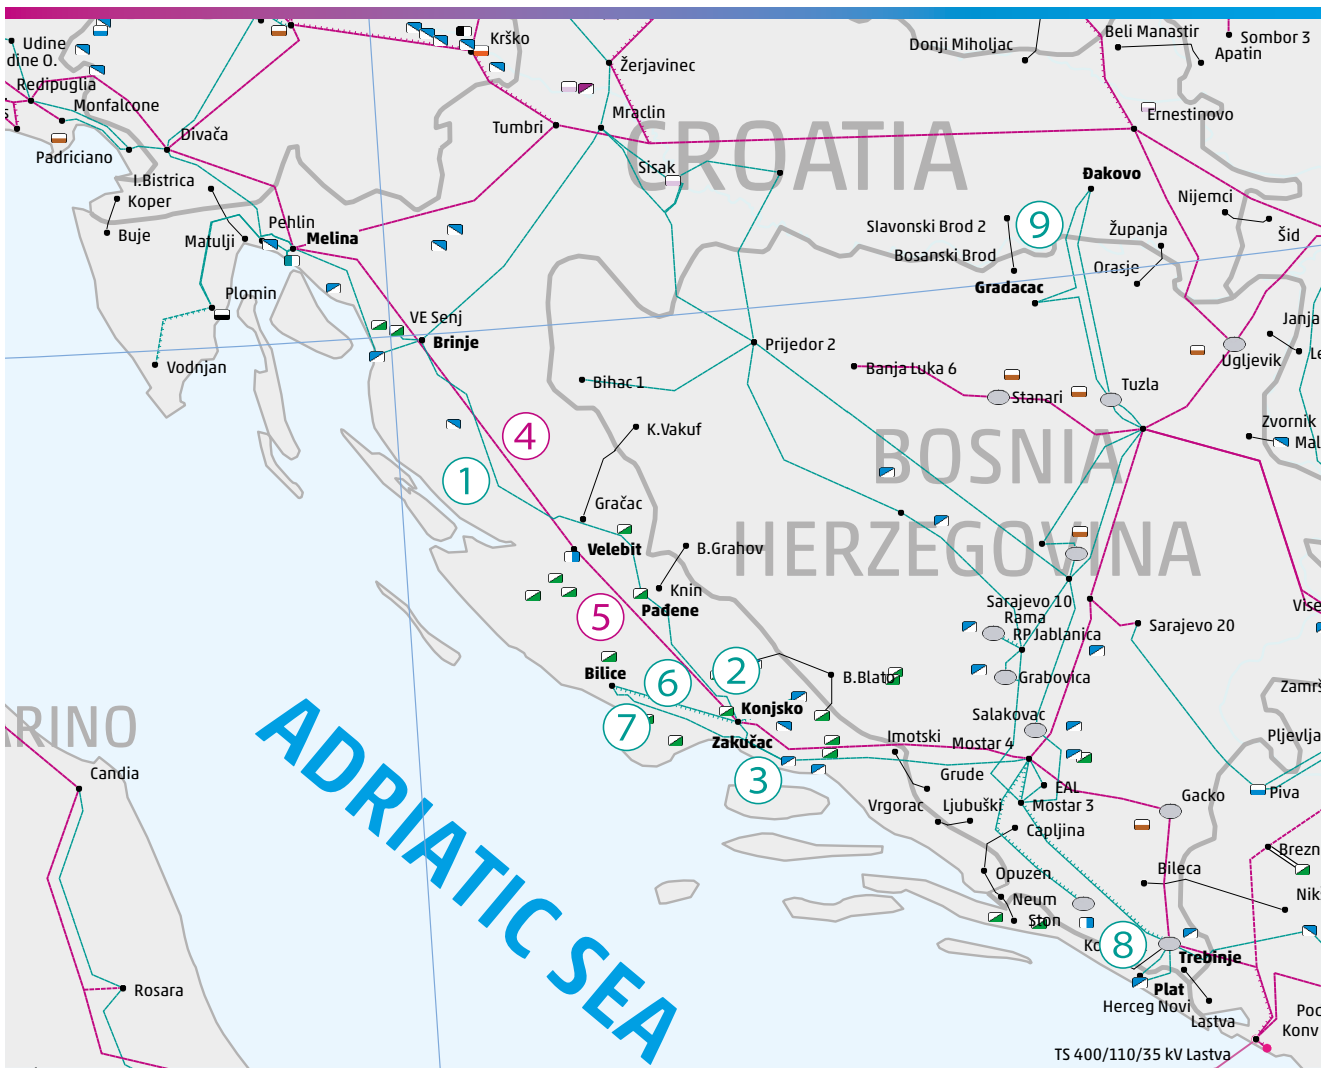
Figure 58: Step-by-step action during the restoration process in the HOPS grid
