# » Grid Incident in South-East Europe on 21 June 2024

ICS Investigation Expert Panel » Interim (factual) Report » 4 November 2024

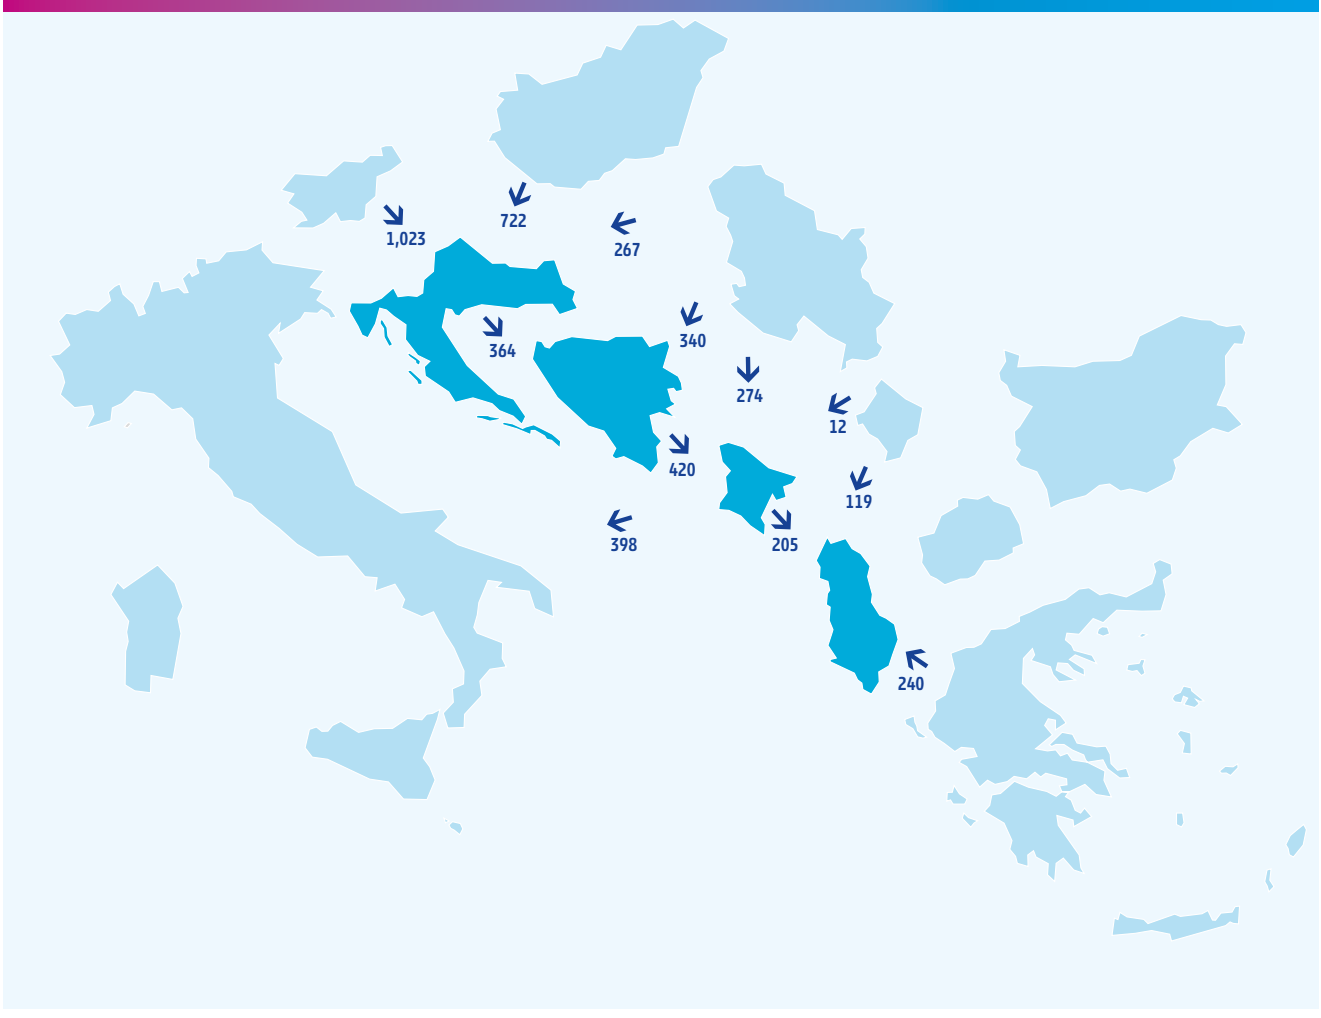
Figure 15: Scheduled commercial exchanges for 12<sup>th</sup> hour, 21 June 2024

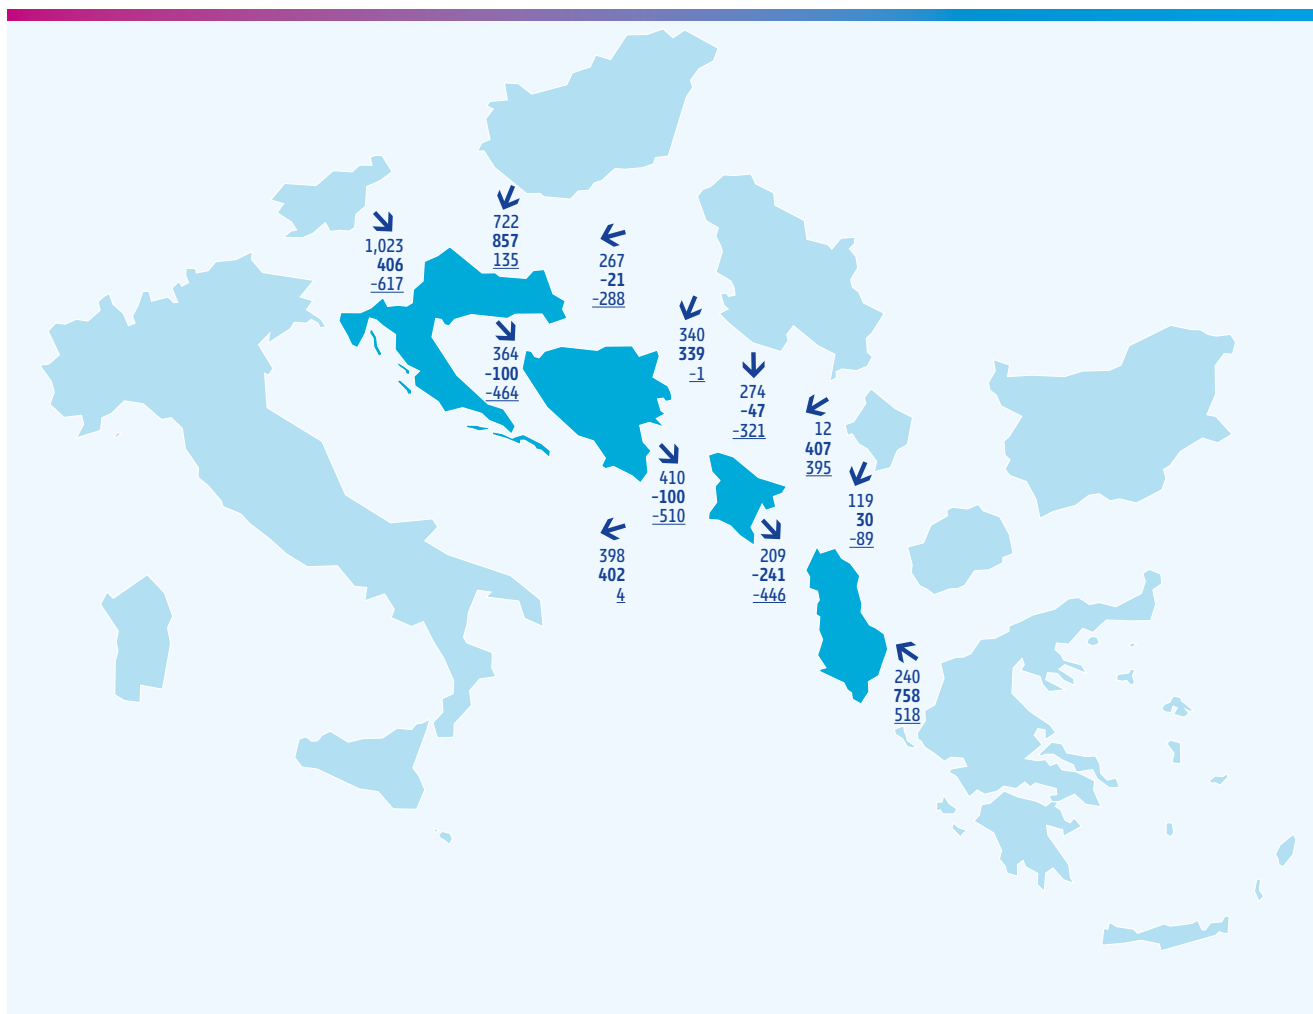
Figure 16: Cross-Border physical flows for 12<sup>th</sup> hour, 21 June 2024 (bold) and corresponding unscheduled loop-flows (underlined) in MW

In essence, the difference between the scheduled and physical flows (mainly loop-flows, as no significant system disbalances were recorded during the day) alongside the Adriatic coast was present on all the borders in the amount of approximately 500 MW.

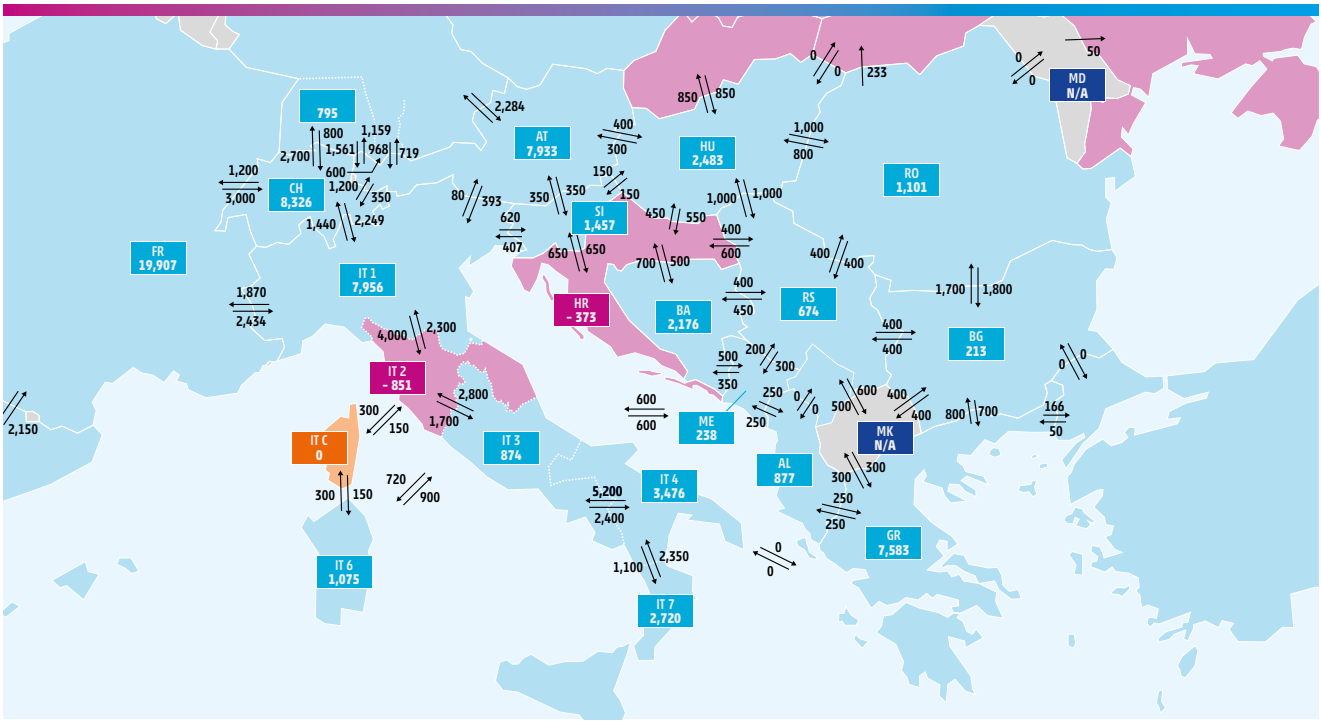
Figure 52: Initial RC values from the STA tool for all affected and neighbouring TSOs for 12:30

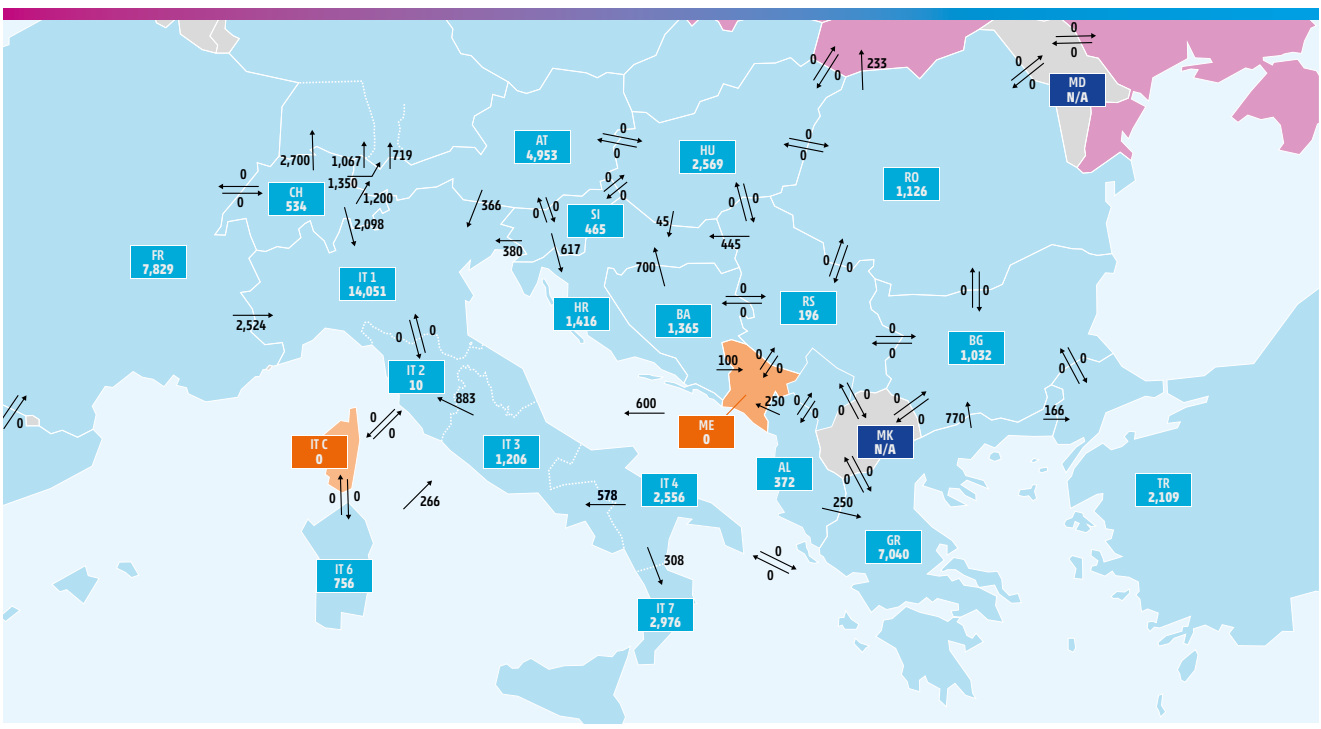
Figure 55: Final Exchanges and RCs from the STA tool for all affected and neighbouring TSOs for 12:30

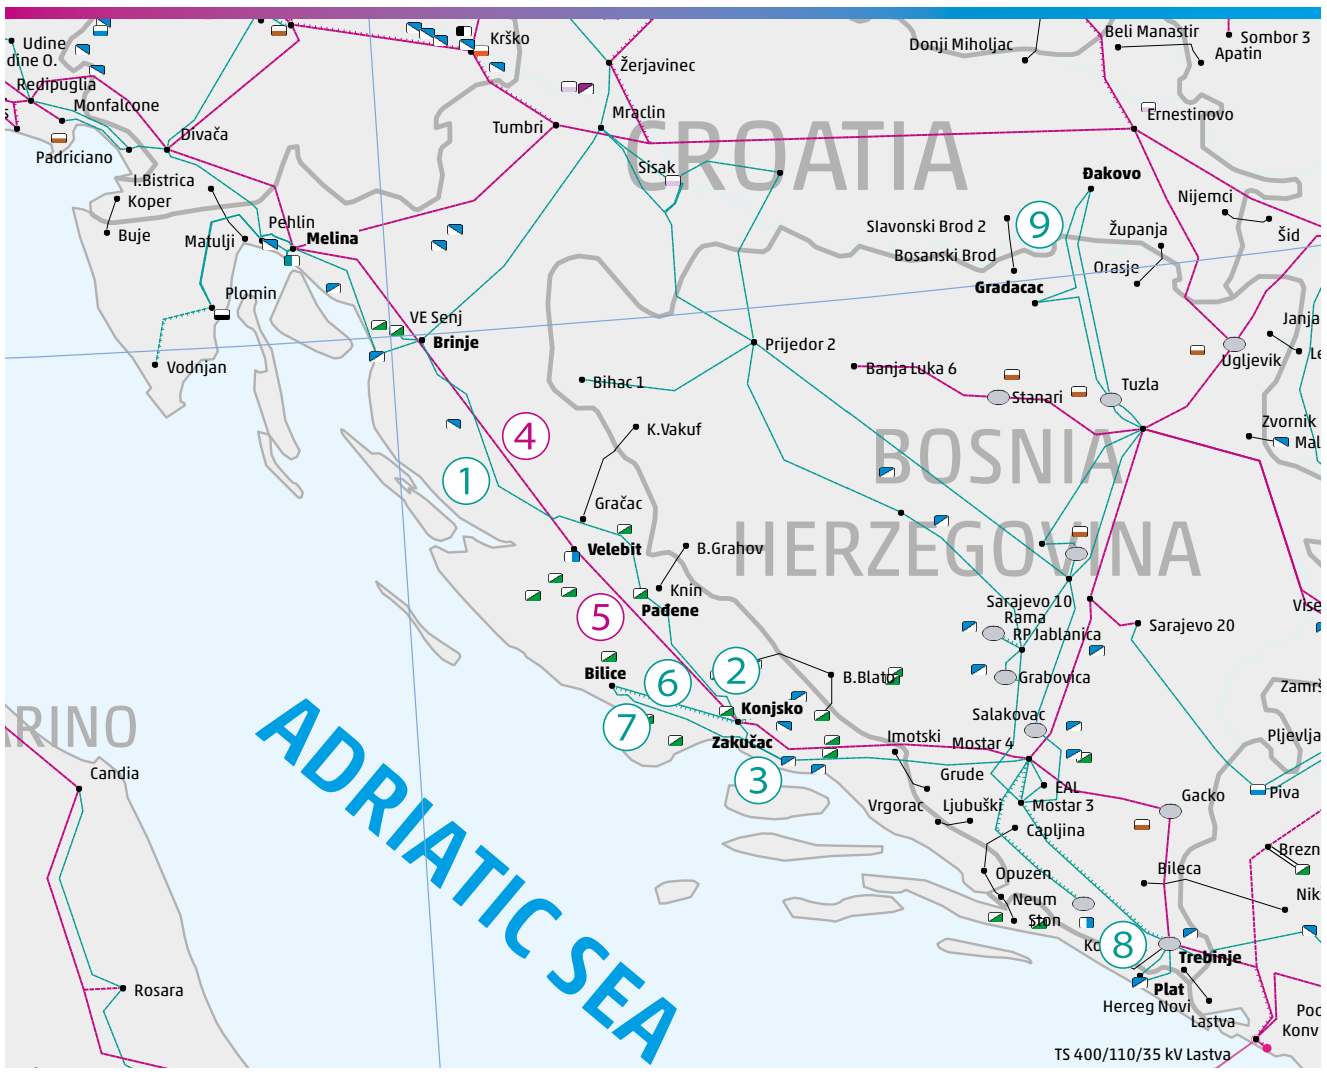
Figure 58: Step-by-step action during the restoration process in the HOPS grid
