» Grid Incident in South-East Europe on 21 June 2024

ICS Investigation Expert Panel » Final Report » 25 February 2025

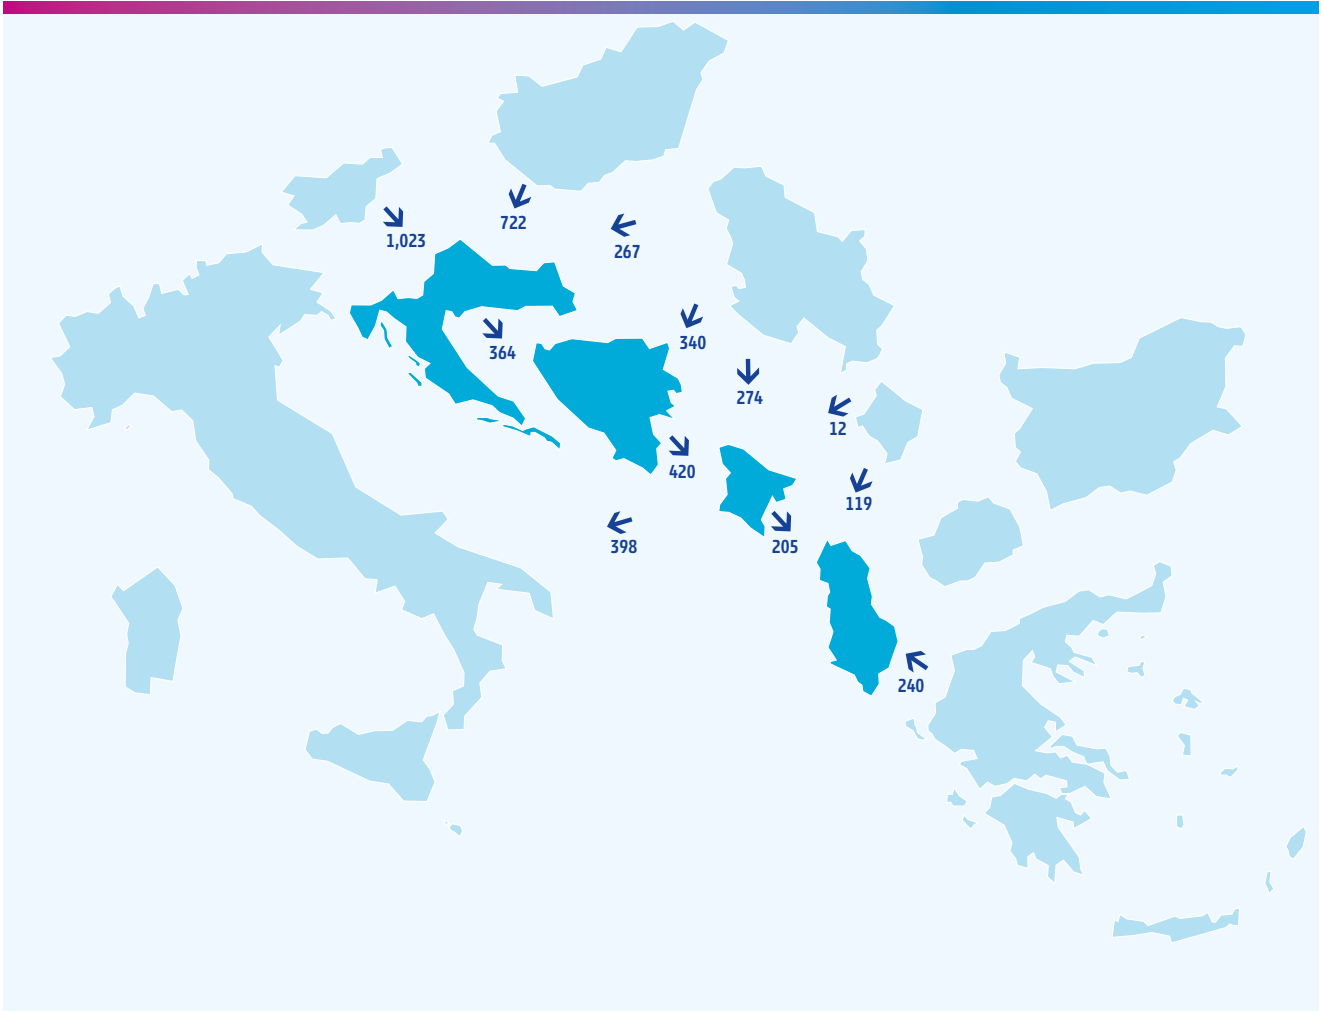
Figure 15: Scheduled commercial exchanges for 12th hour, 21 June 2024

Netted values of commercial exchanges between affected TSOs as well as between the affected area and the rest of the region were closely following market signals as reported in the sub-chapter 2.3. Significant commercial exchanges were reported on the East-West route

along the Adriatic coast, as a consequence of the lower Day-ahead market prices on the most eastern and the most western price zones, comparing to those in Albania and Montenegro price zones.

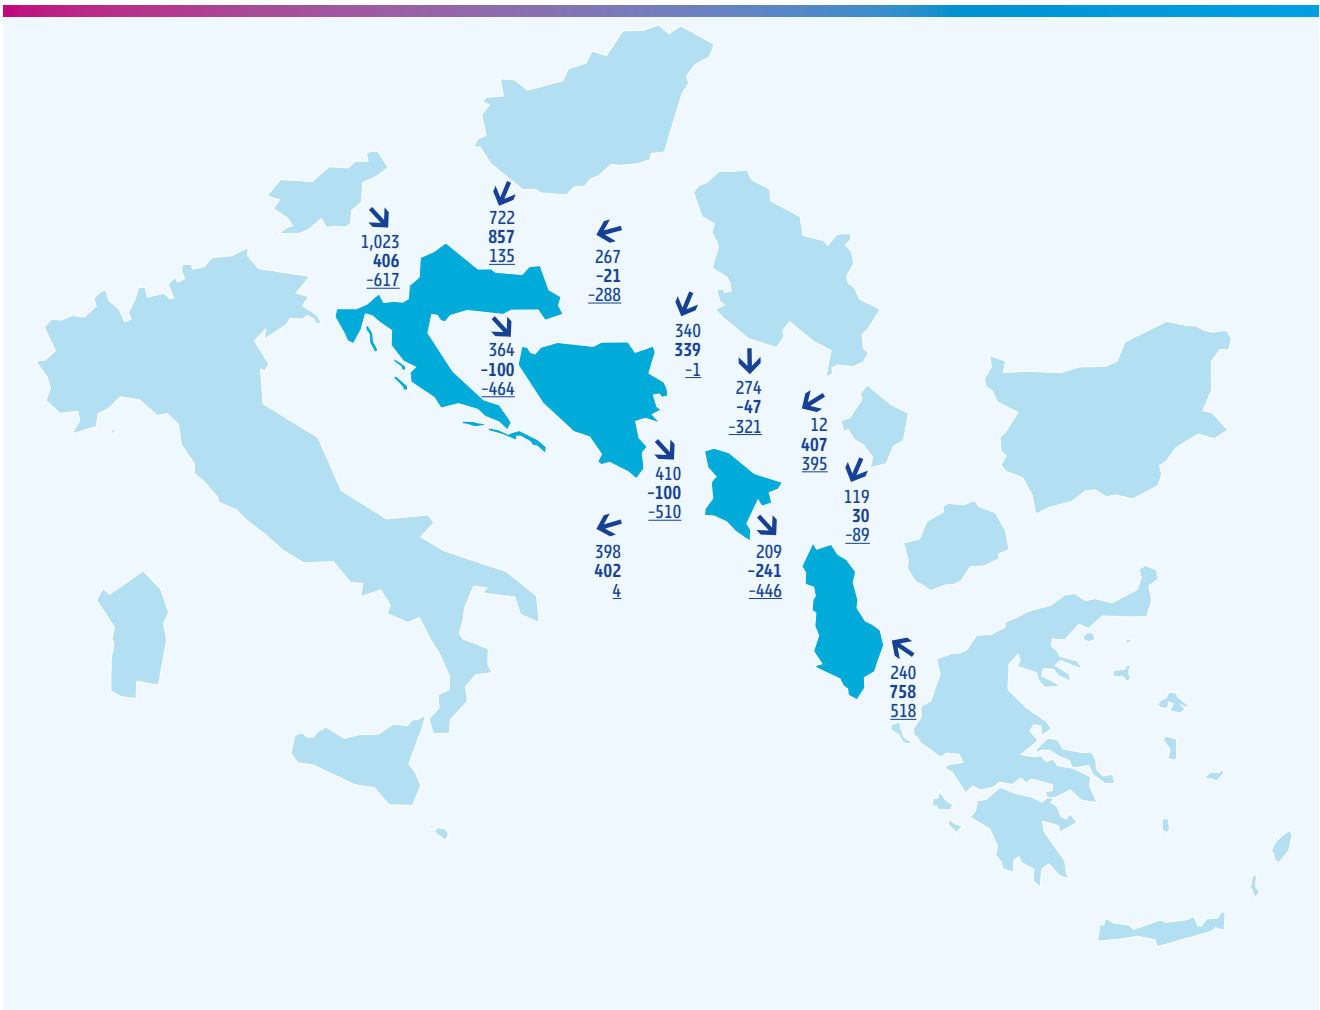
Figure 16: Cross-Border physical flows for 12th hour, 21 June 2024 (bold) and corresponding unscheduled loop-flows (underlined) in MW

In essence, the difference between the scheduled and physical flows (mainly loop-flows, as no significant system disbalances were recorded during the day) alongside the Adriatic coast was present on all the borders in the amount of approximately 500 MW.

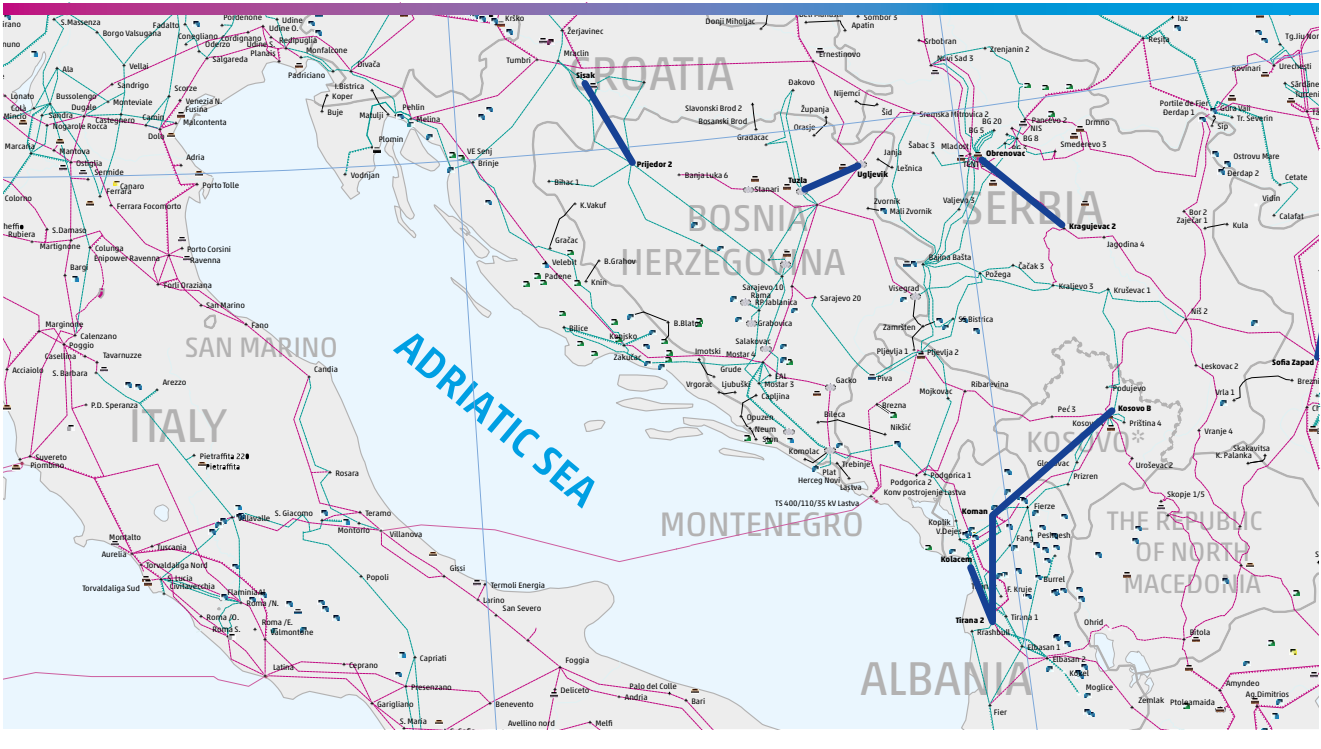
Figure 47: Map of planned disconnections for CW25 (2024-06-15 to 2024-06-21)

The map below shows the planned disconnections for CW25 (2024-06-15 to 2024-06-21)

It should be noted that because of the incident there are some planned outages that are practically changed as follows:

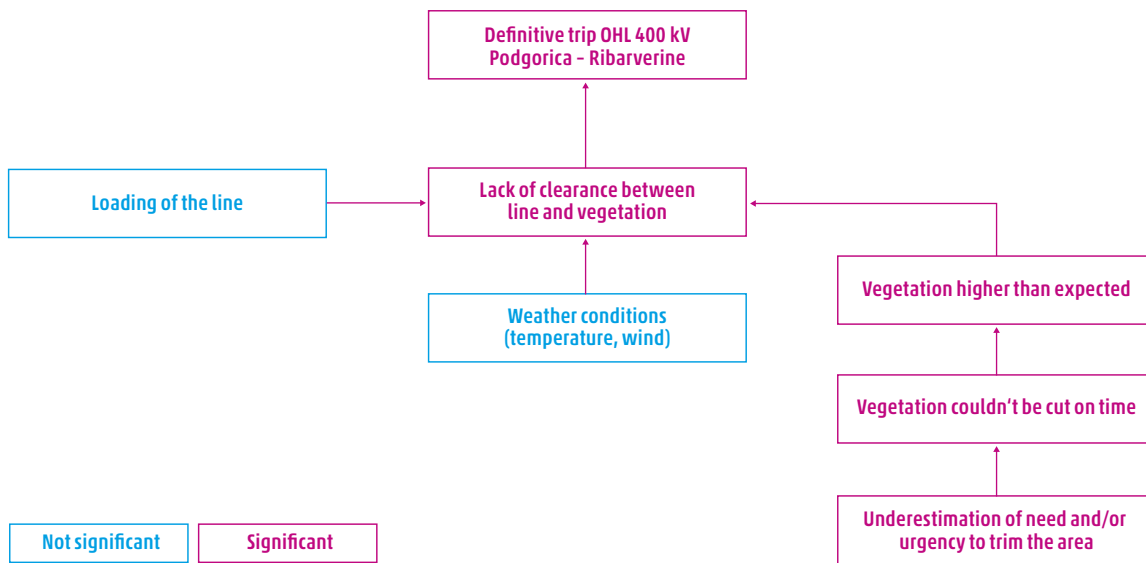
Figure 58: Root cause tree of the short circuit of 400 kV OHL Podgorica – Ribarevine

The root cause tree shown in Figure 58 illustrates the causes and effects of the trip of the 400 kV OHL Podgorica – Ribarevine.

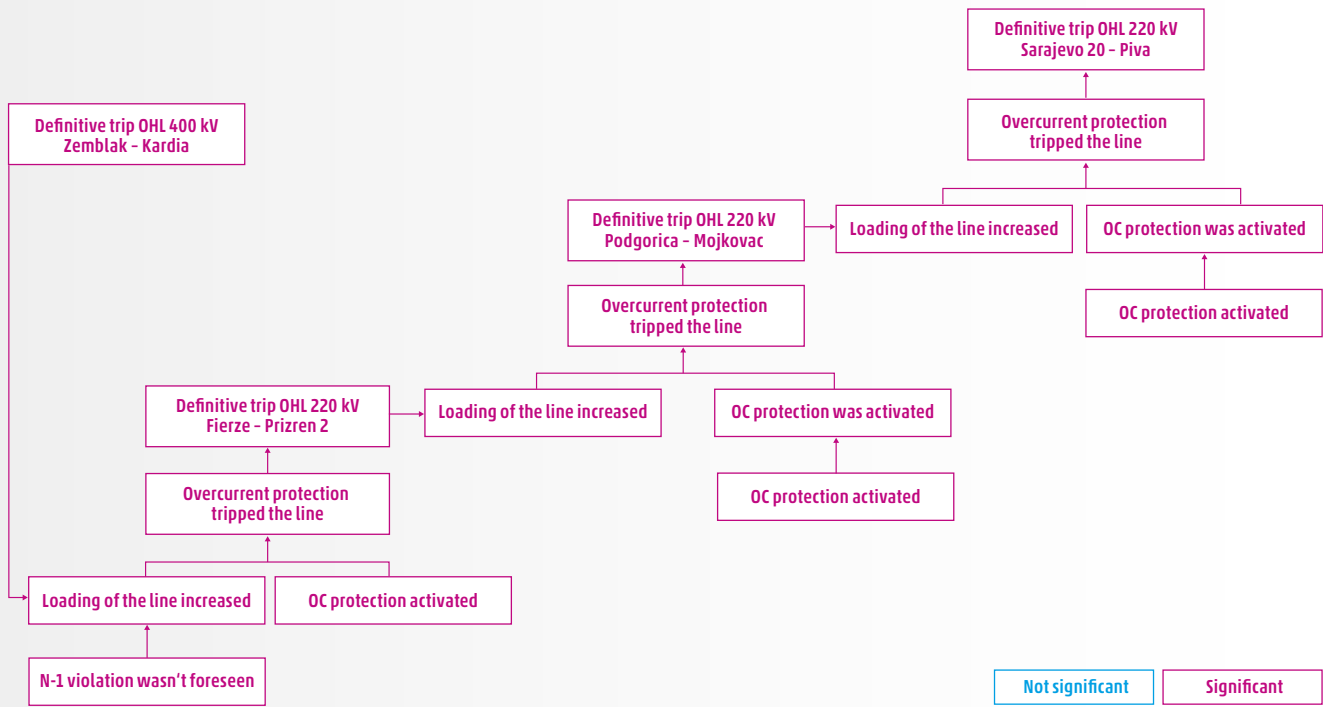
Figure 62: Root cause tree of the tripping of 220 kV Fierze - Prizren 2, 220 kV Podgorica 1 - Mojkovac, and 220 kV TIE Sarajevo 20 - Piva

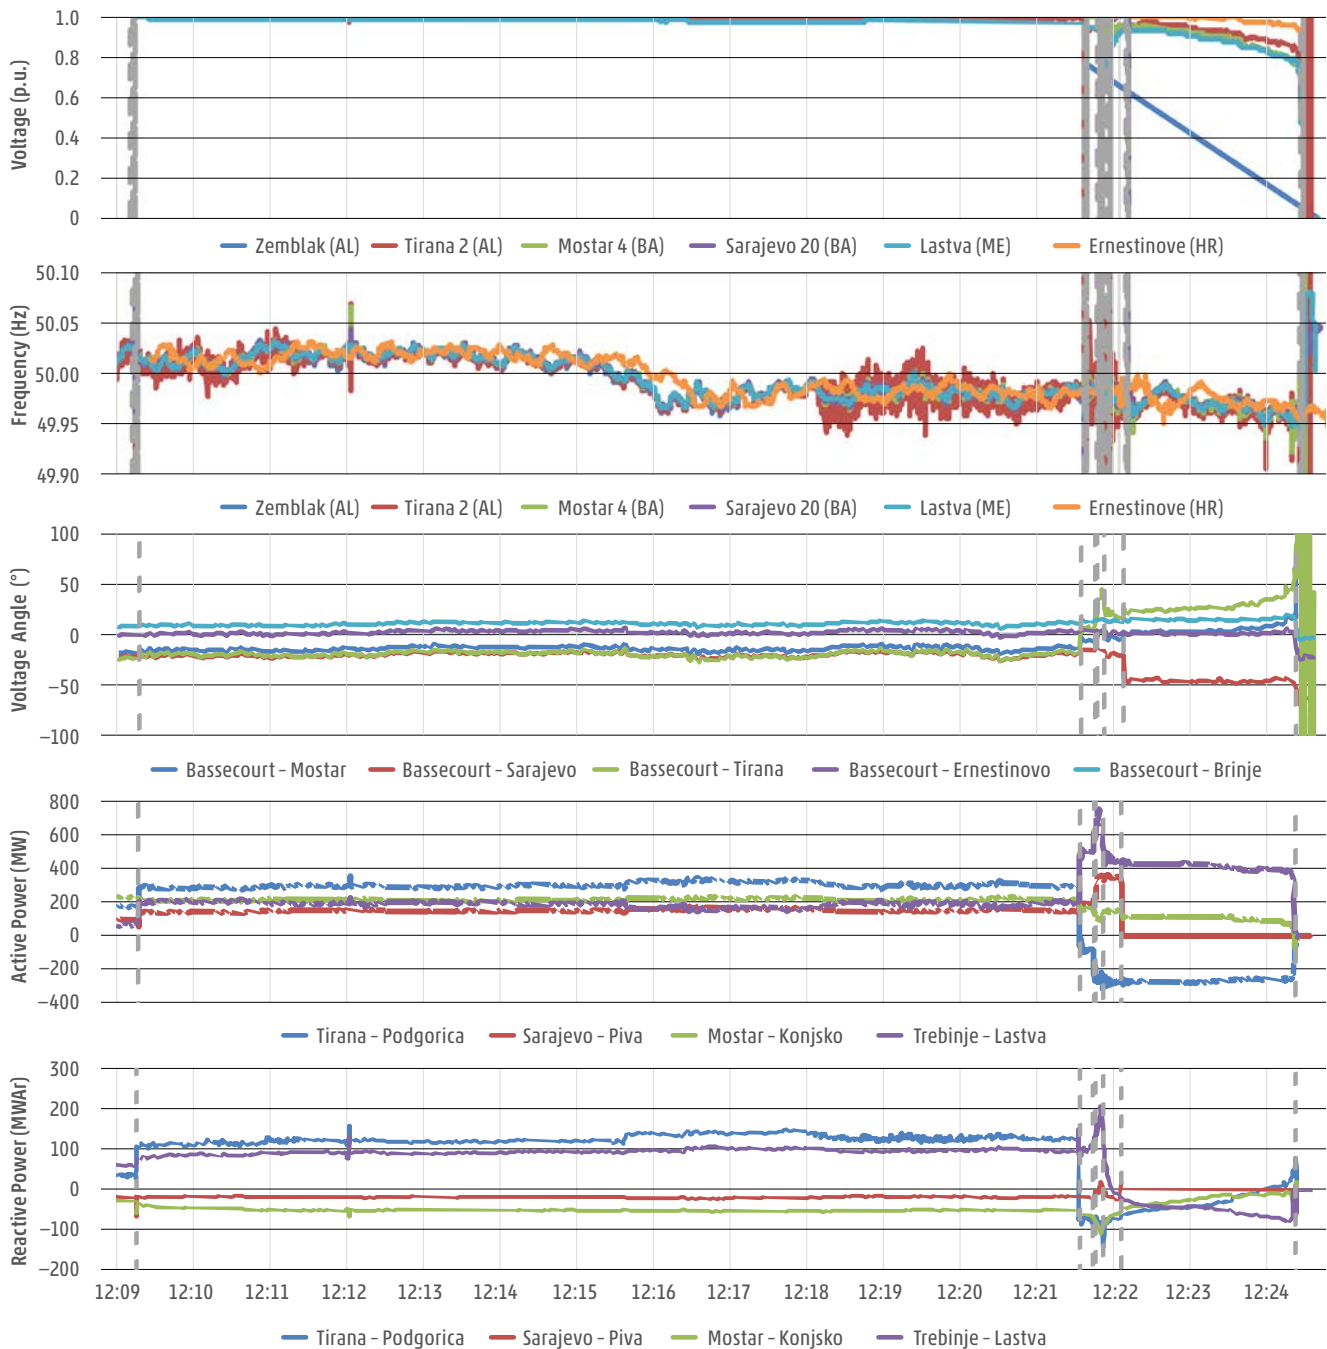
Figure 64: Frequencies, voltages, voltage phase angle differences (reference angle is Bassecourt [CH]), active power, and reactive power

occurred. All bays shown are 400 kV, with the exception of 220 kV Sarajevo 20.

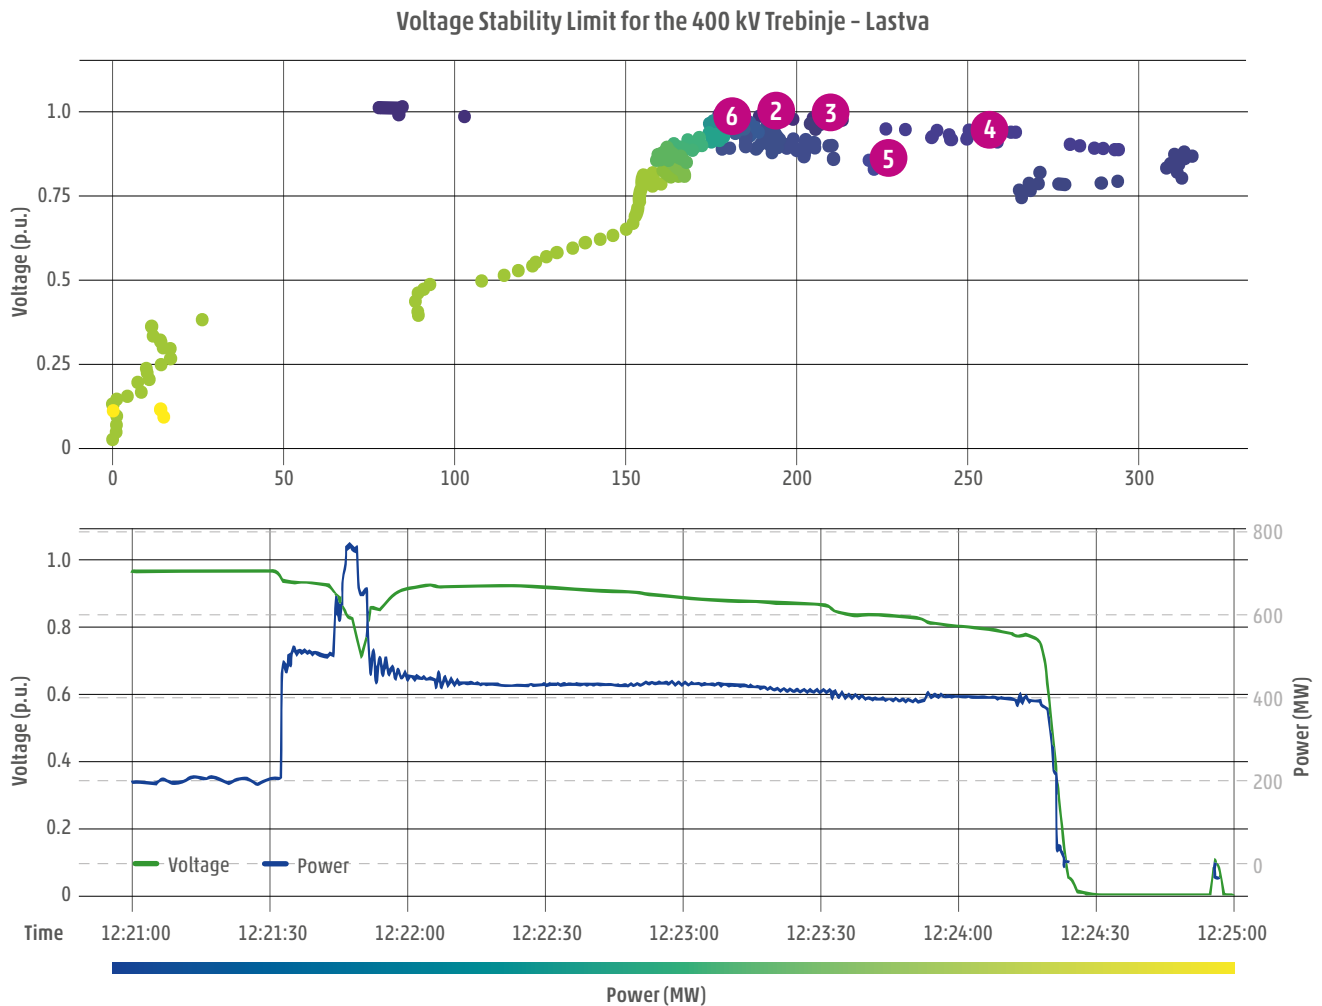
Figure 83: Voltage stability limits for the 400 kV TIE Trebinje - Lastva

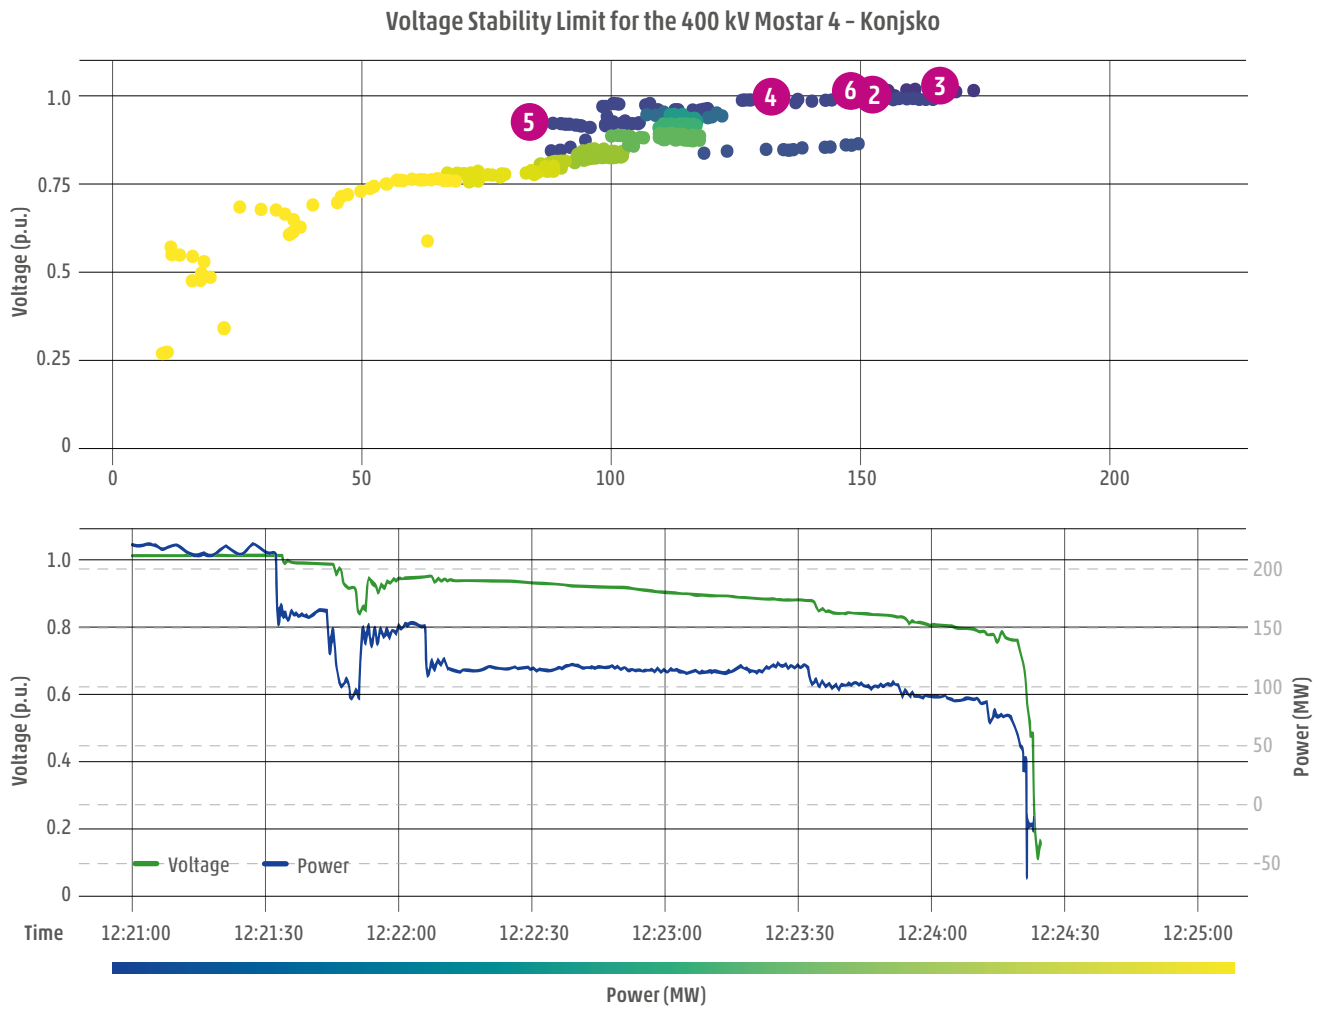
Figure 84: Voltage stability limits for the 400 kV TIE Mostar 4 - Konjsko

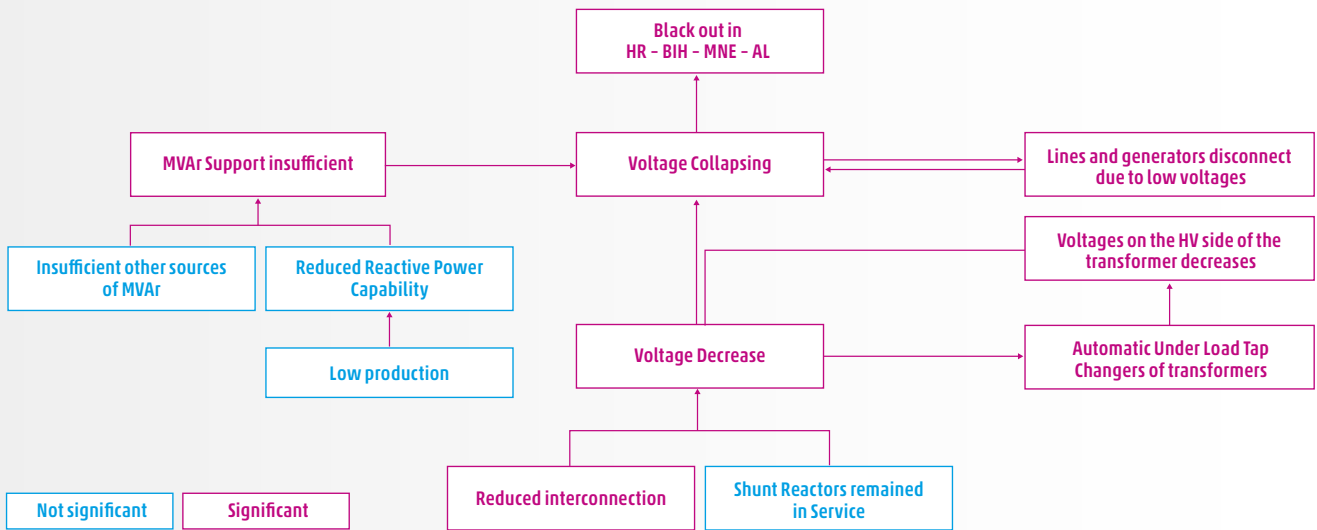
Figure 85: Root cause tree of the voltage collapse

The root cause tree shown in Figure 85 illustrates the causes and effects of the voltage collapse.

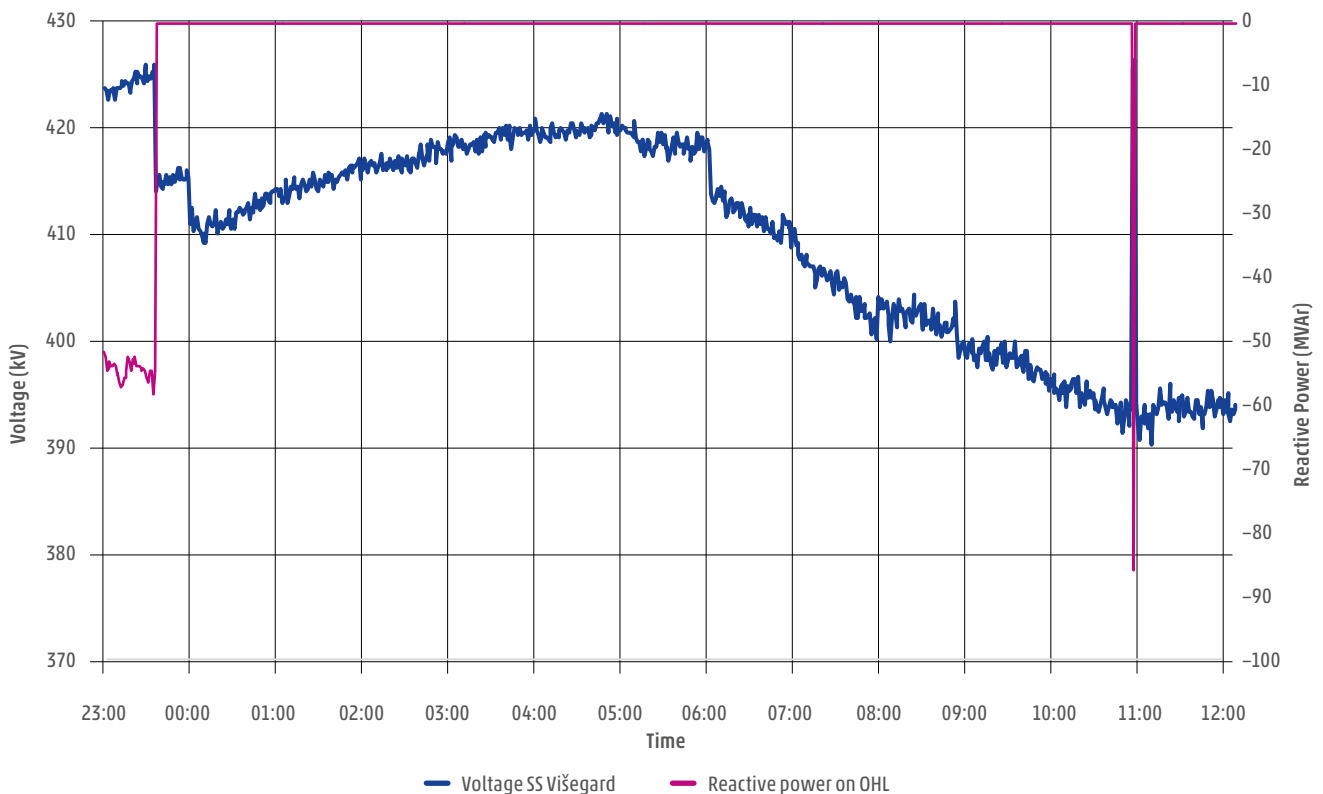
Figure 88: Influence of disconnected 400 kV OHL Tuzla 4 – Višegrad on voltage in SS Višegrad

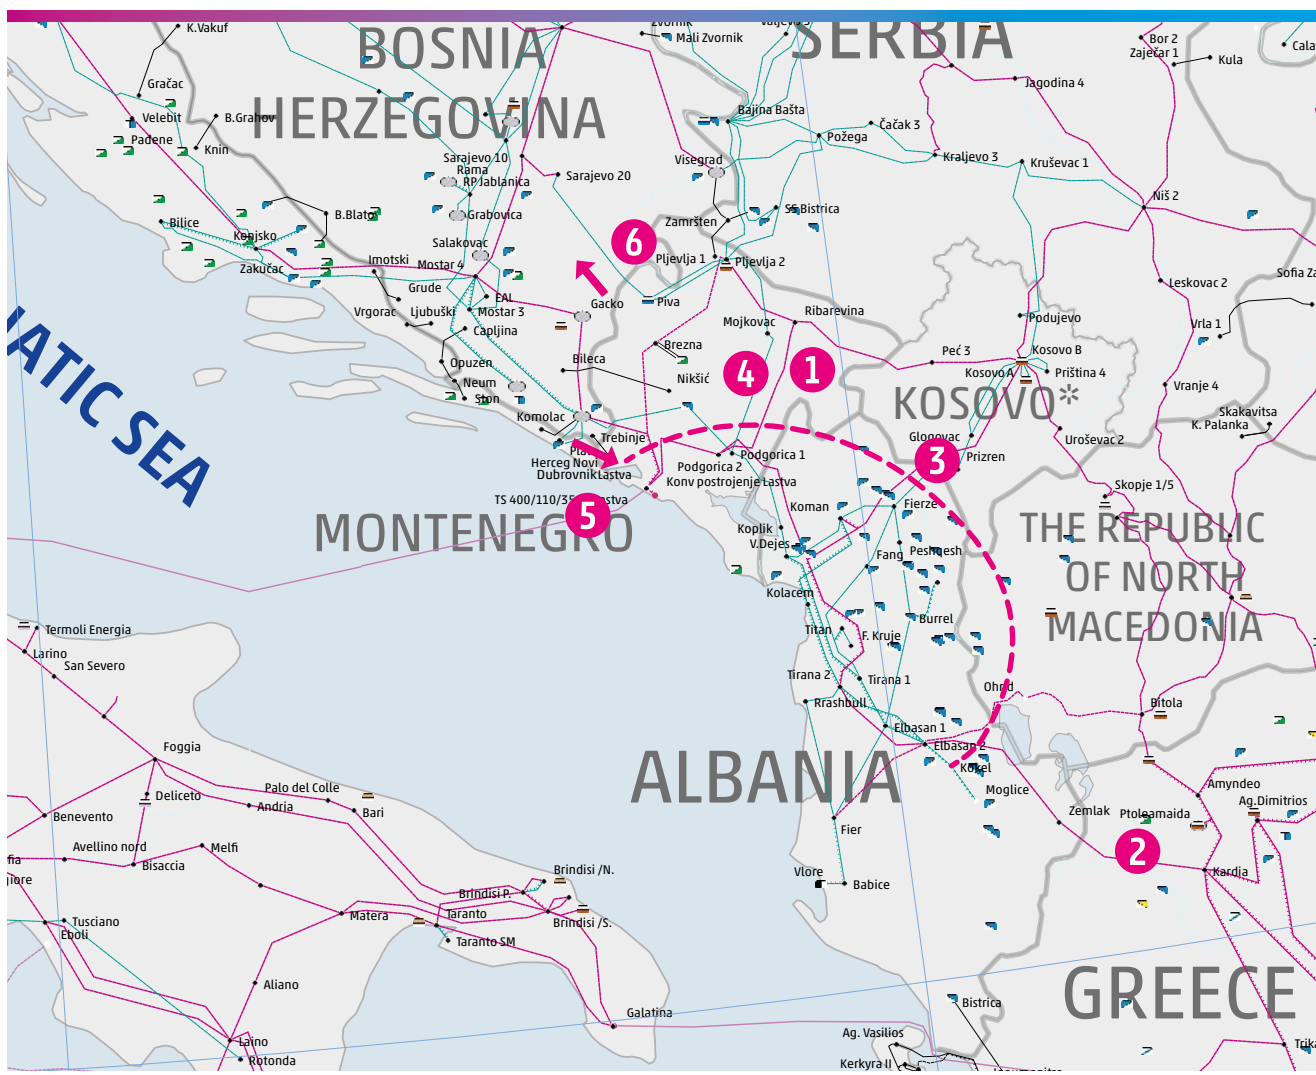
Figure 91: Separation line and power flow

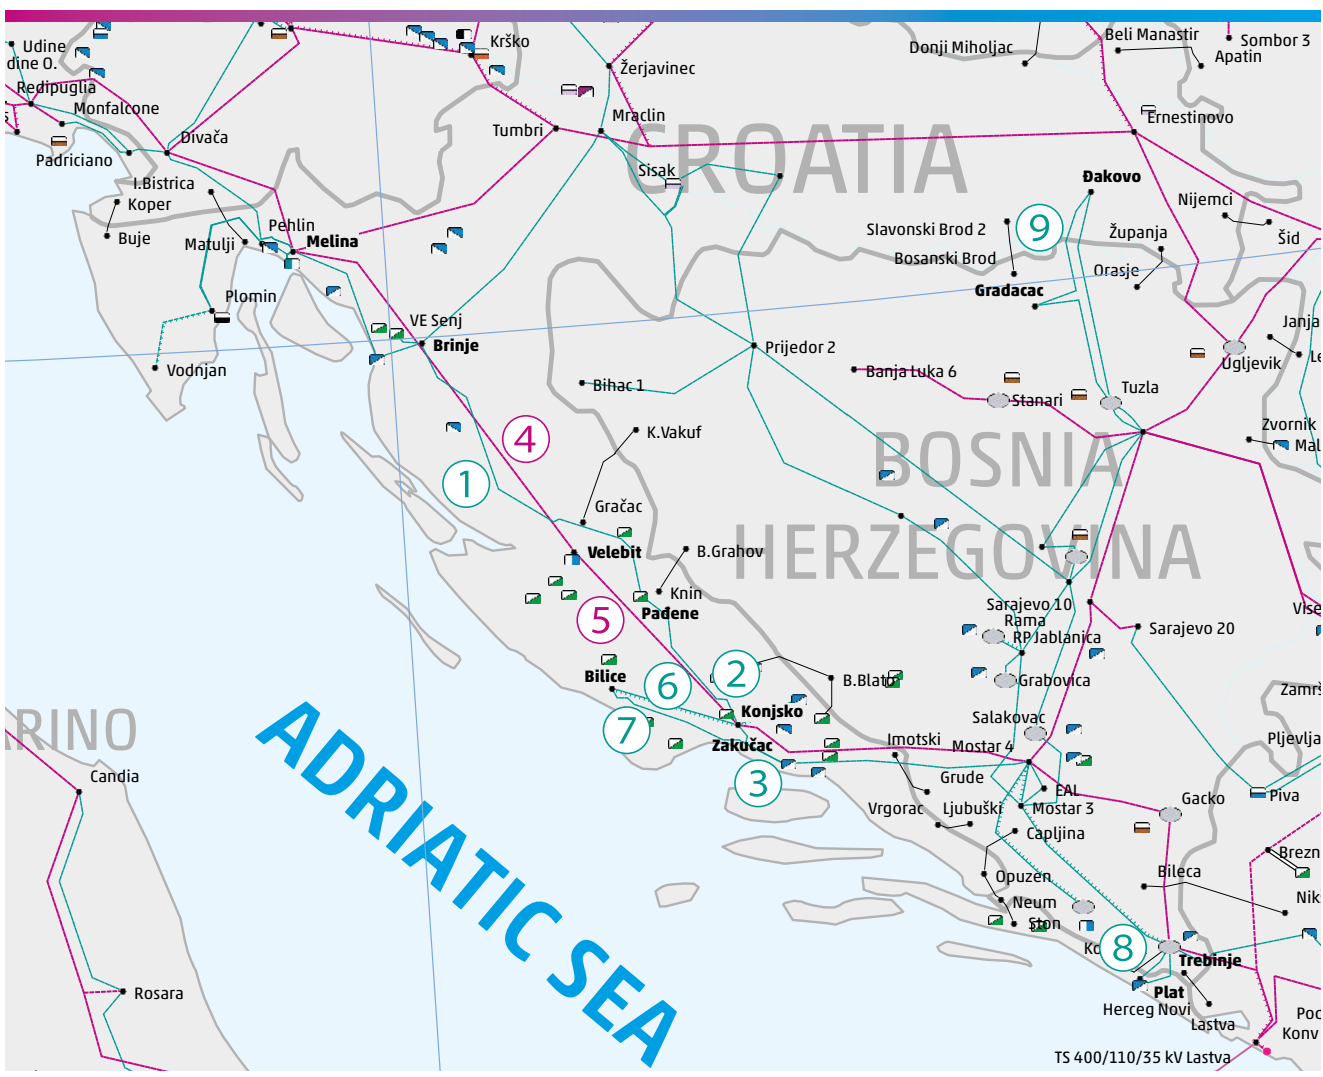
Figure 94: Step-by-step action during the restoration process in the HOPS grid
