» Grid Incident in North Macedonia on 18 May 2025

ICS Investigation Expert Panel
Final Report

20 April 2026

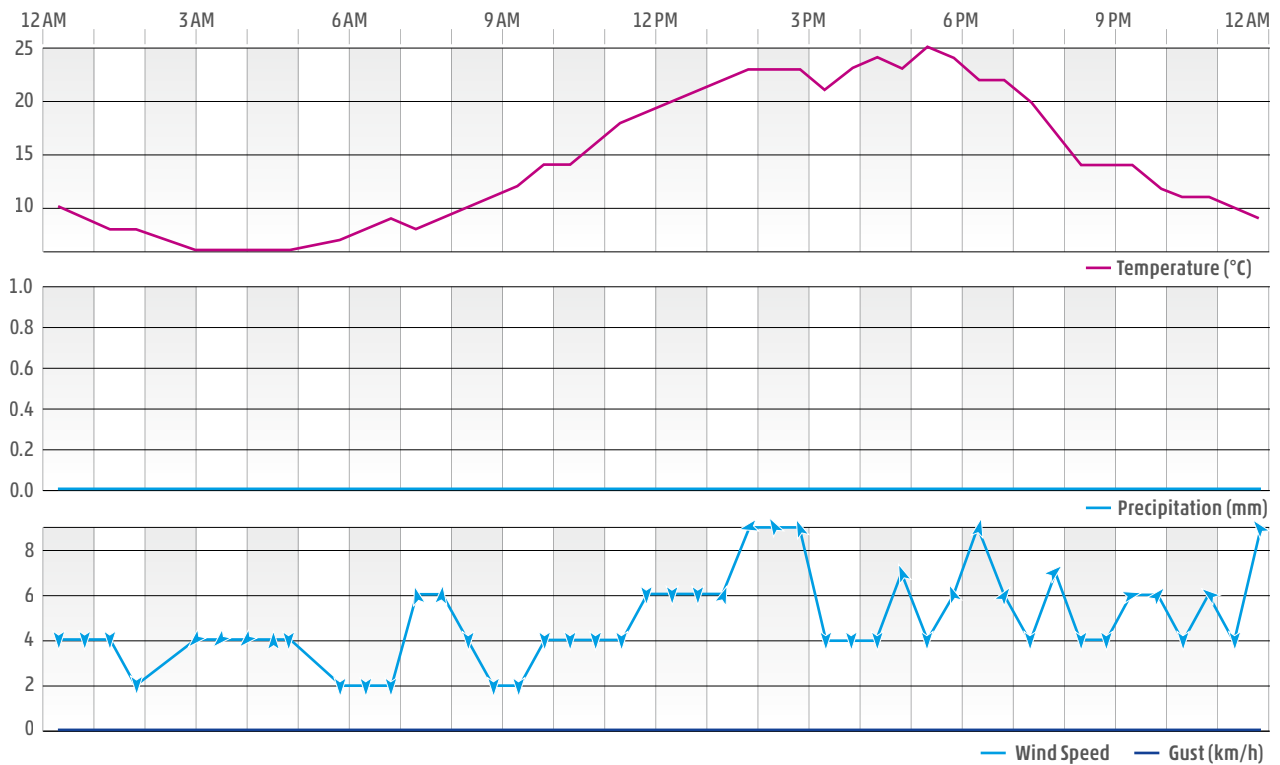
Figure 2.3: Weather conditions in the city of Skopje, North Macedonia, on 18 May 2025¹¹

characterised by rising day and night temperatures, when households typically do not use cooling or heating. These weather conditions can be considered a prerequisite for the “spring effect” – a seasonal phenomenon in which low electricity demand coincides with higher levels of renewable generation.

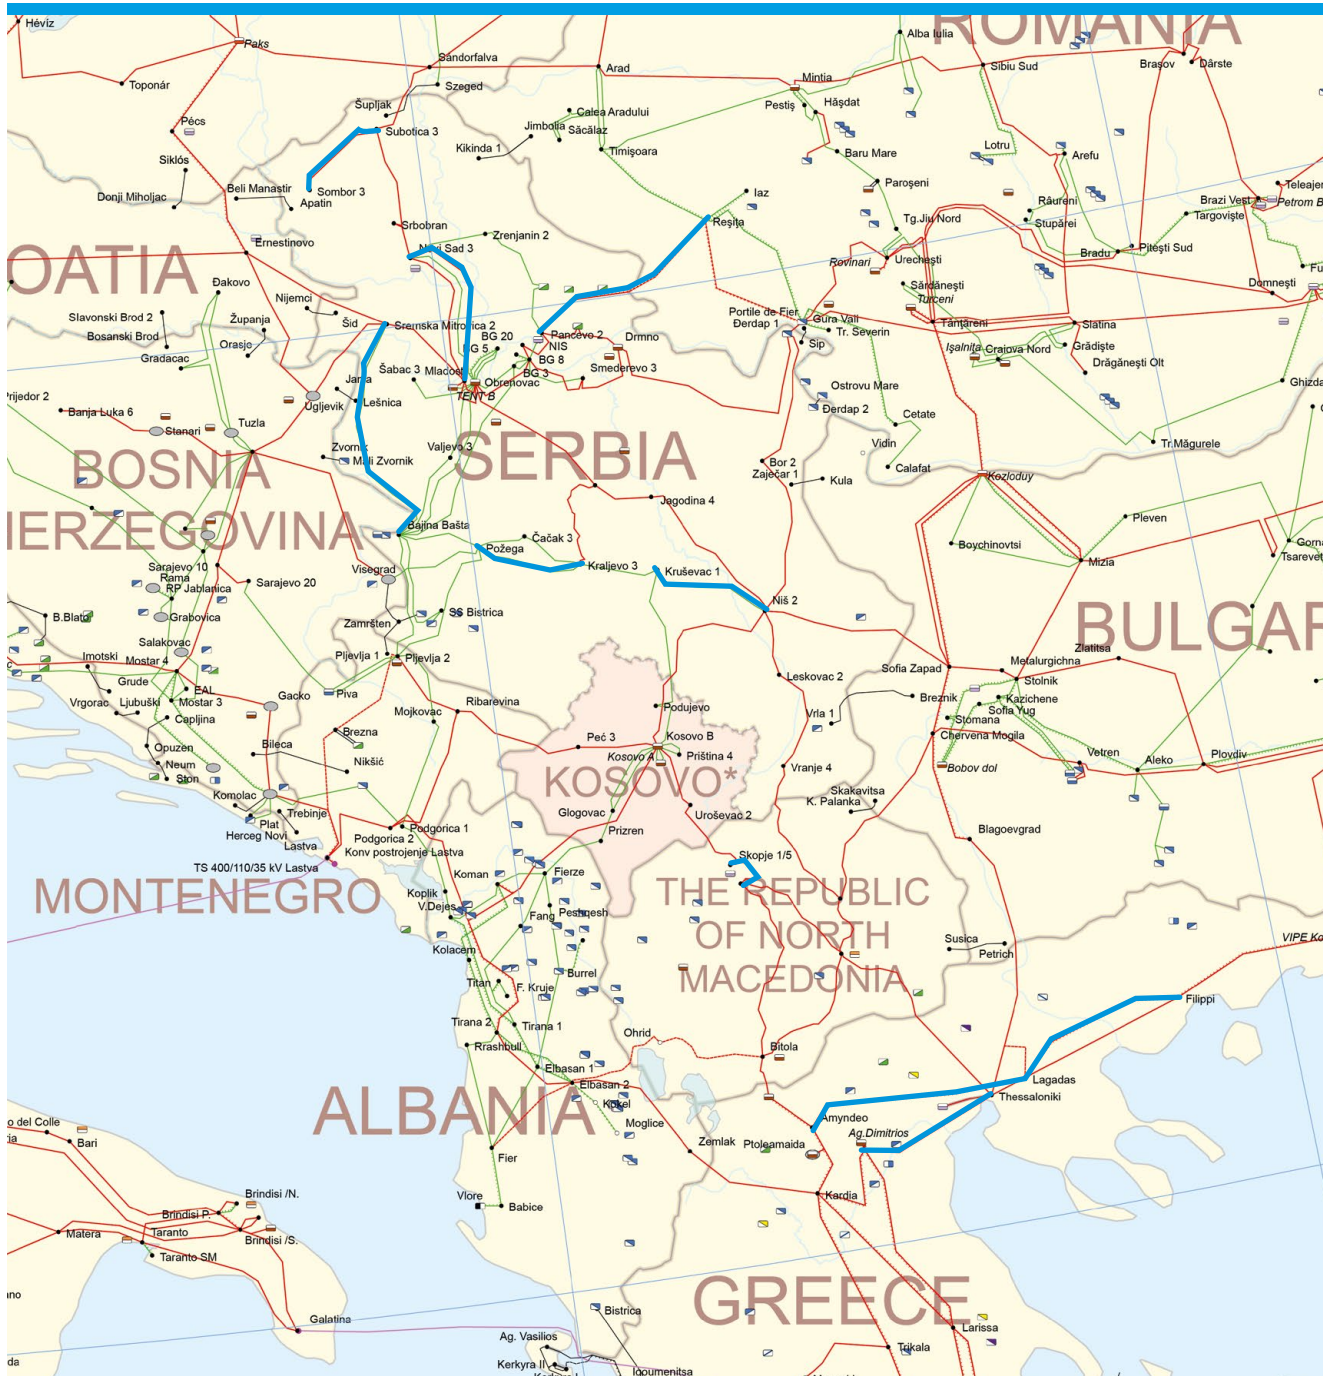
Figure 7.27: Disconnected OHLs in the SEE region for voltage control purposes.

Figure 7.27 shows all transmission lines in the SEE region that were disconnected for voltage control.
