# » Grid Incident in North Macedonia on 18 May 2025

ICS Investigation Expert Panel  
Final Report

20 April 2026

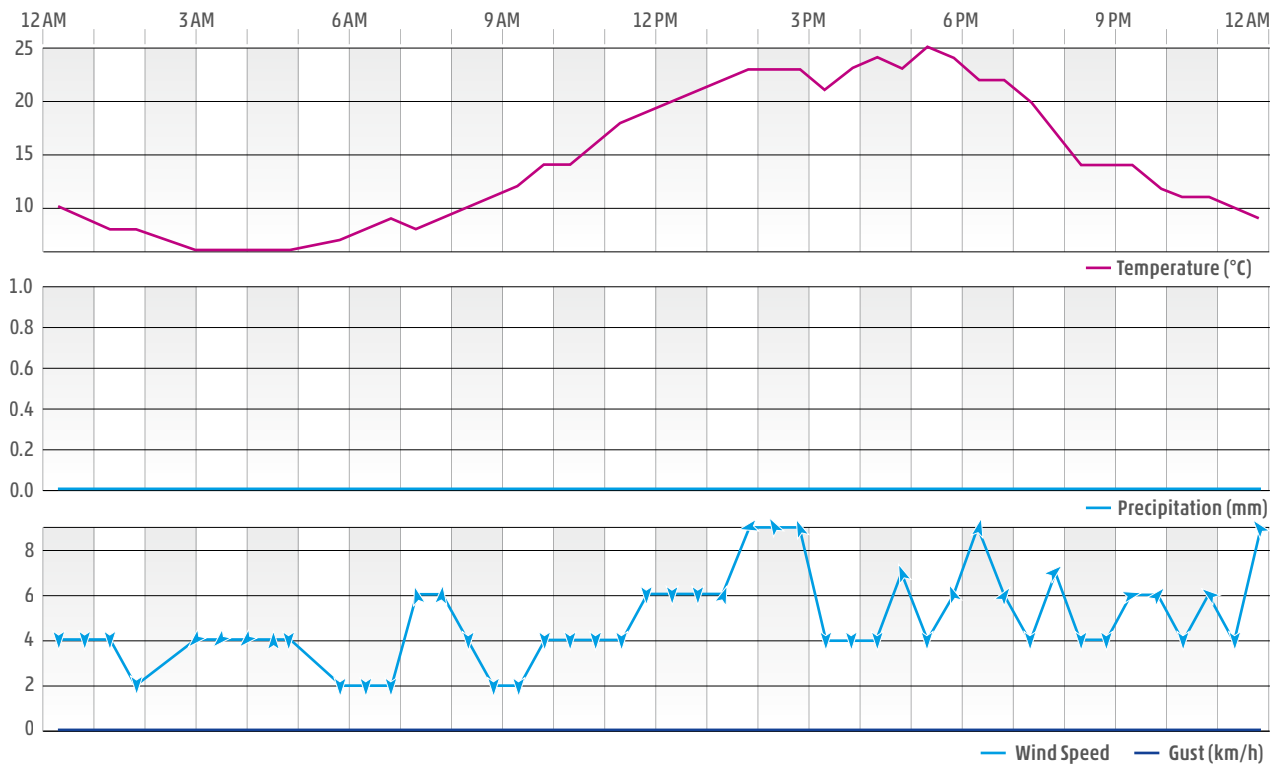
Figure 2.3: Weather conditions in the city of Skopje, North Macedonia, on 18 May 2025<sup>11</sup>

characterised by rising day and night temperatures, when households typically do not use cooling or heating. These weather conditions can be considered a prerequisite for the “spring effect” – a seasonal phenomenon in which low electricity demand coincides with higher levels of renewable generation.

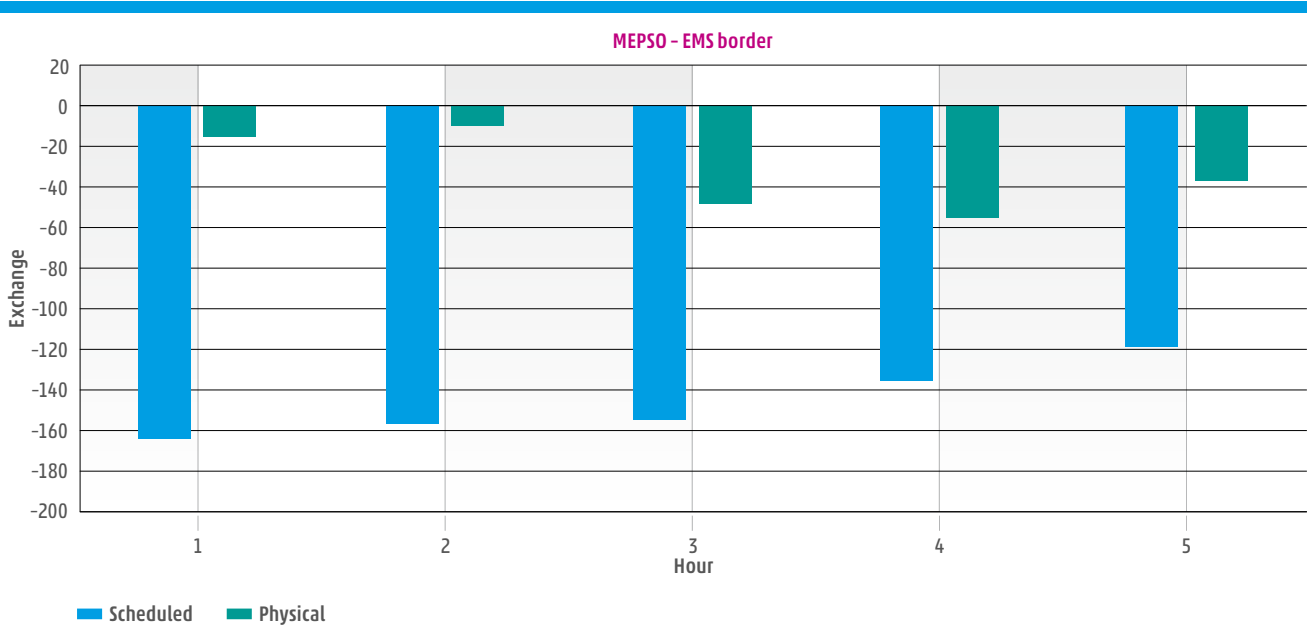
Figure 2.12: Scheduled and physical flows on the MEPSO-EMS bidding zone border

During the observed hours, the scheduled flow indicates continuous export from MEPSO towards EMS (around -160 MW). However, the physical flow was significantly smaller in magnitude.

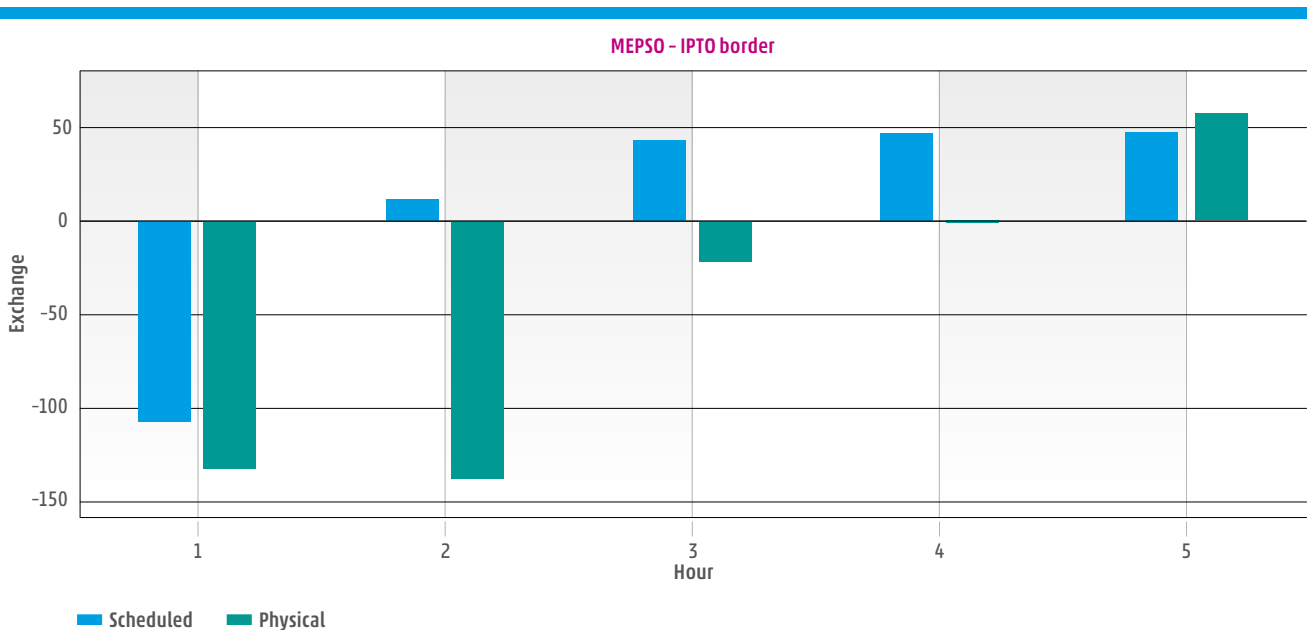
Figure 2.13: Scheduled and physical flows on the MEPSO-IPTO bidding zone border

While schedules show alternating import and export values, the physical flows deviate strongly, especially between 02:00 and 04:00, when the measured exchange was substantially lower than planned.

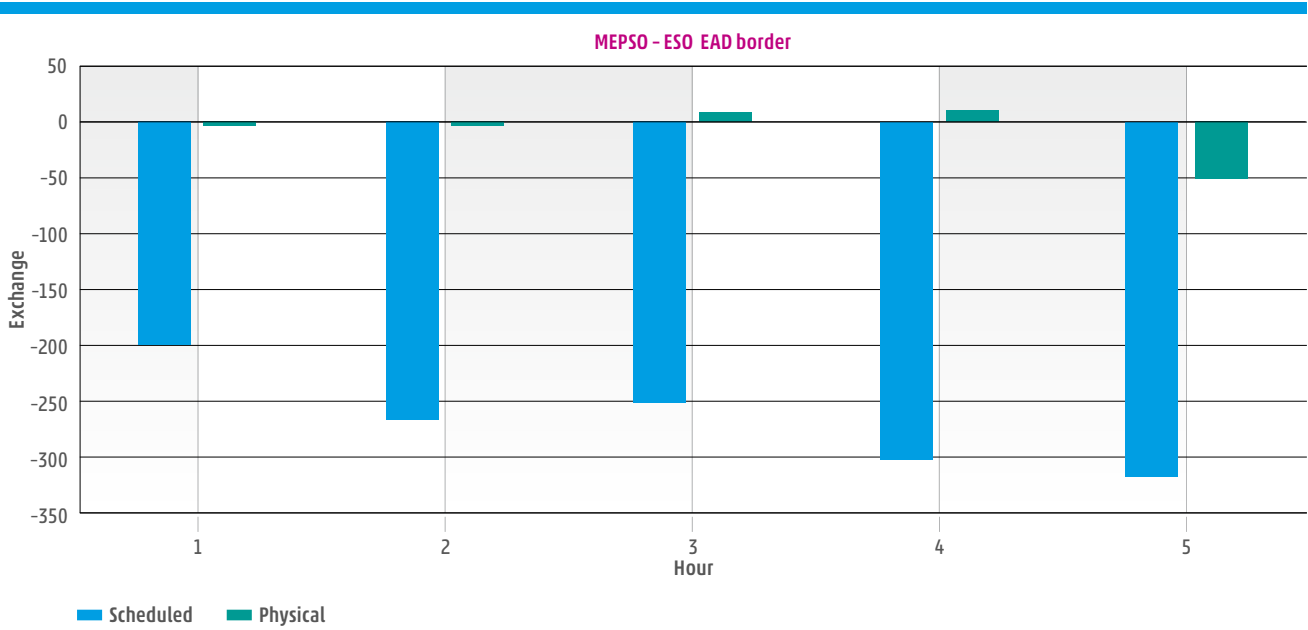
Figure 2.14: Scheduled and physical flows on the MEPSO-ESO bidding zone border

The scheduled values indicate a stable export from MEPSO towards ESO (around -250 MW). The physical flow, however, remained close to zero until 05:00.

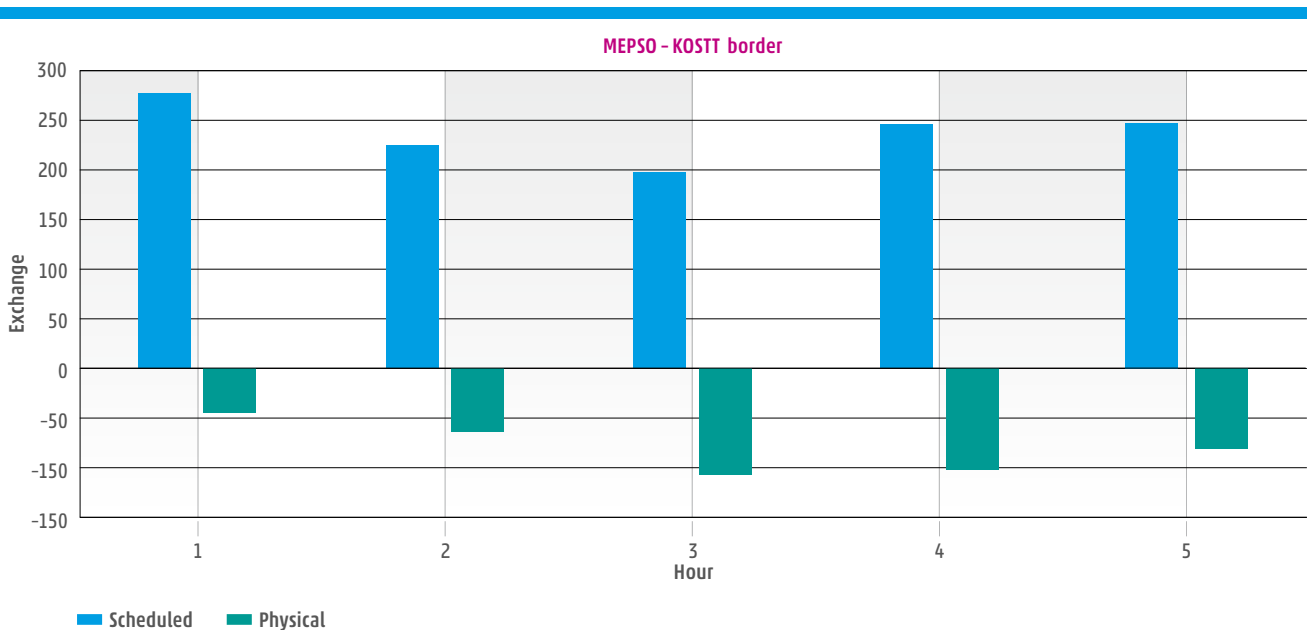
Figure 2.15: Scheduled and physical flows on the MEPSO-KOSTT bidding zone border

The interconnection with the KOSTT transmission system shows rapid fluctuations and frequent direction changes.

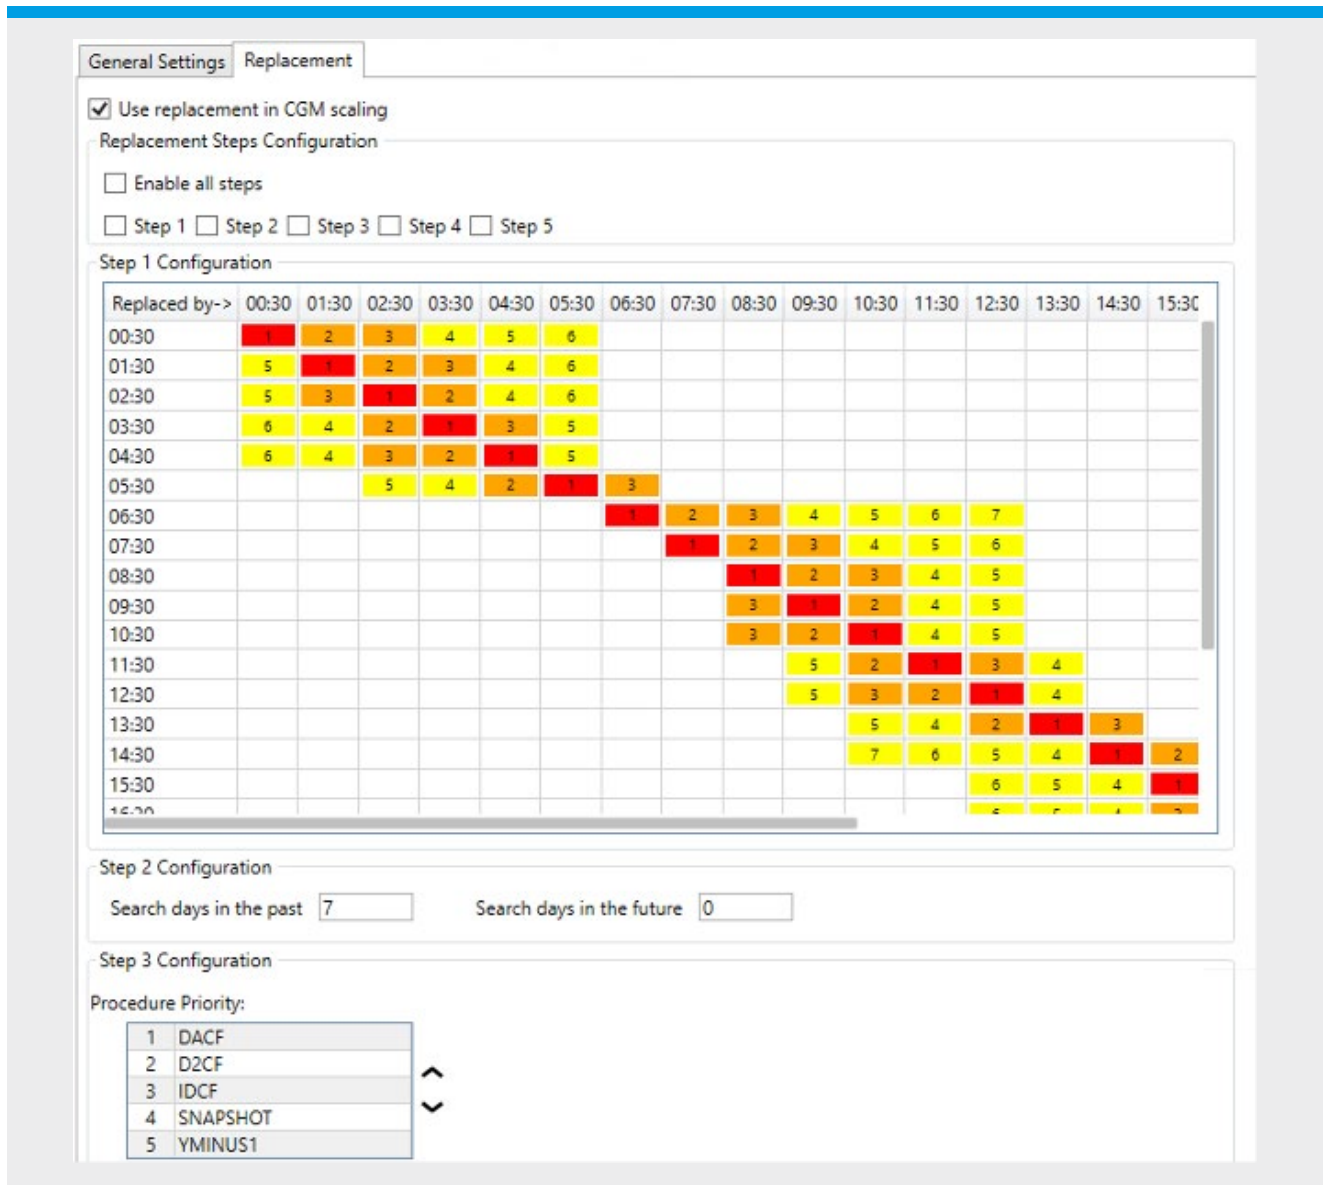
Figure 2.19: CGM replacement strategy

For Steps 2 and 4, the IGMs are used from the last seven days.

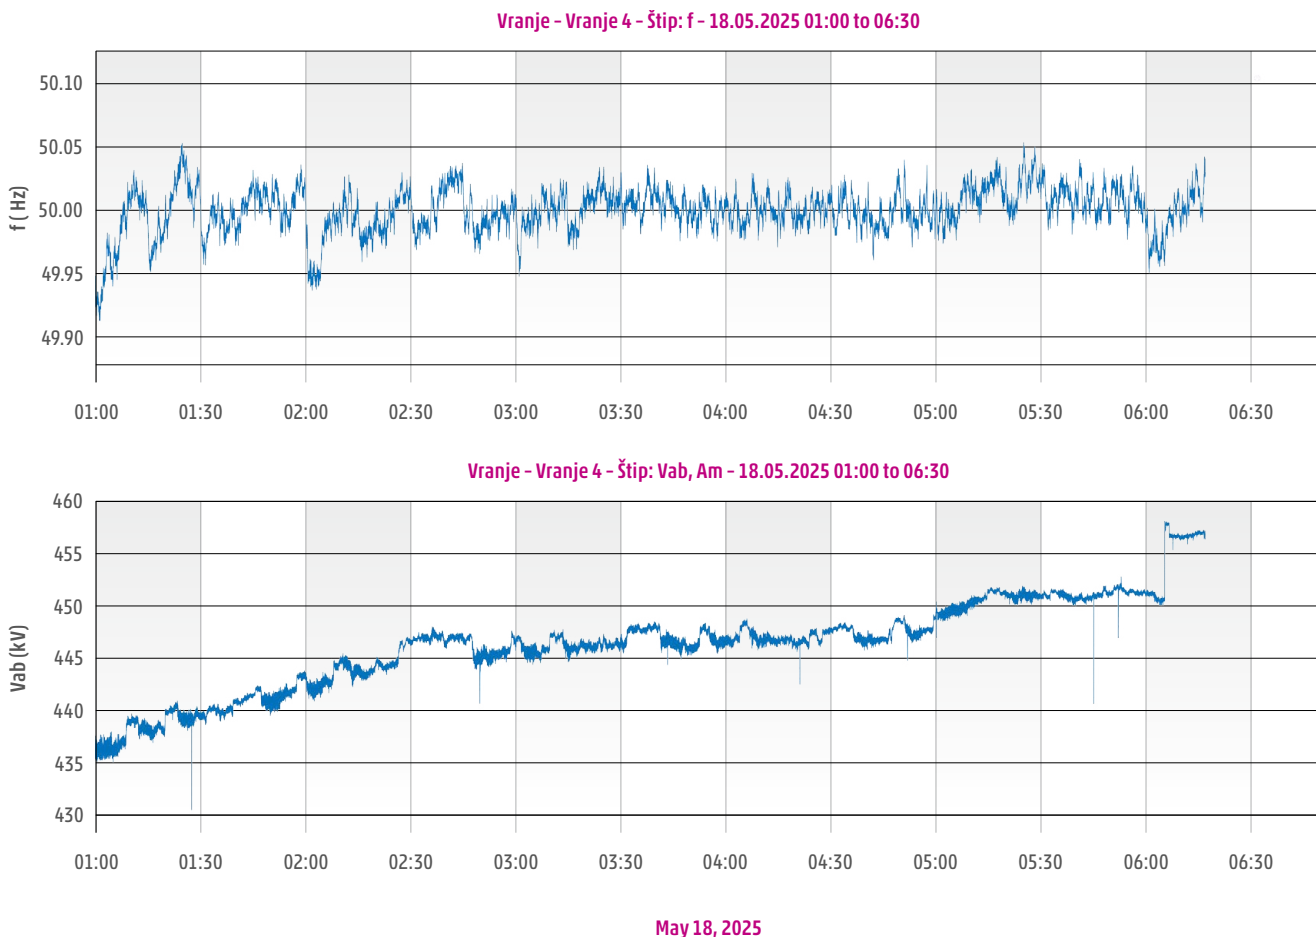
Figure 3.17: Voltage and frequency overview on 18 May 2025 based on PMU data

The line was in operation until 06:05 and then disconnected as a corrective measure by MEPSO. The measurements after 06:05 with voltages above 455 kV do not represent the state of the transmission system of North Macedonia but result from the single-sided disconnection of the line. The line was finally disconnected on the Serbian side at 06:16.

The significant frequency drops (Figure 3.17) at the hour change – for example, at 01:00, 02:00, 03:00, and 06:00 – are not related to events in the transmission system of North Macedonia. Rather, these are deterministic frequency deviations (DFD) that essentially result from the schedule change at the power plants and can be observed regularly throughout the CE SA.

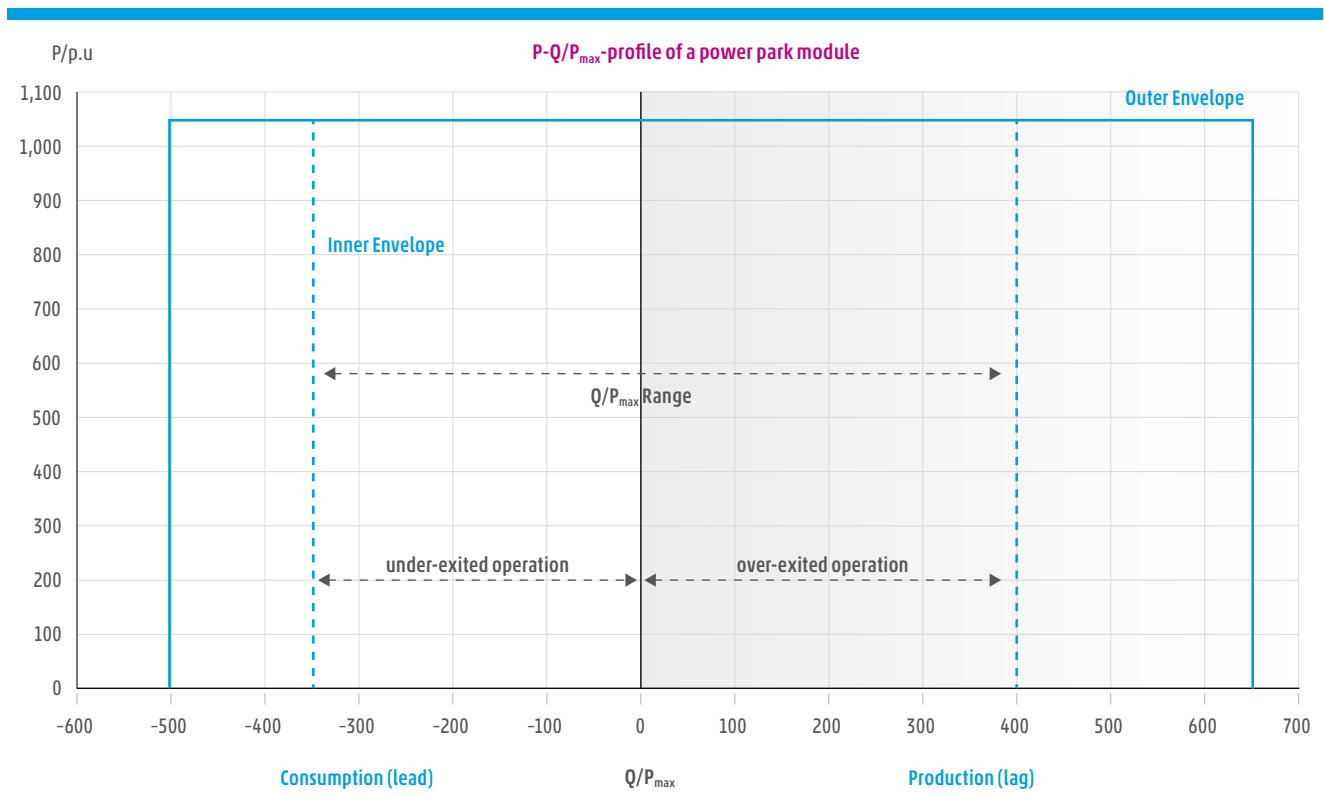
Figure 7.4: Update of reactive power capability below maximum power applicable to PPMs

Overall, this approach will significantly strengthen the operational flexibility and reliability of generation units, while enabling more secure integration of large-scale RES into the transmission system.
