# » Grid Incident in Czech Republic on 4 July 2025

ICS Investigation Expert Panel  
Factual Report

19 December 2025

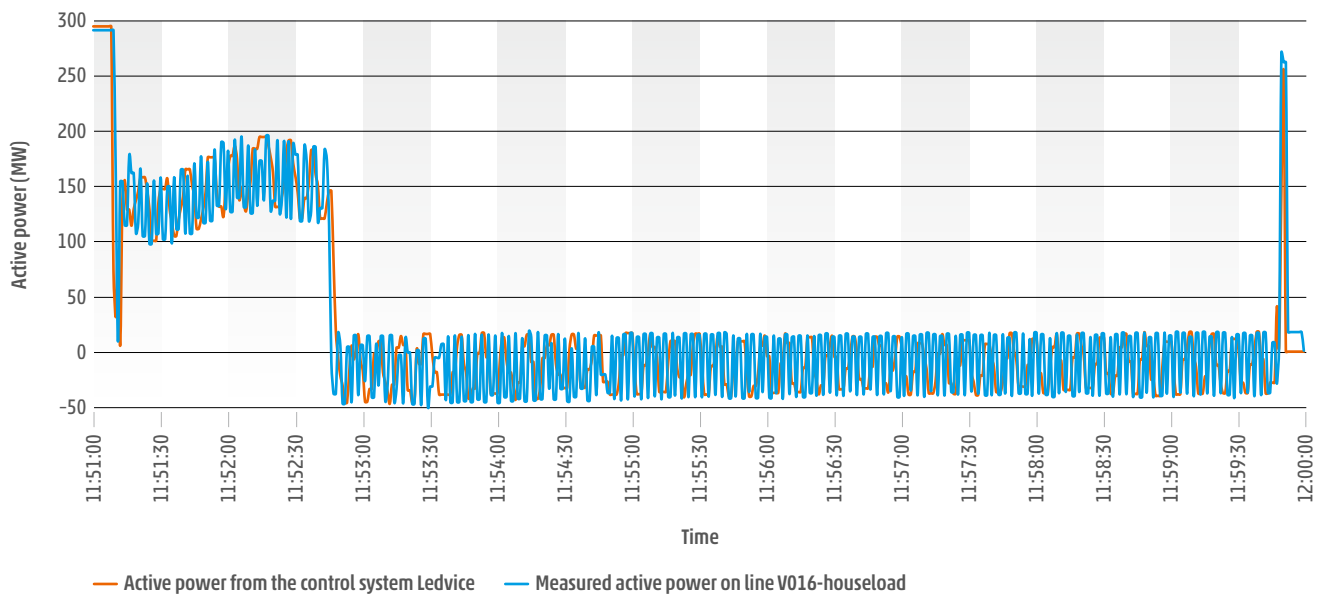
Figure 3.11: Comparison of the active power trend of the generator with the measurement on line V016 adjusted for the house load of ELED from 11:51 to 12:00

For comparison, Figure 3.11 shows measurements from the control system of unit 6 and line V016. The measurement on line V016 is adjusted for the power plant house load. The graph clearly shows that the measurements overlap, and the line measurement also indicates oscillations (even with a shorter period) in the active power of generator unit 6.

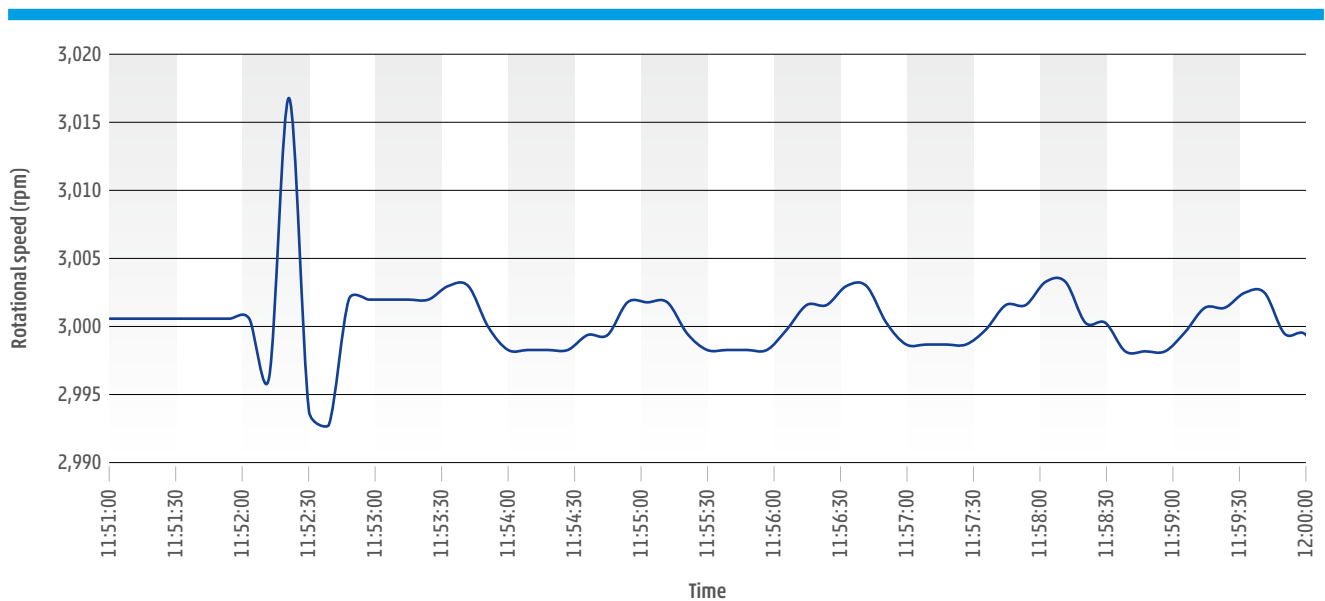
Figure 3.13: Zoomed view of speed measurement during the V411 outage

From the speed measurement, it is evident that a transient change was recorded following the outage of line V411, during which the rotor speed reached approximately 3,016 rpm at 11:51:09.

Since a frequency deviation of 200 mHz as a threshold for transition to droop speed control mode corresponds to 12 rpm, unit 6 recorded a deviation greater than the set limit.

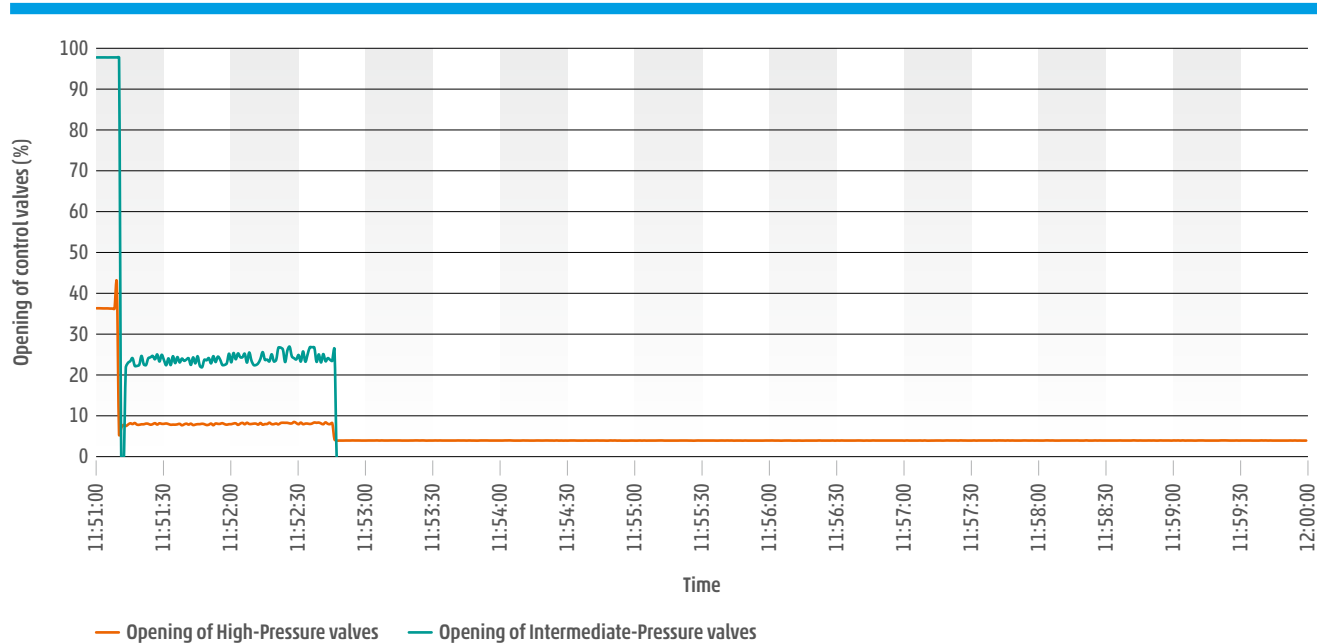
According to the statement from TPP Ledvice, at 11:51:46, a boiler outage occurred due to the activation of protection triggered by a high-temperature steam signal behind the high-pressure bypass stations. This was caused by an unforeseen technical fault in one of the high-pressure steam temperature control valves in the turbine bypasses steam piping. The valve failed to open due to an actuator motor malfunction, which was specifically caused by a defective relay.

The following graphs show profiles of the opening of bypass stations and control valves of the TPP Ledvice unit 6. The graphs show that changes in the variables occurred already after the V411 outage.

Figure 3.14: Trend of control valves opening for ELED unit 6 from 11:51 to 12:00

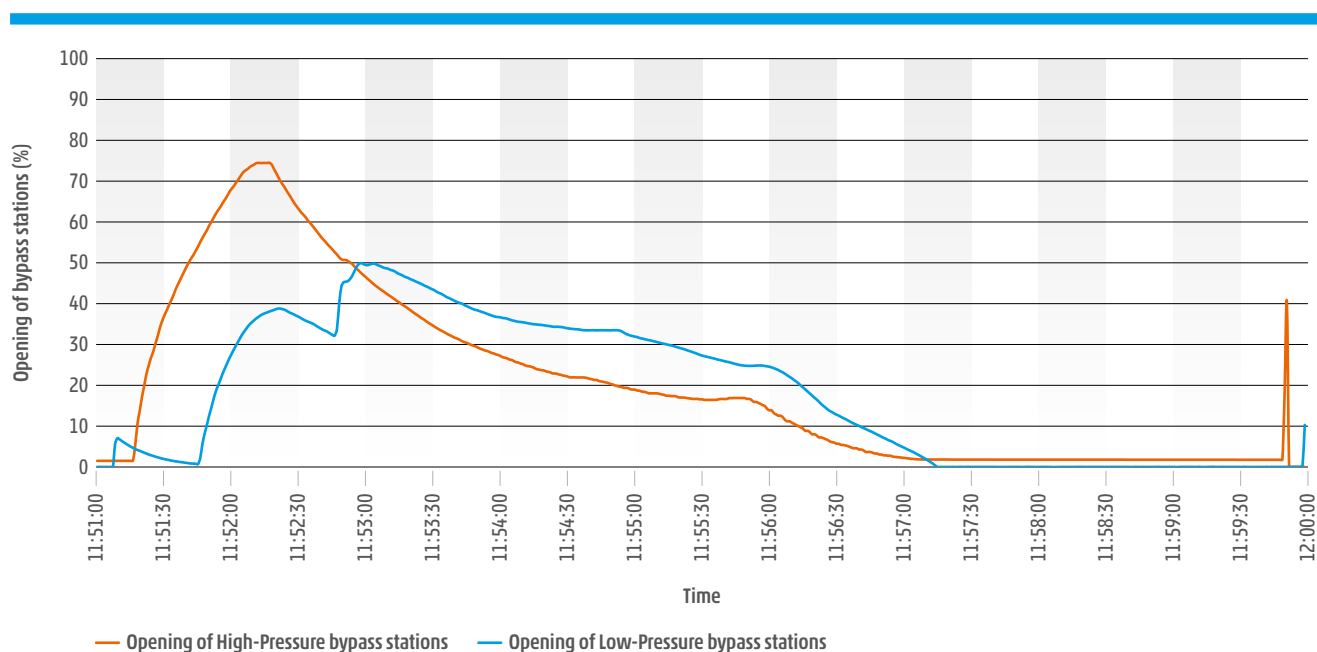
Figure 3.15: Trend of bypass stations opening for ELED unit 6 from 11:51 to 12:00

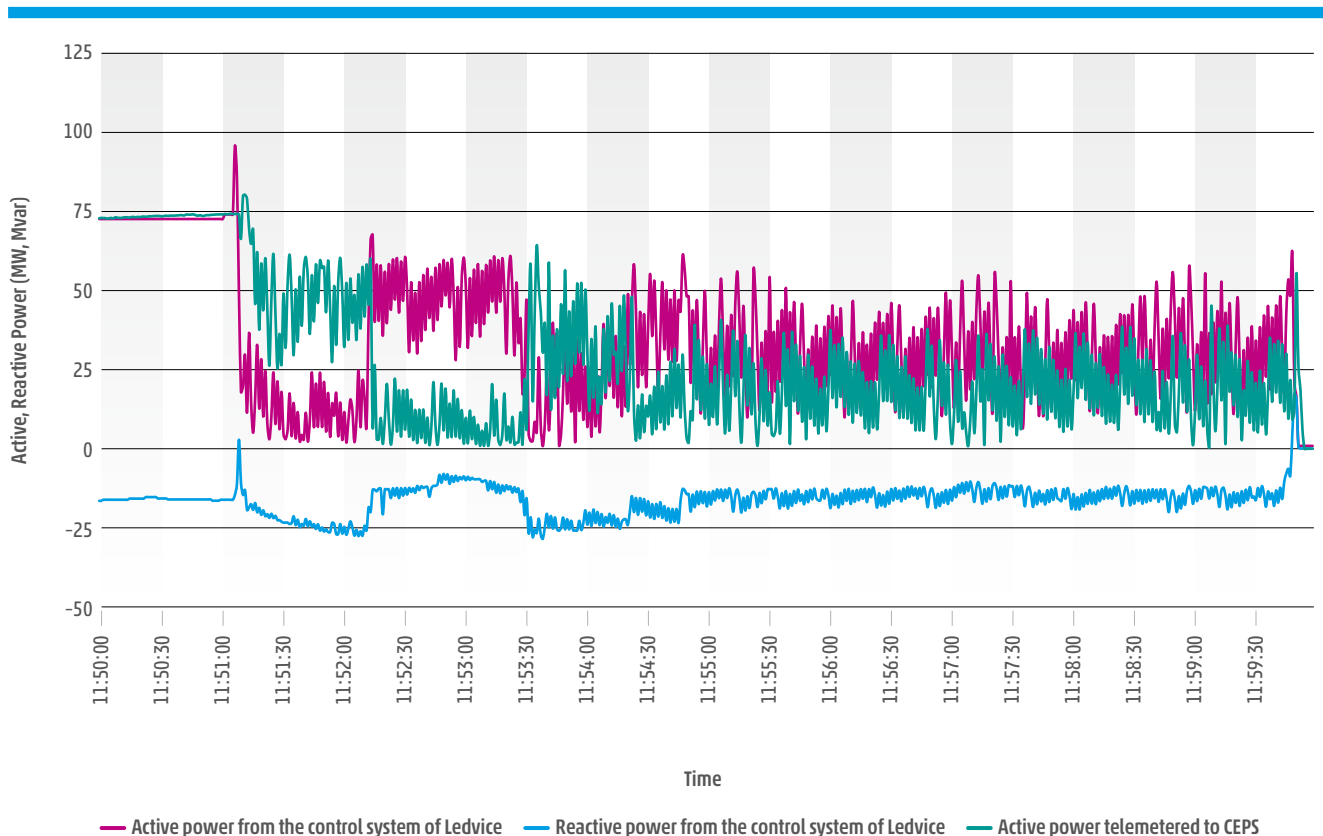
Figure 3.16 shows the output of the TPP Ledvice unit 4 generator, again compared with the values from the Ledvice power plant control system and the telemetered values to the ČEPS dispatch control system. From the trends, it is evident that unit 4 experienced oscillations, and the output active power telemetered to the ČEPS dispatch control system differs from the output power recorded in the power plant control system. Therefore, it is also more difficult to calculate the total loss of active power generation after the V411 outage.

Figure 3.16: Trend of power output at generator terminals of ELED unit 4 from 11:50 to 12:00

According to the power plant statement, unit 4 of TPP Ledvice had a droop setting of 0 % in droop speed control mode, meaning that the proportional speed controller's gain was theoretically infinite. Such a gain would theoretically mean that, for any positive frequency deviation from 50 Hz, the unit would drop to zero active power, and for any negative deviation, it would go to its maximum available output. The gain is limited in practice by the mechanical equipment's capabilities. This droop setting represents an inappropriate setup.

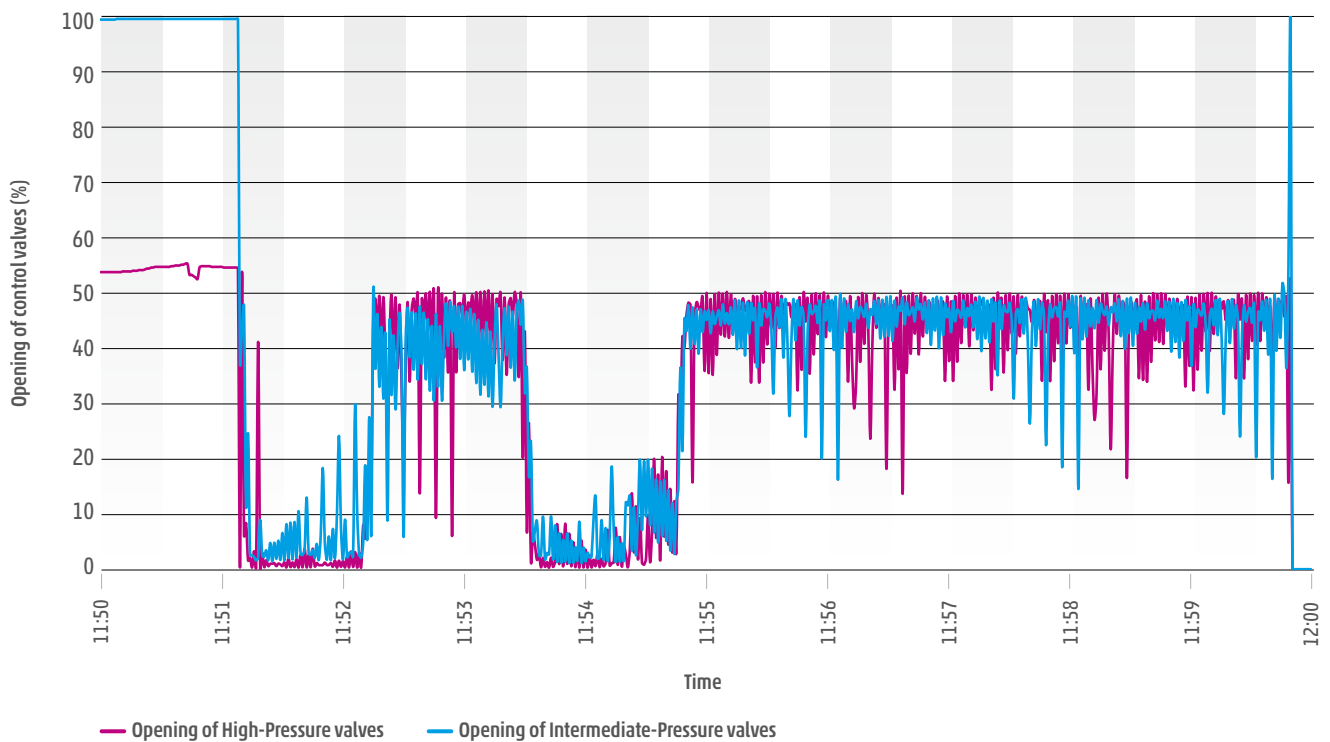
Oscillations are also evident in the opening of the turbine control valves on TPP Ledvice unit 4 following the V411 trip and the switch to droop speed control mode.

Figure 3.17: Trend of control valves opening for ELED unit 4 from 11:50 to 12:00

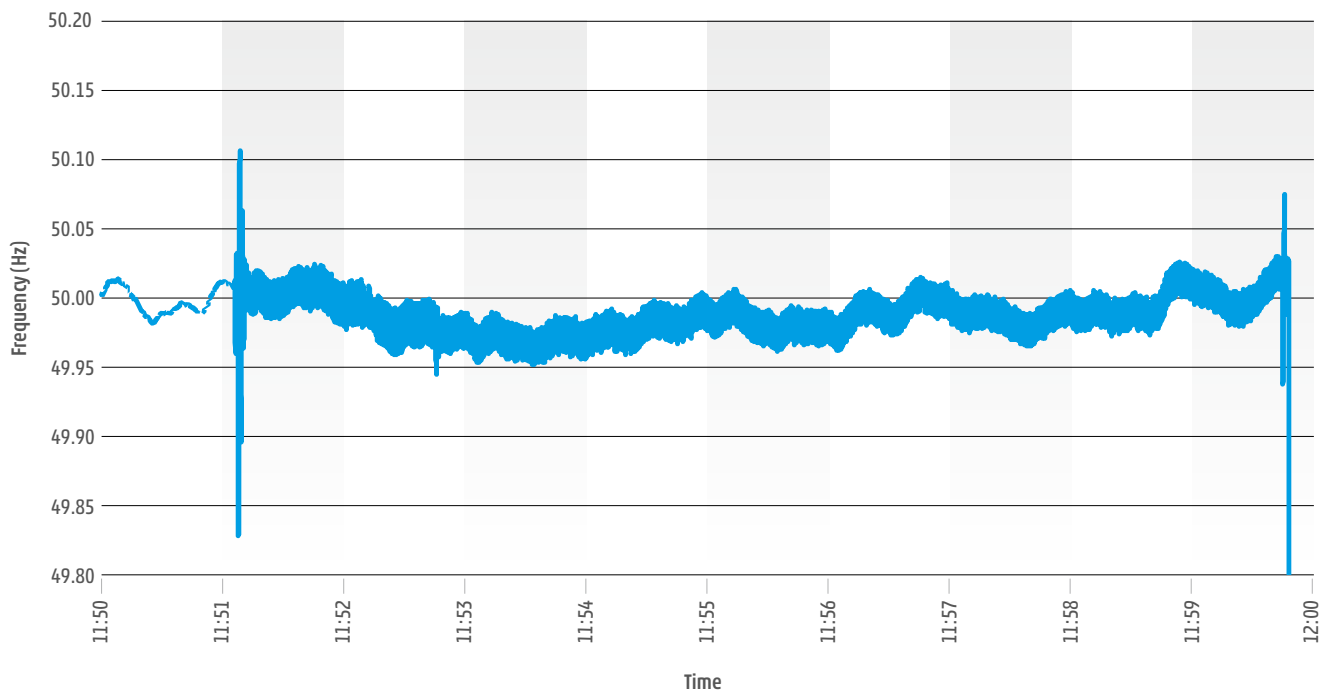
Regarding the grid's behaviour, Figure 3.18 shows frequency measurements from the WAMS system at the Čechy Střed substation between 11:50 and 12:00, with a displayed granularity of 50 samples per second. This is the only substation in the transmission system area equipped with WAMS measurement that was affected by a voltage outage at 11:59.

The graph clearly shows the moment when line V411 was disconnected at 11:51:08, which caused a frequency oscillation in the area. Although the frequency value stabilised around the nominal value 50 Hz after the disconnection of line V411 – since the affected part of the grid remained synchronously connected to the surrounding system – frequency oscillations are still visible. Figure 3.19 therefore shows a zoomed-in view of the frequency measurement over a 10-second interval, revealing ongoing oscillations with a period of approximately 1 s with a peak-to-peak amplitude of 30 mHz.

Figure 3.18: WAMS frequency measurement at the CST substation in the V400 line bay from 11:50 to 12:00

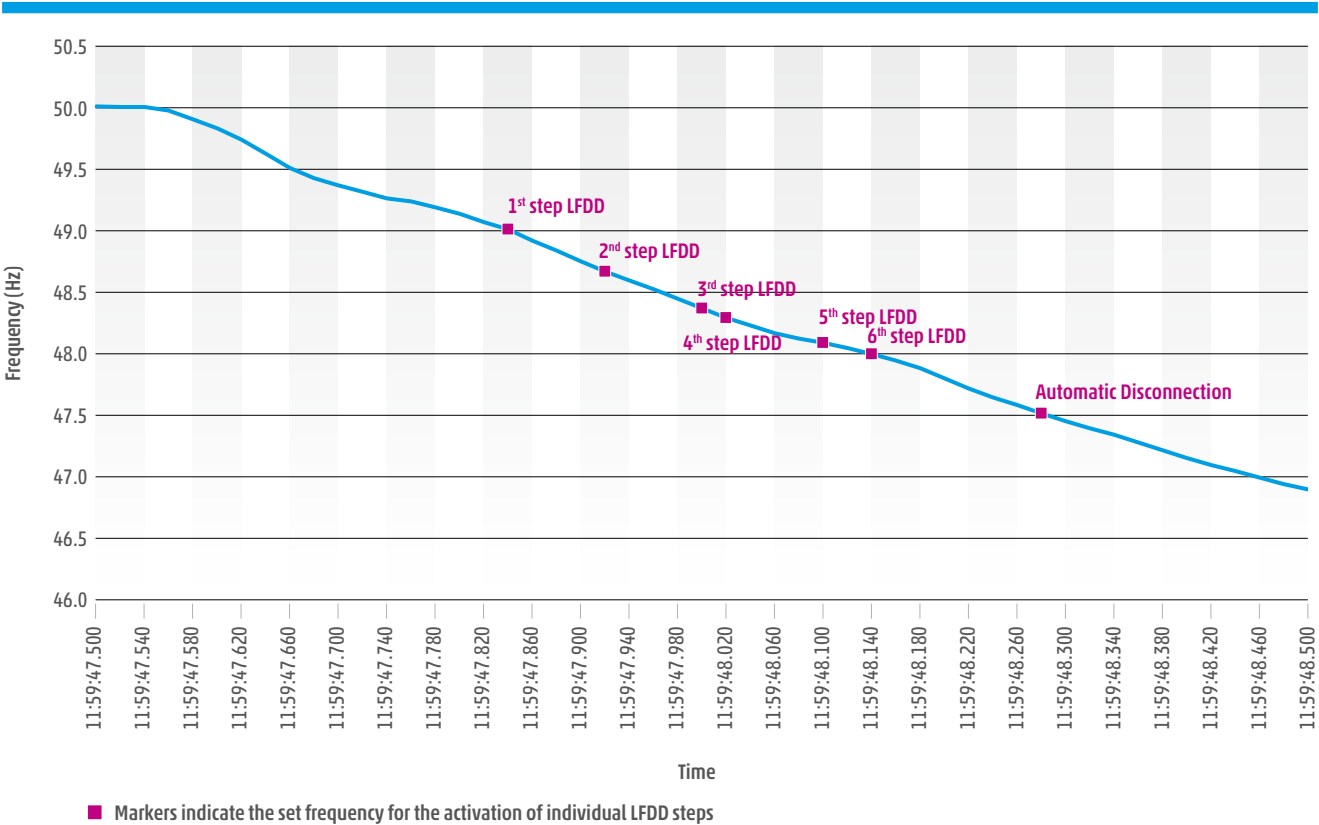
of its disconnection – even the activation of LFDD was insufficient to prevent the final collapse. Figure 3.24 illustrates the expected activation sequence of individual LFDD steps.

Figure 3.24: Frequency profile during the frequency collapse with indication of the set limits for LFDD steps

The graph clearly shows that due to the rapid frequency drop, there was insufficient time to activate all steps of LFDD. The time difference between reaching the frequency threshold for activating each step is as follows:

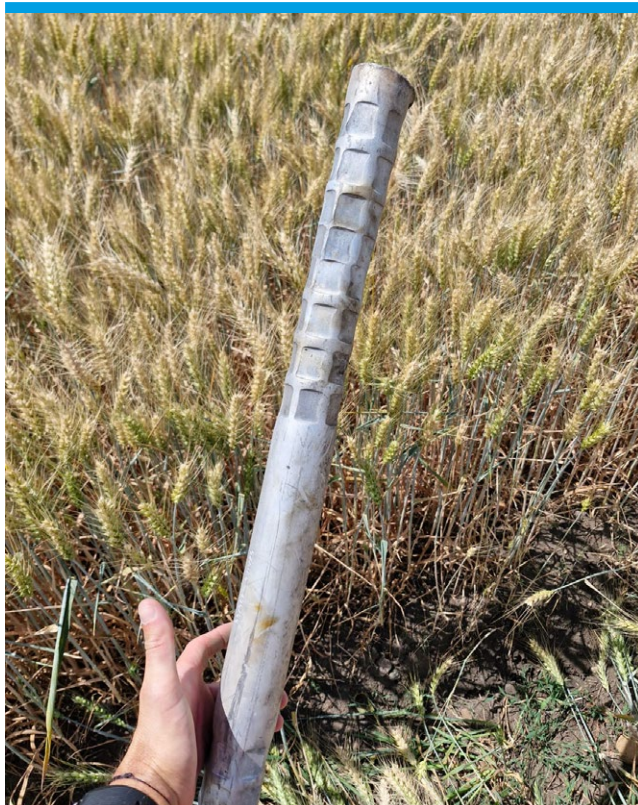
The cause of the wire breakage was identified as a mechanical failure. The failure occurred at the tension coupling, which was installed during an emergency repair at the beginning of December 2024.

The Klokner Institute of the Czech Technical University confirmed the findings that the tensile coupling showed an insufficiently tight connection. The mechanical connection of the steel core of the rope was properly tight, but the connection of the aluminium part of the conductor was insufficiently tight, resulting in higher contact resistance. The heat generated by the electrical current affected the mechanical properties of the steel core during operation, which subsequently caused the rope to break and the conductor to fall.

Figure 4.1: Photo of the tensile coupling

### The repair included:

- » removal of the damaged part of the original cable (installed in 1961);
- » adding a new cable of the appropriate length;
- » installation of two tensile couplings;
- » replacement of damaged spacers.

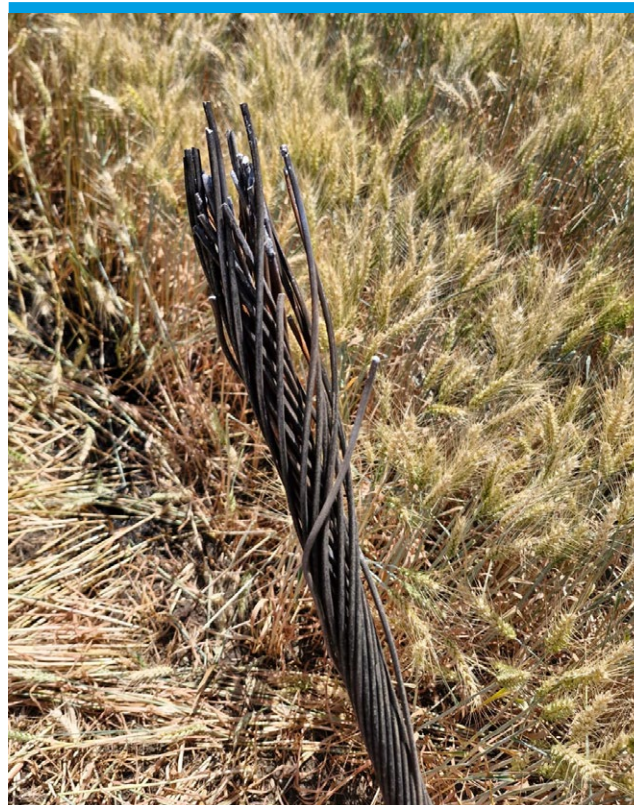
On 4 July 2025 at 11:51:08, the V411 line failed due to an unsuccessful reconnection (automatic recloser) in phase L2. The cause was a phase conductor failure, specifically a break in one of the cables between towers 35 and 36 near the village of Kličín.

Figure 4.2: Photo of the end of the conductor
