» Grid Incident in Czech Republic on 4 July 2025

ICS Investigation Expert Panel
Final Report

26 June 2026

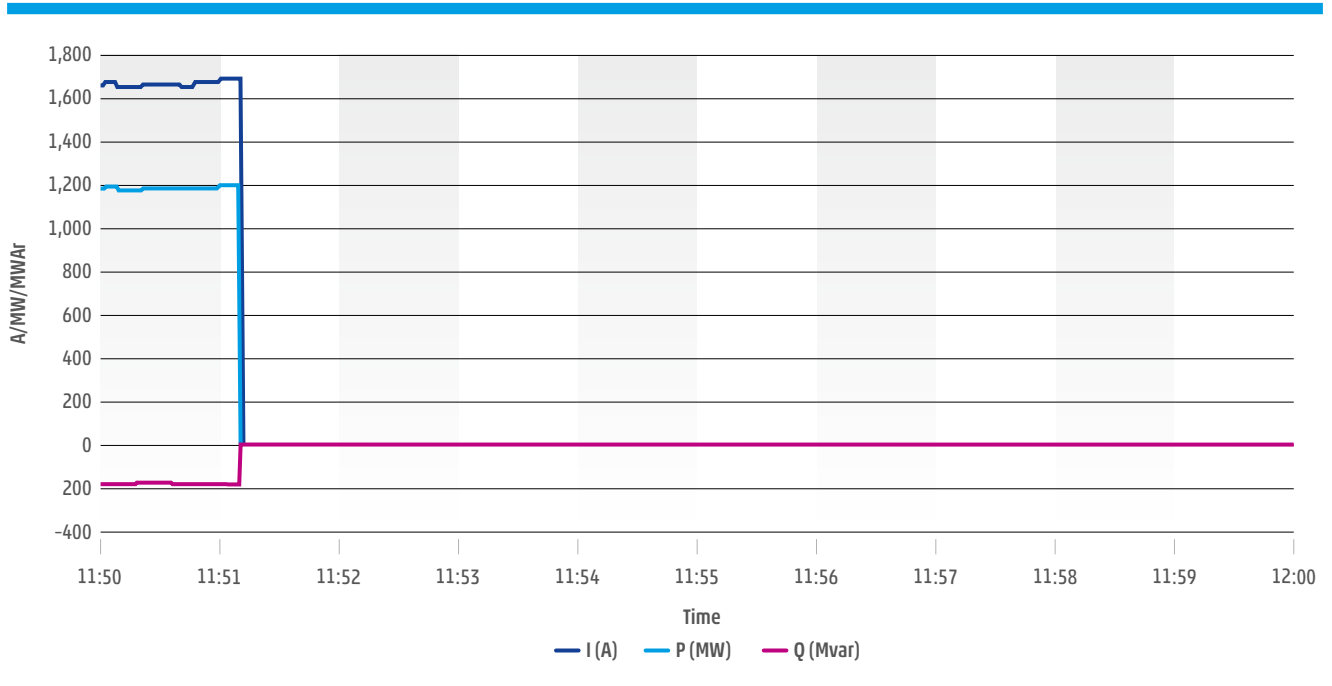
Figure 3.3: Current, active power and reactive power on Výškov line V411

Figure 3.3 to Figure 3.6 show active and reactive power flow and current on the element supplying the affected area for the period from 11:50 to 12:00.

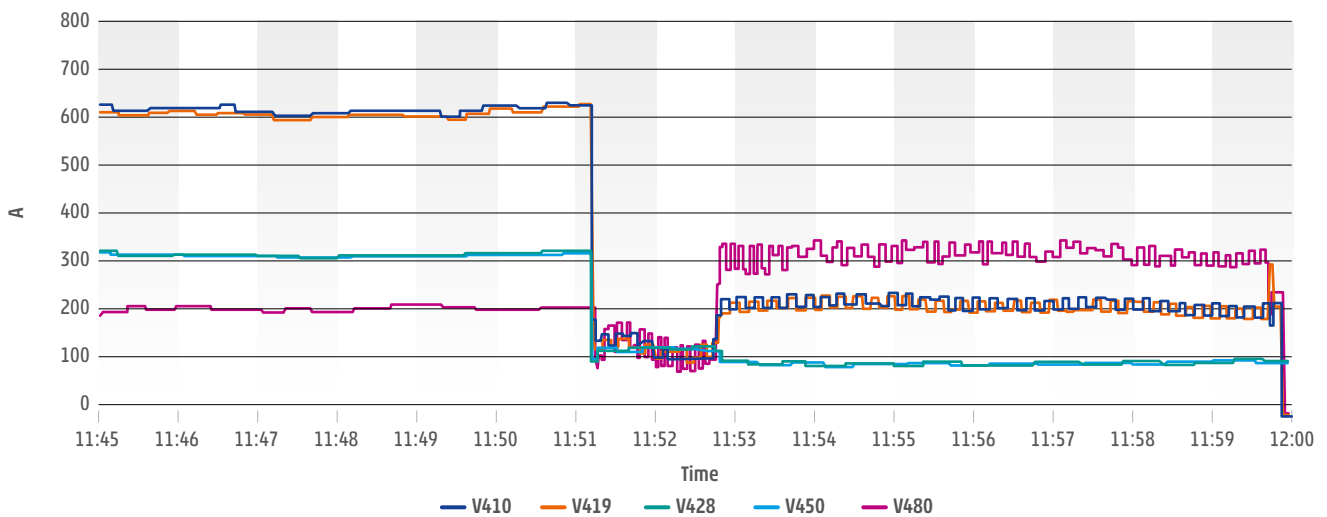
Figure 3.7: Flows on lines in the Výškov substation¹⁸

¹⁸ Oscillations of active power on lines V480, V410 and V419 were caused by power oscillations on units 4 and 6 of TPP Ledvice. These were caused by setting (0%) of the droop speed control mode of unit 4 of TPP Ledvice.

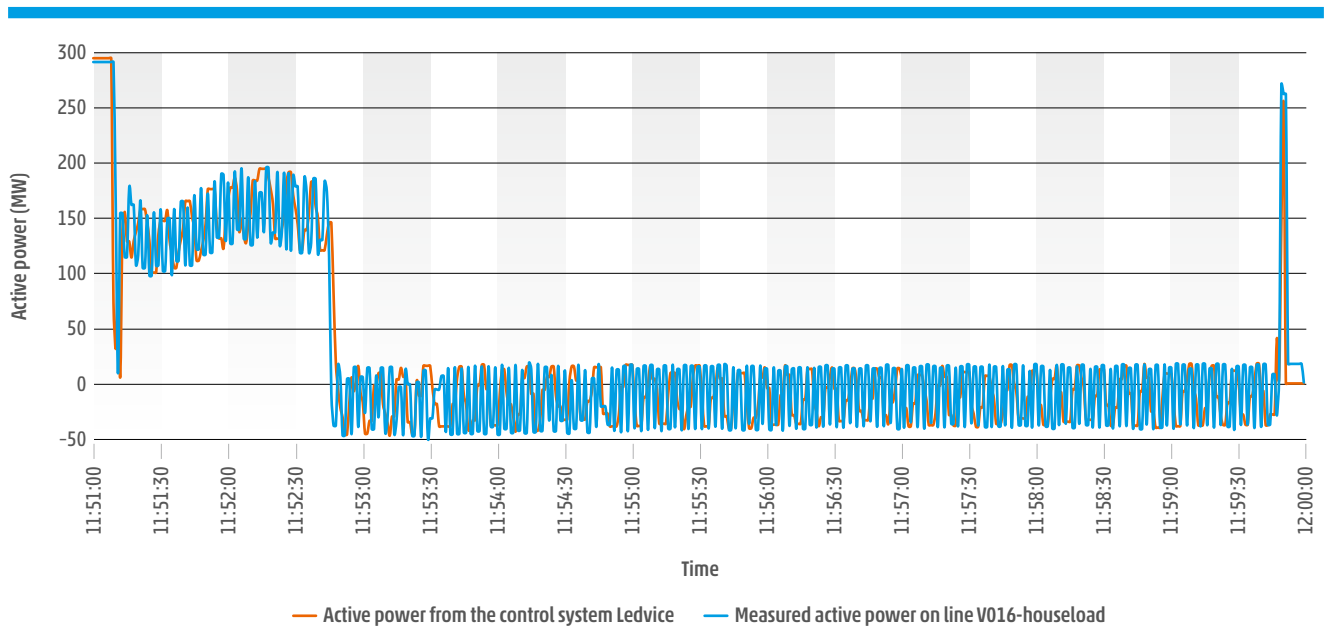
Figure 3.11: Comparison of the active power trend of the generator with the measurement on line V016 adjusted for the house load of ELED from 11:51 to 12:00

For comparison, Figure 3.11 shows measurements from the control system of unit 6 and line V016. The measurement on line V016 is adjusted for the power plant house load.

The graph clearly shows that the measurements overlap, and the line measurement also indicates oscillations (even with a shorter period) in the active power of generator unit 6.

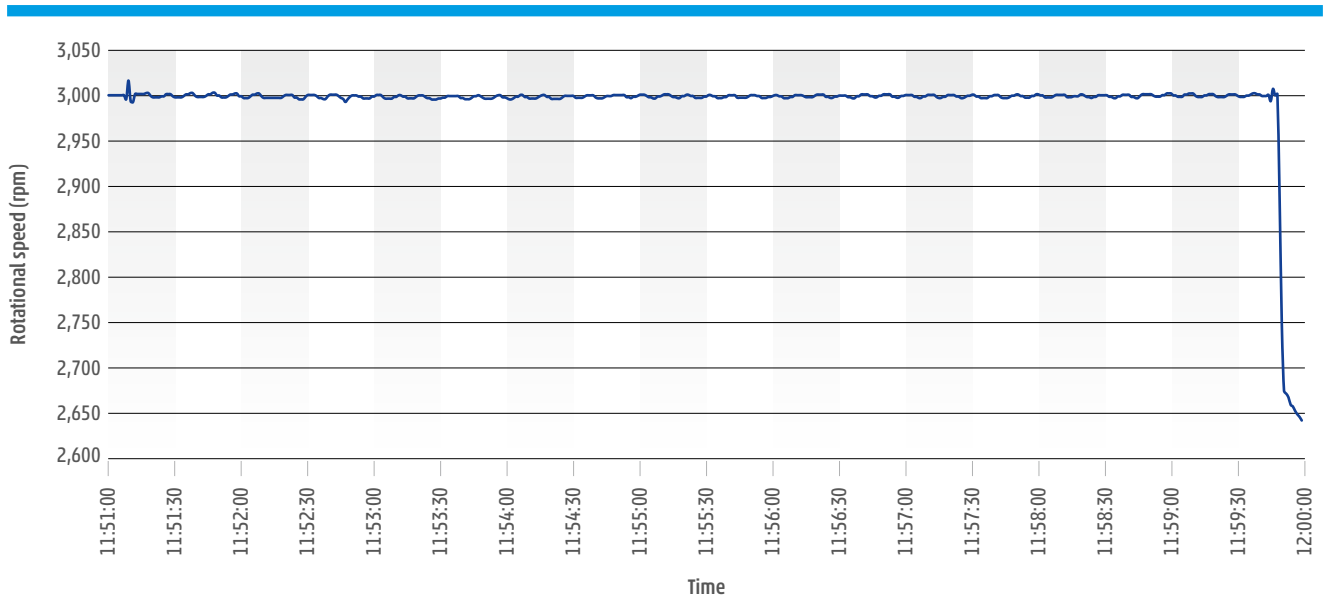
Figure 3.12: Trend of measured turbogenerator speed of ELED unit 6 from 11:51 to 12:00

The following graphs show the turbogenerator speed profile at TPP Ledvice unit 6. Figure 3.12 displays the period from 11:51 to 12:00, capturing both the V411 outage event and the subsequent frequency collapse in the affected part of the grid. The graph also shows that even after the boiler outage, the generator remained synchronised with the grid (i.e. operating at synchronous speed).

For unit 6, it is a two-pole turbogenerator; therefore, the synchronous speed corresponding to a 50 Hz grid frequency is 3,000 rpm. Small oscillations are also visible in the speed profile after the V411 outage. For better clarity, a zoomed-in view of the generator speed at the time of the V411 outage was also created.

From the speed measurement, it is evident that a transient change was recorded following the outage of line V411, during which the rotor speed reached approximately 3,016 rpm at 11:51:09.

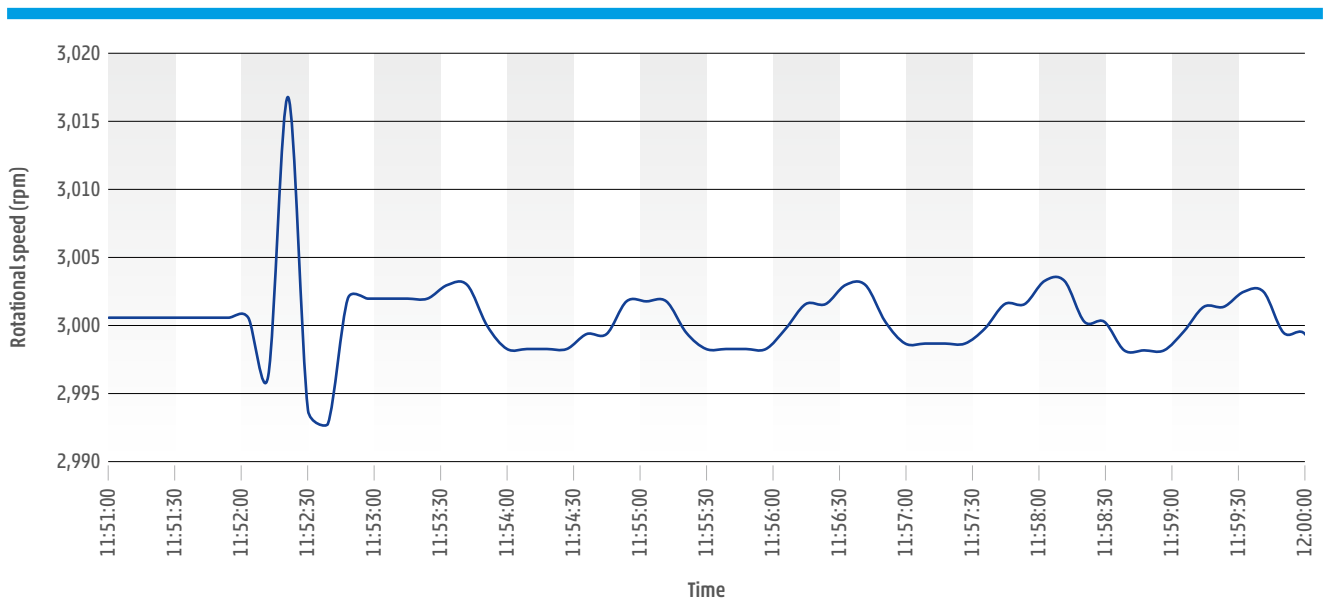
Figure 3.13: Zoomed-in view of speed measurement during the V411 outage

Since a frequency deviation of 200 mHz as a threshold for transition to droop speed control mode corresponds to 12 rpm, unit 6 recorded a deviation greater than the set limit.

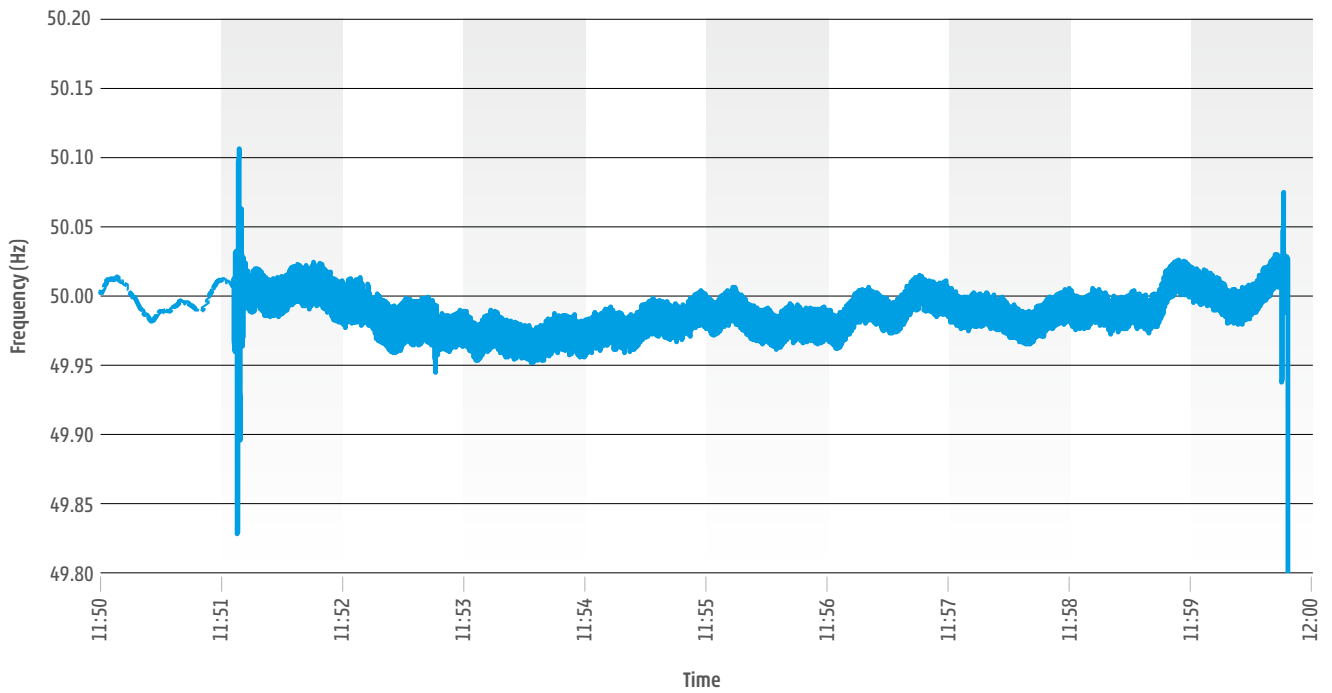
Figure 3.18: WAMS frequency measurement at the CST substation in the V400 line bay from 11:50 to 12:00

Regarding the grid’s behaviour, Figure 3.18 shows frequency measurements from the WAMS system at the Čechy Střed substation between 11:50 and 12:00, with a displayed granularity of 50 samples per second. This is the only substation in the transmission system area equipped with WAMS measurement that was affected by a voltage outage at 11:59. The graph clearly shows the moment when line V411 was disconnected at 11:51:07, which caused a frequency oscillation in the area.

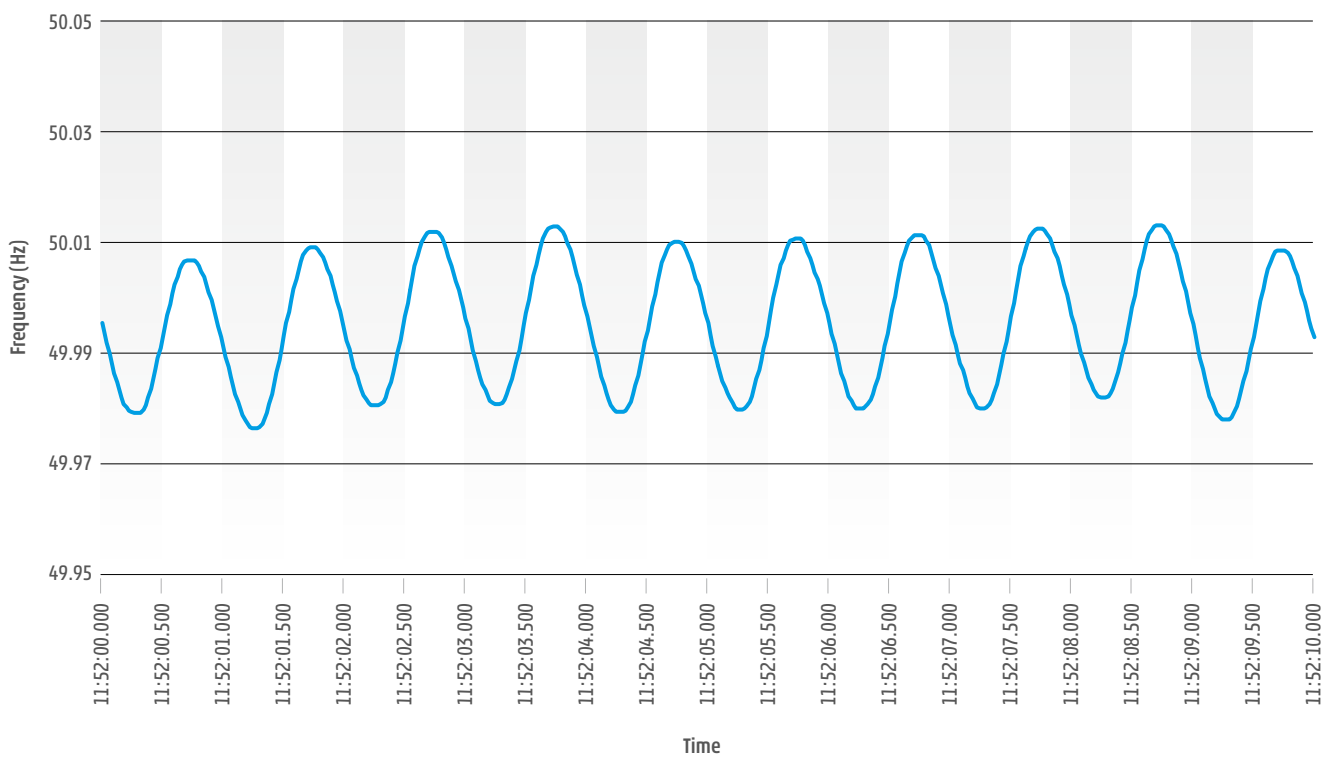
Figure 3.19: Zoomed-in view of the WAMS frequency measurement at the CST substation in the V400 line bay

Although the frequency value stabilised around the nominal value 50 Hz after the disconnection of line V411 – since the affected part of the grid remained synchronously connected to the surrounding system – frequency oscillations are still visible. Figure 3.19 therefore shows a zoomed-in view of the frequency measurement over a 10-s interval, revealing ongoing oscillations with a period of approximately 1 s with a peak-to-peak amplitude of 30 mHz.

This oscillation was observed only in the area (at least according to available WAMS measurements) that was subsequently affected by a voltage outage. The graph below shows frequency measurements from the Hradec substation, which the V411 line connects to. The data is taken from the V412 Hradec-Řeporyje line bay.

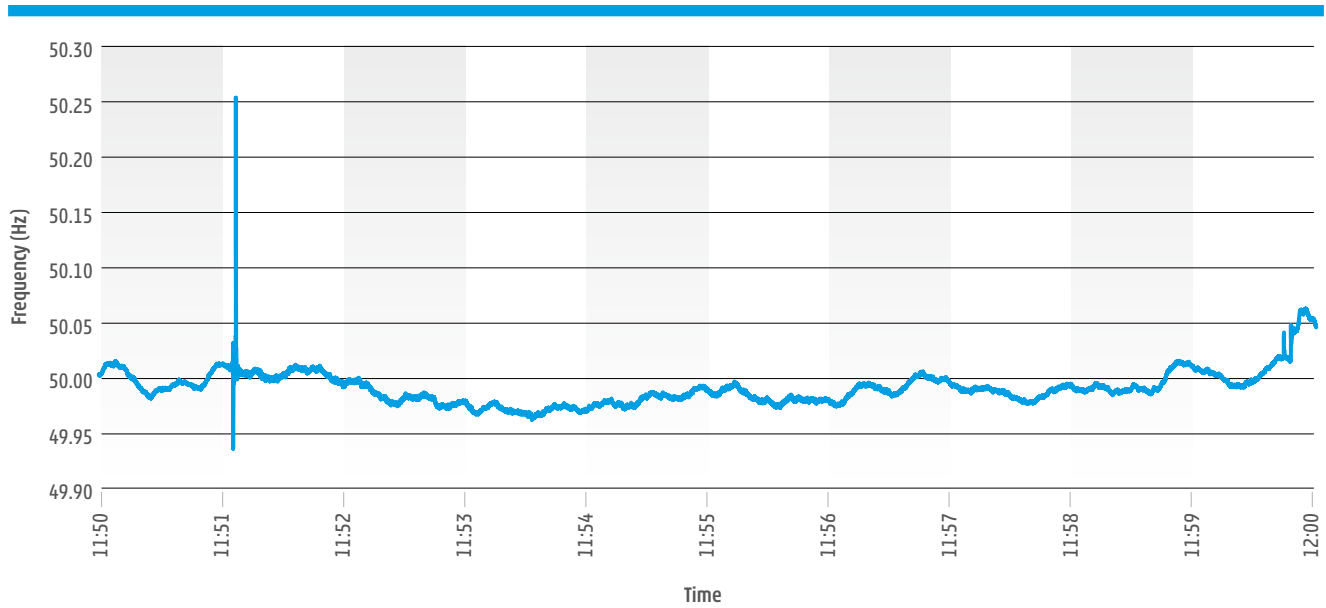
Figure 3.20: WAMS frequency measurement at the HRA substation in the V412 line bay from 11:50 to 12:00

In this waveform, oscillations following the V411 outage are not visible. Furthermore, the frequency measurement from the Hradec substation clearly shows that a frequency deviation greater than 200 mHz was recorded during the V411 line outage, representing the WAMS measurement closest to the V411 line.

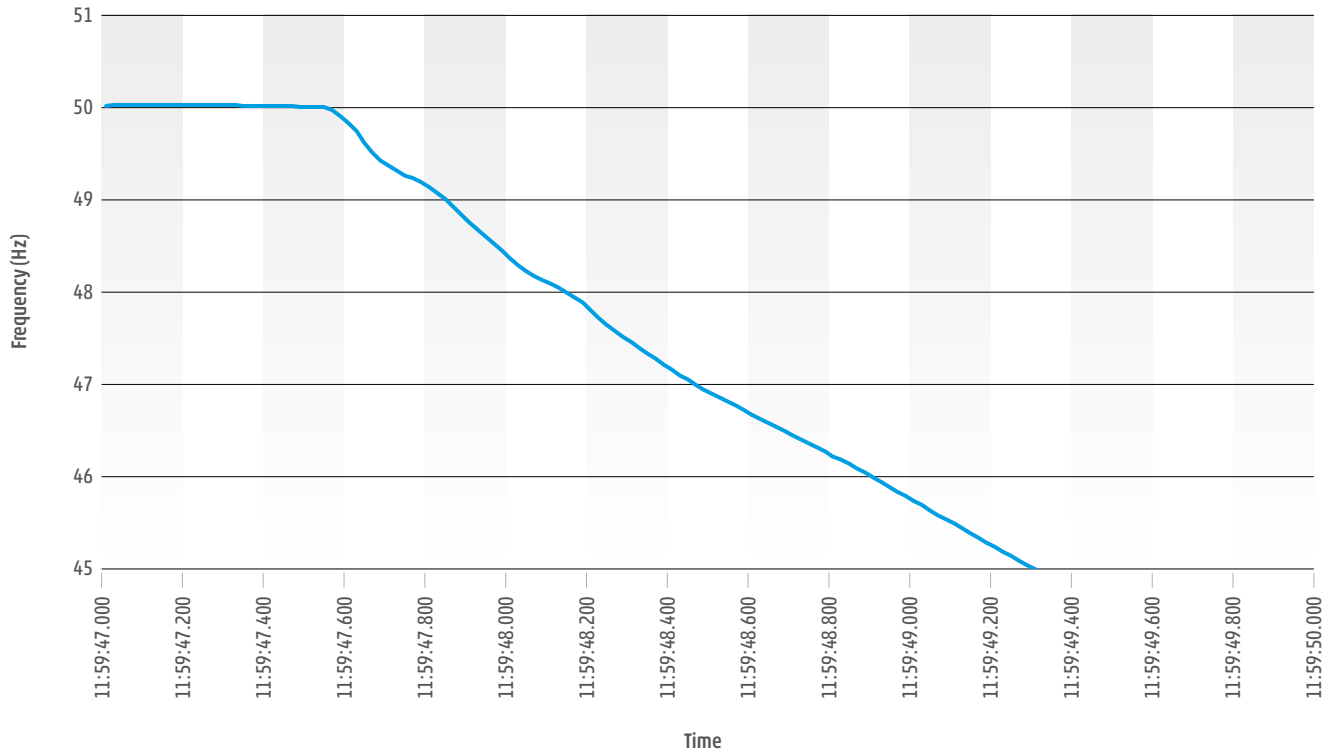
Figure 3.22: Recorded frequency collapse in the WAMS frequency measurement at the CST substation

As mentioned above, the WAMS measurement in the area affected by the voltage outage is installed at the Čechy Střed substation. The following course of the frequency collapse of the already-formed deficit island after the Krasíkov busbar coupler was switched off at 11:59:47 is also taken from this measurement.

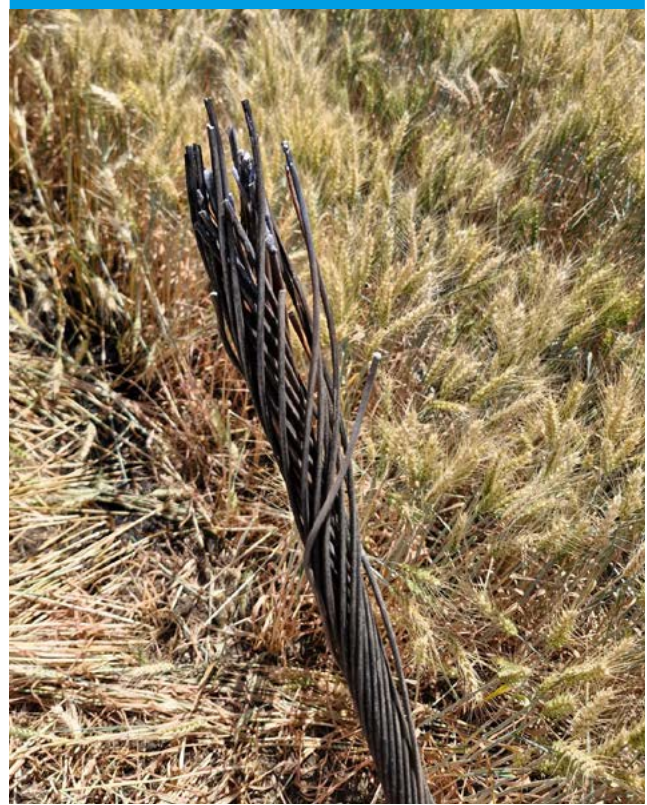
Figure 6.2: Photo of the end of the conductor

The cause of the wire breakage was identified as a mechanical failure. The failure occurred at the tension coupling, which was installed during an emergency repair at the beginning of December 2024.

After the July 2025 failure, a sample of the rope was requested and submitted to the Czech Police for examination. When ČEPS received the examined material back, specifically the ends of the broken metal conductor equipped with a tensile coupling, it submitted it for further expert examination to a certified laboratory.

The Klokner Institute of the Czech Technical University concluded that the tensile coupling showed an insufficiently tight connection. The mechanical connection of the steel core of the rope was properly tight, but the connection of the aluminium part of the conductor was insufficiently tight, resulting in higher contact resistance. The heat generated by the electrical current affected the mechanical properties of the steel core during operation, which subsequently caused the rope to break and the conductor to fall.

The repair included:

- » Removal of the damaged part of the original cable (installed in 1961)
- » Addition of a new cable of the appropriate length
- » Installation of two tensile couplings
- » Replacement of damaged spacers

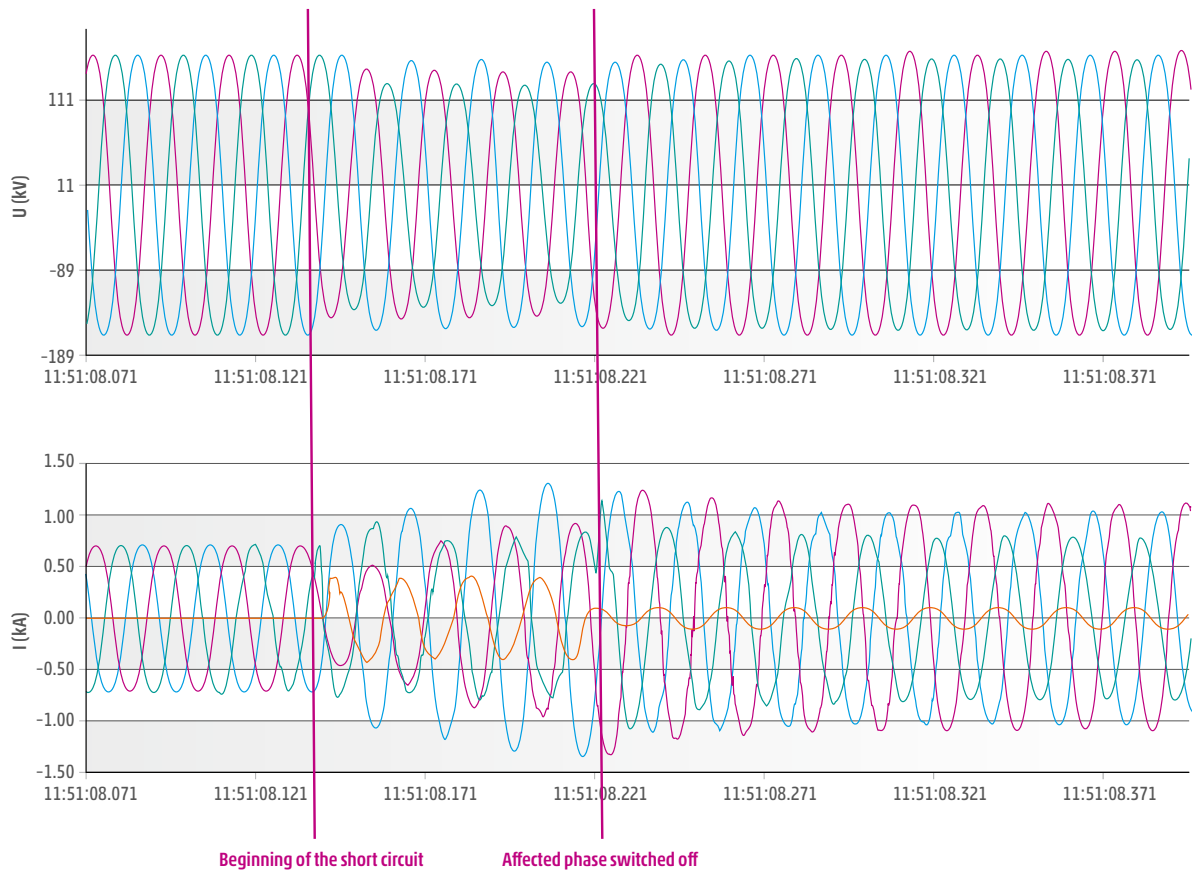
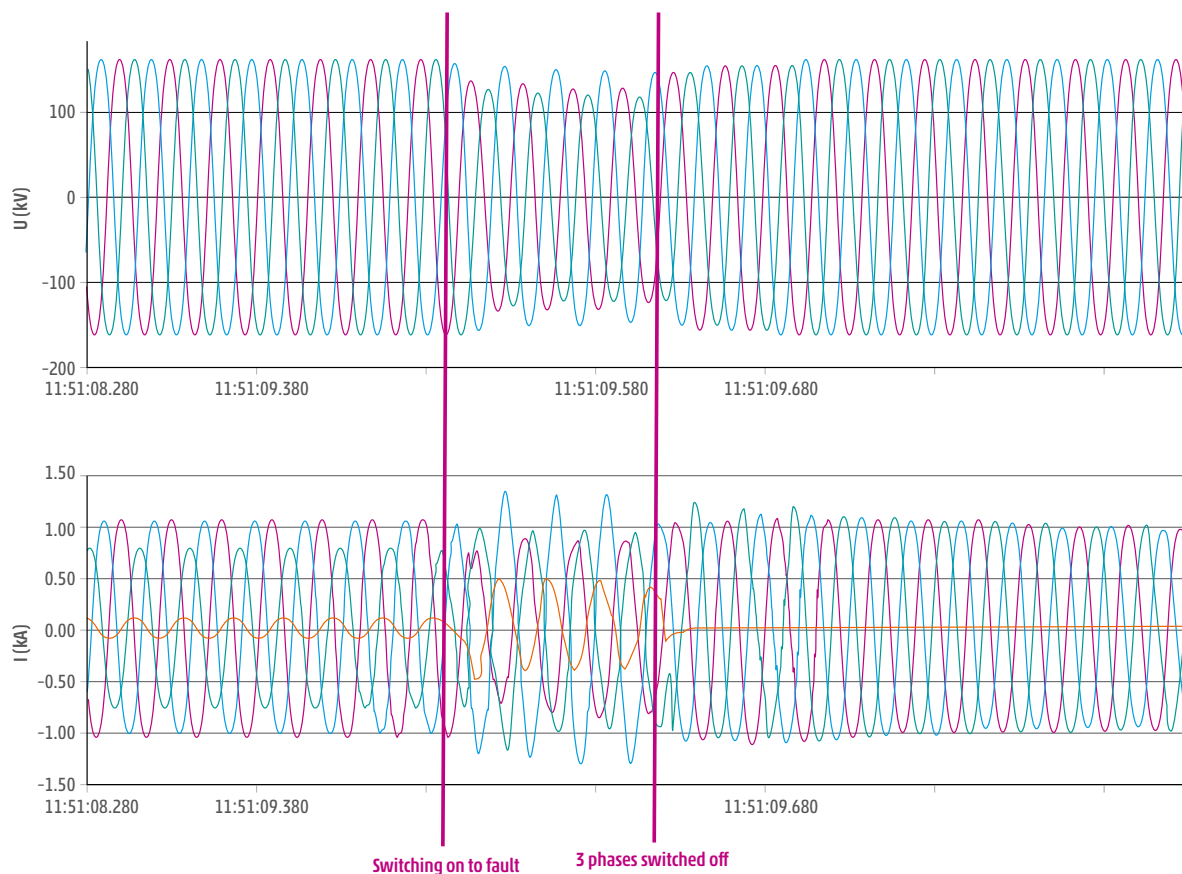
This measurement shows that on the 110 kV side of the T401BEZ transformer, the voltage in none of the three phases dropped below 100 kV during the entire fault period (i.e. during the initial one pole short circuit, during the single-pole auto-recloser or during the switch to the fault).

Since the measurement location is physically closer to the location of the initial fault itself, it can be evaluated that the voltage drop observed at the connection point of the PV did not exceed FRT limits.

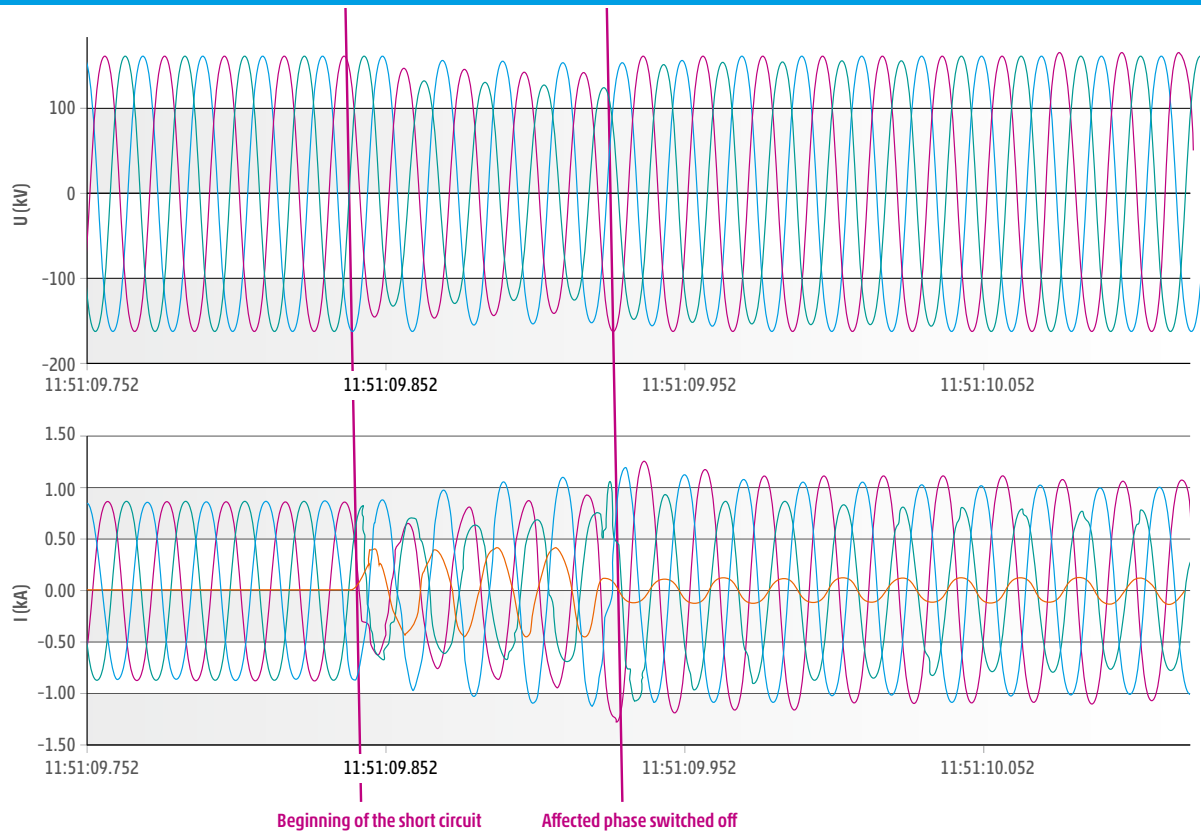
Figure 6.8: Measurements from the quality meters on the 110 kV side of the T403CST transformer at the beginning of the short circuit

The accurate measurements from the quality meters on the 110 kV side of the T403CST transformer show that, on

the 110 kV side of the T403CST transformer, the voltage in none of the three phases dropped below 100 kV during the entire fault period (i.e. during the initial one pole short circuit, during the single-pole auto-recloser, or during the switch to the fault).

Since the measurement location is physically closer to the location of the initial fault itself, it can be evaluated that the voltage drop observed at the connection point of PV B did not exceed FRT limits.

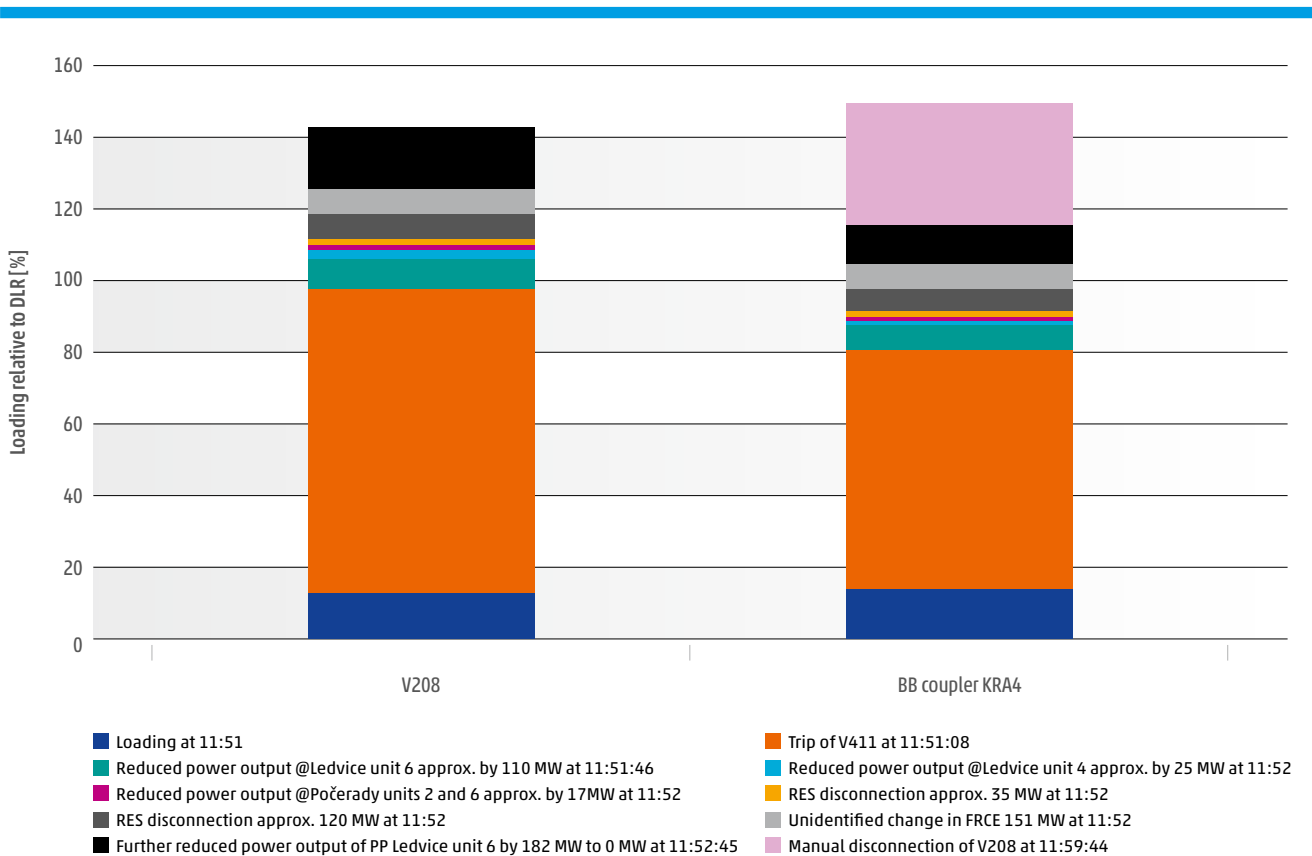
Figure 8.1: Decomposition of the loading of the line V208 and the busbar coupler at Krasíkov

led to a severe overload of V208, reaching up to 142%. After that, the line V208 was disconnected, marking the point of no return (as described in the fault tree).

For a detailed time series of the loading of affected elements please refer to Figure 3.4 and Figure 3.5

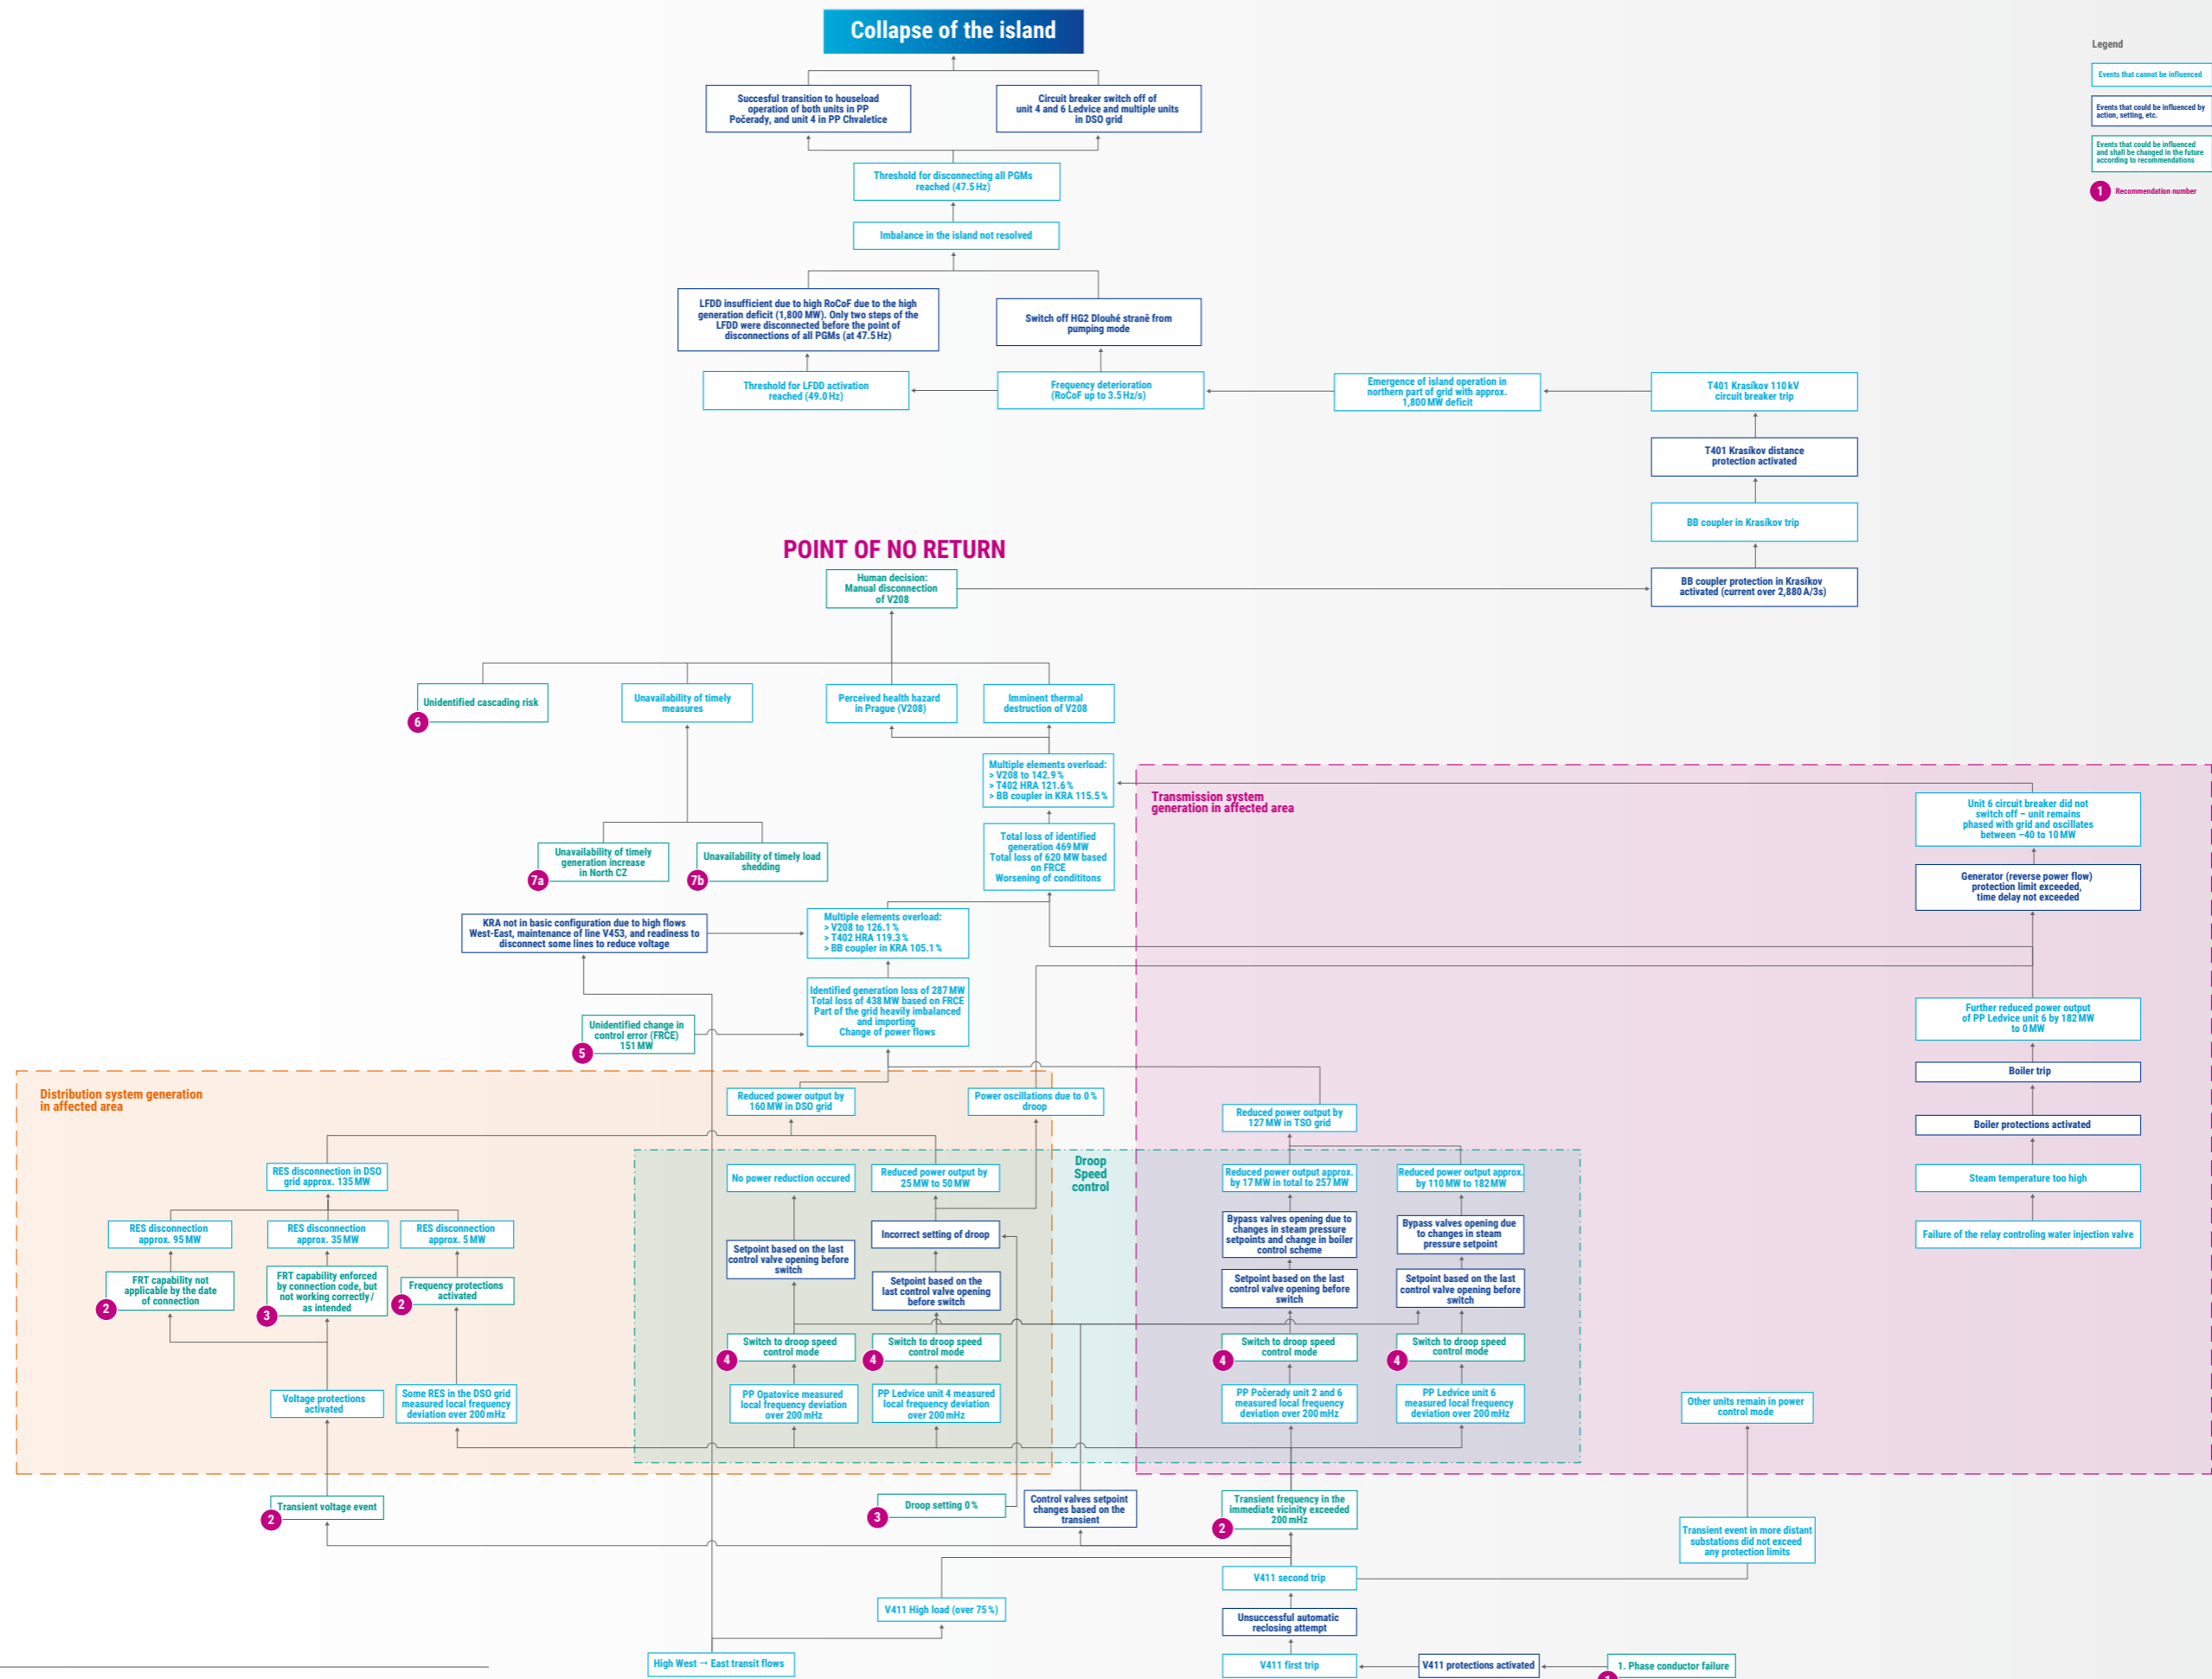
Figure 8.2: Root Cause Tree

The numbers at selected events refer to recommendations addressing these events. Those are described in Chapter 9.
